State of the Art Report on Past Performance of Steel Moment-Frame Buildings in Earthquakes

SAC Joint Venture

September 2000

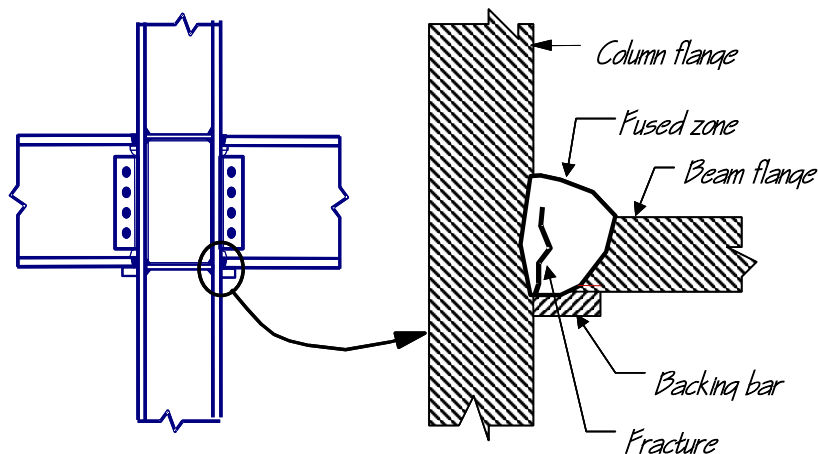
Observation of damage sustained by buildings in the 1994 Northridge earthquake indicated that contrary to the intended behavior, in many cases brittle fractures initiated within the connections at very low levels of plastic demand, and in some cases, while the structures remained essentially elastic. Typically, but not always, fractures initiated at the complete joint penetration (CJP) weld between the beam bottom flange and column flange (Figure 1-2). Once initiated, these fractures progressed along a number of different paths, depending on the individual joint conditions.

Figure 1-2 Common Zone of Fracture Initiation in Beam-Column Connection

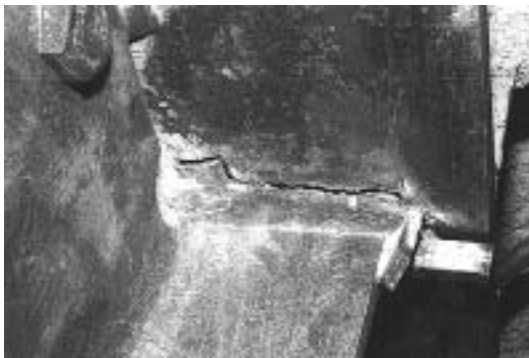
In some cases, the fractures progressed completely through the thickness of the weld, and when fire protective finishes were removed, the fractures were evident as a crack through exposed faces of the weld, or the metal just behind the weld (Figure 1-3a). Other fracture patterns also developed. In some cases, the fracture developed into a crack of the column flange material behind the CJP weld (Figure 1-3b). In these cases, a portion of the column flange remained bonded to the beam flange, but pulled free from the remainder of the column. This fracture pattern has sometimes been termed a “divot” or “nugget” failure.

a. Fracture at Fused Zone

Figure 1-3 Fractures of Beam-to-Column Joints

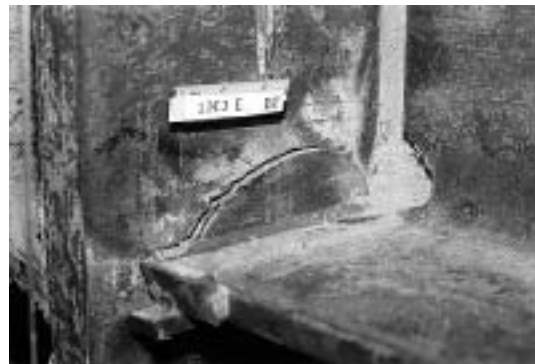
b. Column Flange "Divot" Fracture

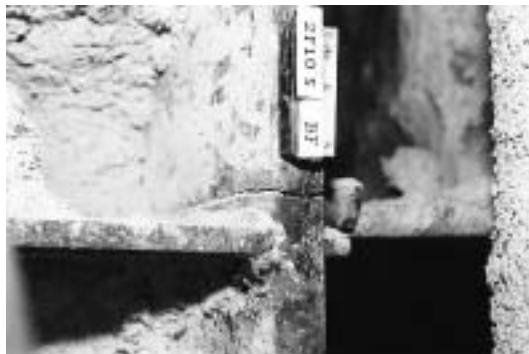
A number of fractures progressed completely through the column flange, along a near-horizontal plane that aligns approximately with the beam lower flange (Figure 1-4a). In some cases, these fractures extended into the column web and progressed across the panel zone (Figure 1-4b). Investigators have reported some instances where columns fractured entirely across the section.

a. Fractures through Column Flange

Figure 1-4 Column Fractures

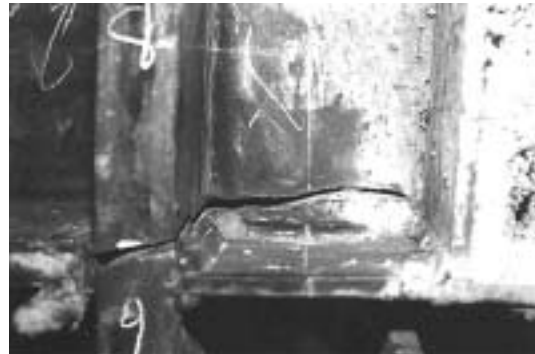
a. Fracture Progresses into Column Web

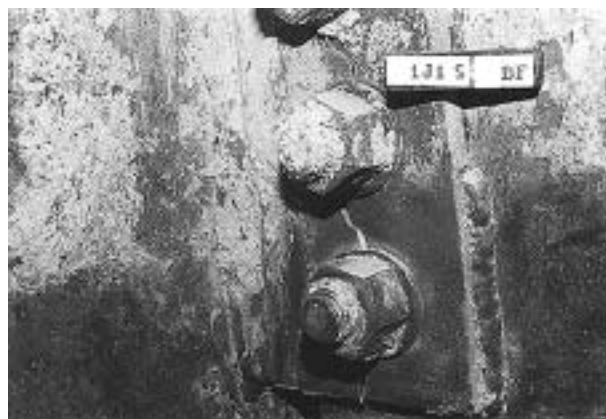
Once such fractures have occurred, the beam-column connection has experienced a significant loss of flexural rigidity and strength to resist those loads that tend to open the crack. Residual flexural strength and rigidity must be developed through a couple consisting of forces transmitted through the remaining top flange connection and the web bolts. However, in providing this residual strength and stiffness, the bolted web connections can themselves be subject to failures. These include fracturing of the welds of the shear plate to the column, fracturing of supplemental welds to the beam web, or fracturing through the weak section of shear plate aligning with the bolt holes (Figure 1-5).

Figure 1-5 Vertical Fracture through Beam Shear Plate Connection

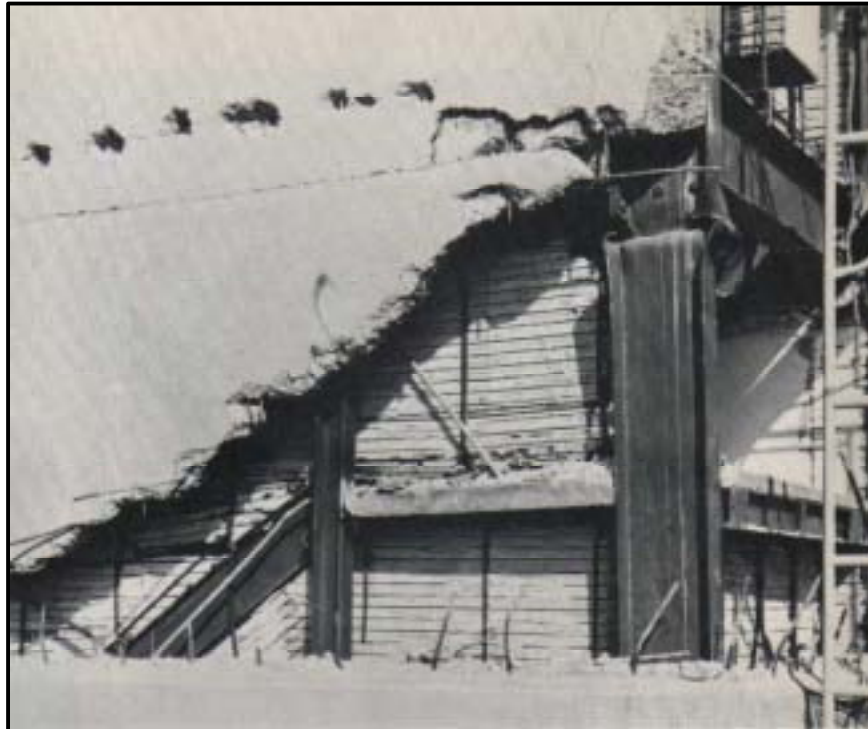
The Cordova building, a six-story office building, suffered perhaps the worst steel frame damage. The building had a full steel moment frame in one direction and “partial moment-resisting beam-to-column connections [in the other].” Moment connections were made using shop welding and field bolting with high-strength bolts. Damage was generally concentrated at the first floor where a number of wide flange columns (typically 14WF30 or 14WF61) buckled. The damage appears to be axially induced with the column flanges sometimes tearing away from the column web directly below the beam-column connection. A damaged column is shown in Figure 5-1. Popov and Bertero (1970) would later cite damage at the Cordova Building as an indication that monotonic testing is inadequate for demonstrating seismic performance.

Figure 5-1 Damaged Moment-Frame Column, Prince William Sound Earthquake, 1964

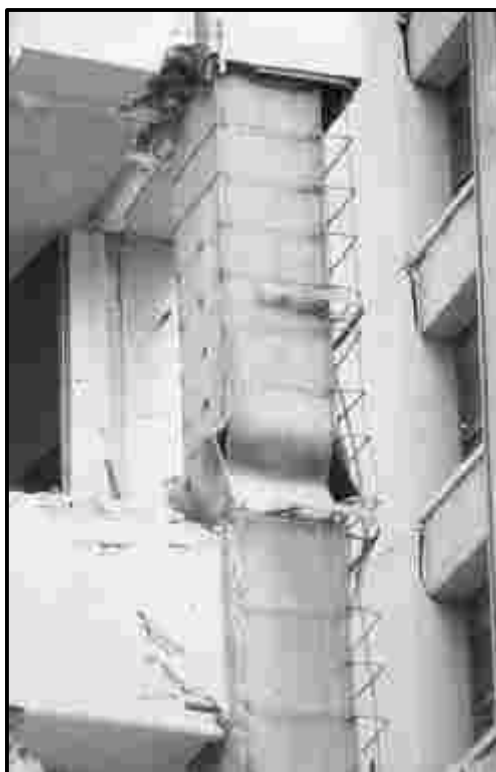
The Pino Suarez buildings used a combination of steel moment frames and braced frames. Box columns were formed from four welded plates. Girders were built up sections consisting of plates welded to angle sections forming a flange, with diagonal angle webs. The flange plates were welded to horizontal shear tabs, which were welded to the columns. Figure 5-2 shows a damaged column. Damage was typically in the box columns, which buckled and were probably the ultimate cause of the collapse and near collapse of the 21-story structures.

Figure 5-2 Damage to Steel Frame Column, Mexico City Earthquake, 1985

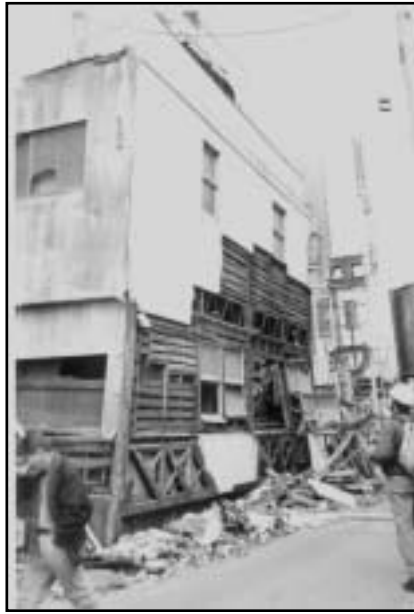
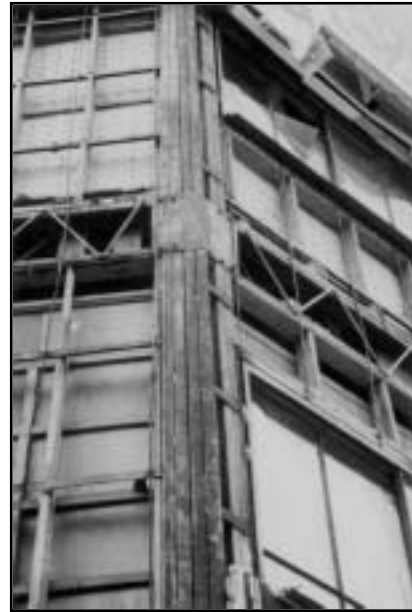
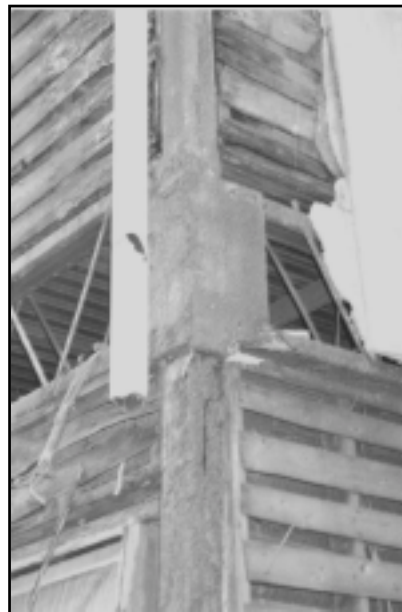
Figure C-2 Damage to Old Steel Buildings; (a) Collapse; (b) Construction with Light-Gauged Sections; (c) Corroded Sections

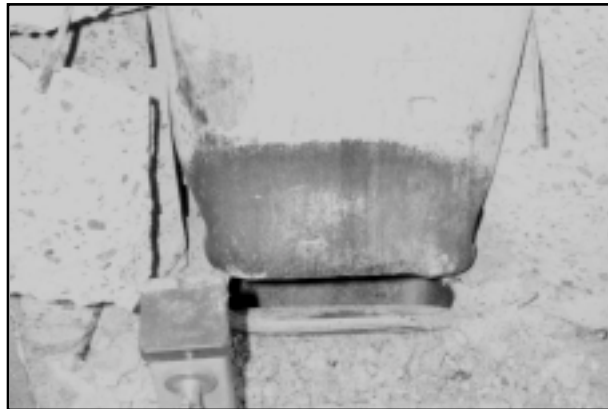
Figure C-8 Fracture at Cold-Formed Square Tube Column

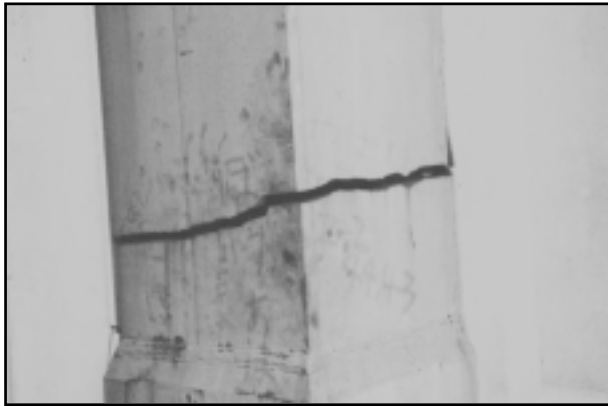
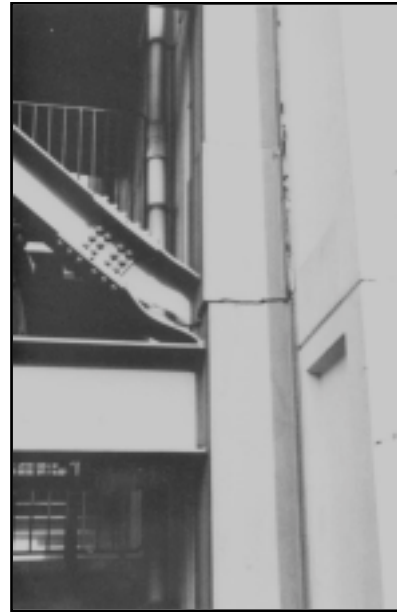
**Figure C-9 Fracture of Square Tube Jumbo Columns; (a) Fracture at Base Metal;
(b) Fracture at Brace-To-Column Connection**

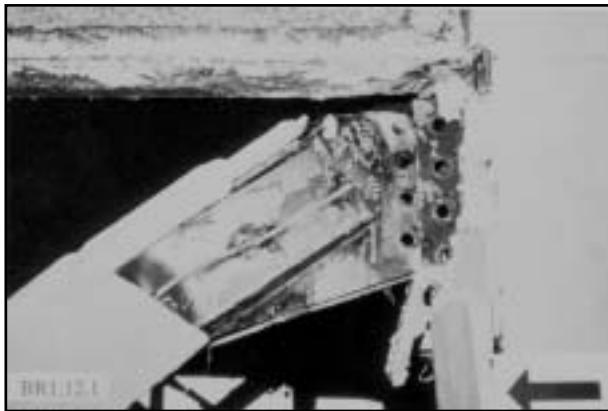
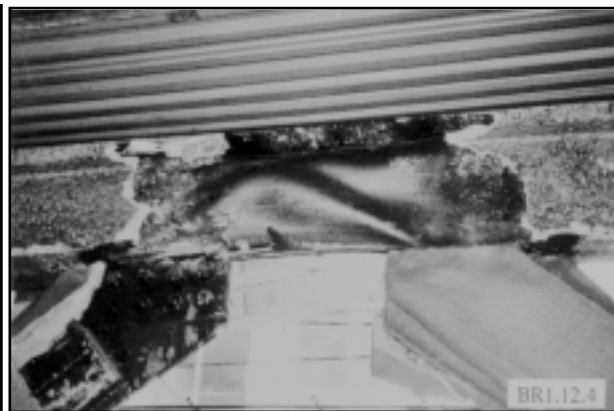
**Figure C-10 Damage To Brace Connections; (a) Breakage of Bolts; (b) Beam Web
Buckling and Out-of-Plane Deformation**

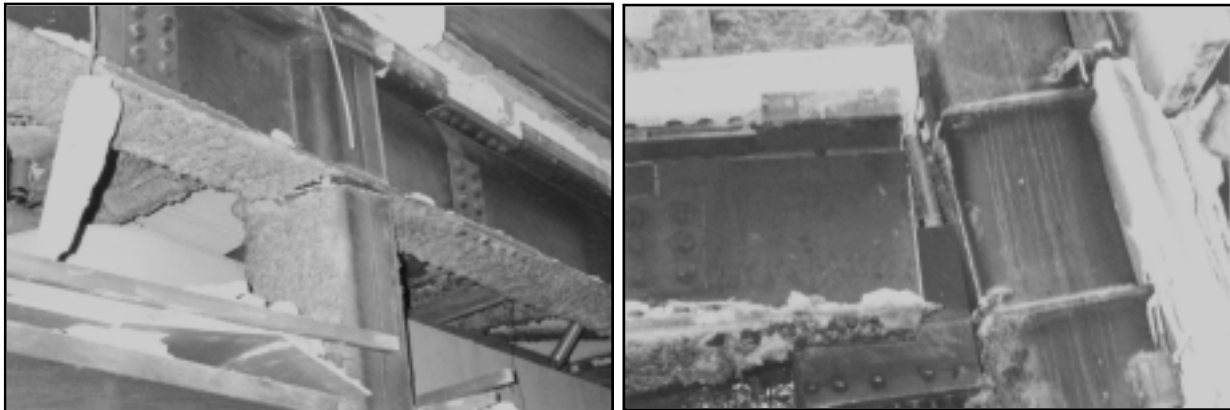
Figure C-12 Fracture at Beam-To-Column Connections with Fillet Welding of Small Sizes; (a) Fracture at Column Top; (b) Fracture at Beam End

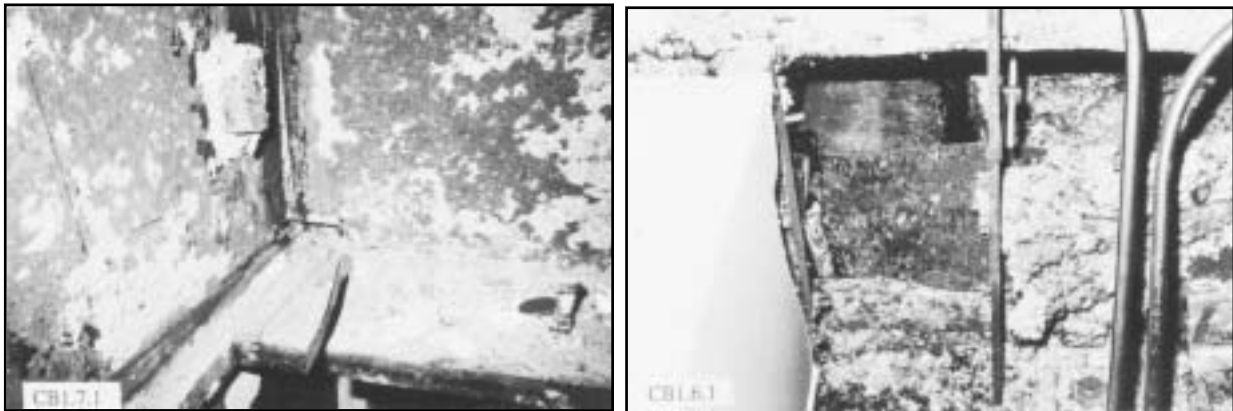
Figure C-13 Fracture at Beam-To-Column Connections with Full Penetration Groove Welding; (a) Fracture at Base Metal Initiating from Toe of Weld Access Hole; (b) Fracture Involving Yielding and Local Buckling

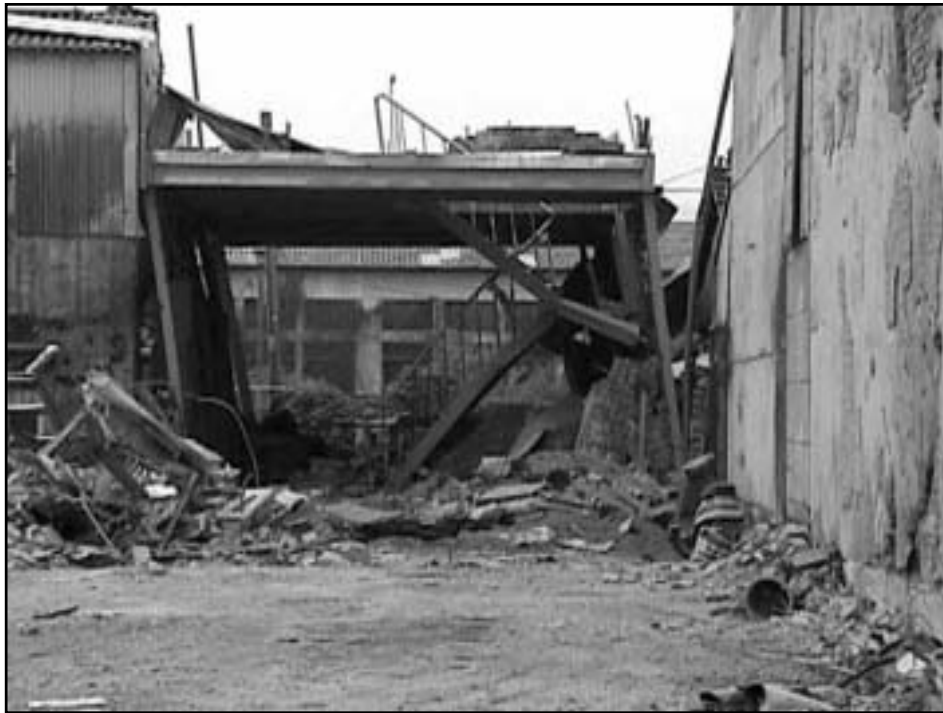
Figure D-1 Permanent Lateral Displacement in Small Steel Frame

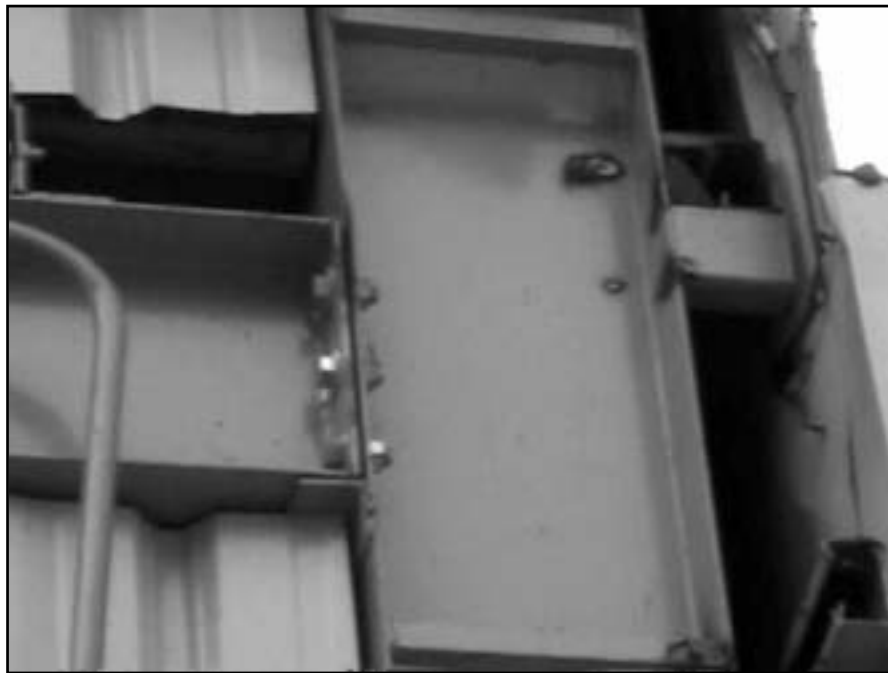
Figure D-4 Bolted End Plate Connection in Light Steel Frame Building Showing Evidence of Local Yielding
