# Chile Earthquake – 2/27/2010

## Implications for U.S. Building Codes and Standards

John Wallace, EERI LFE Team Member  
John Hooper, ASCE SEI Team Leader

San Francisco – June 2, 2010

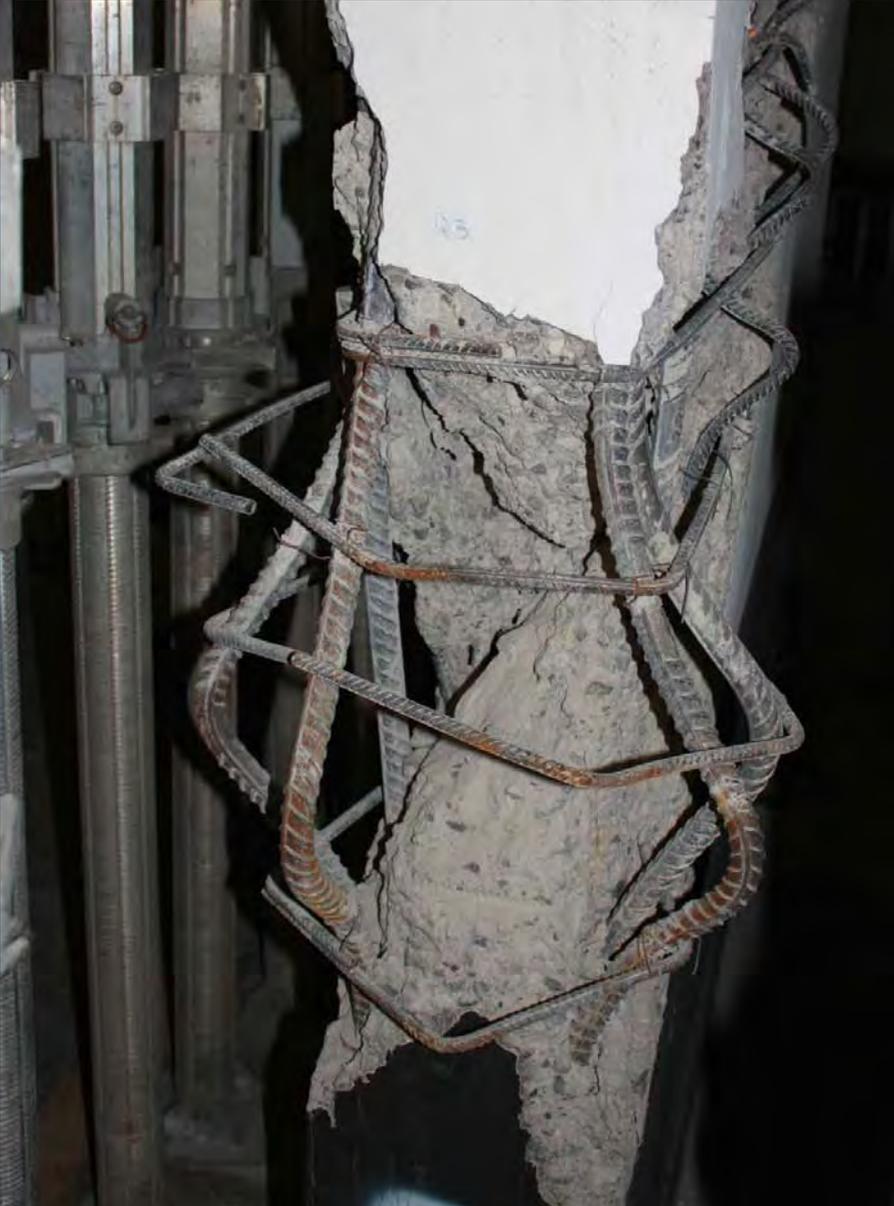
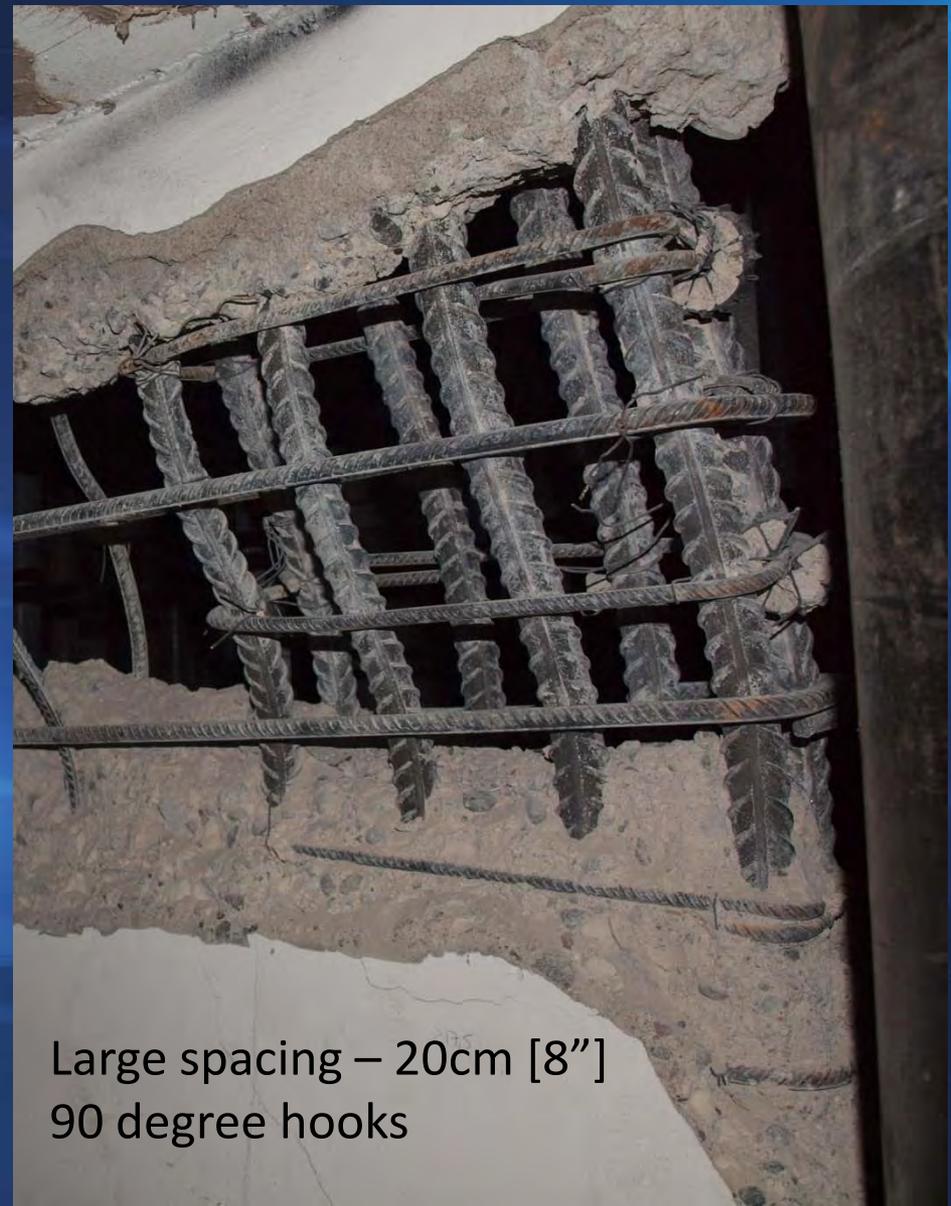
- Chile Code NCh 433.Of96 is based on ACI 318-95 with important exceptions
- Chapter 21 – Section 21.6.6
  - “Special Boundary Elements”
  - Transverse reinforcement at wall boundary to confine the concrete and restrain rebar buckling is not required based on the good performance of wall buildings in Viña del Mar in the 1985 earthquake.
- ACI 318-02 added modified requirements for required transverse reinforcement at splices

Large spacing – 20cm [8"]  
90 degree hooks

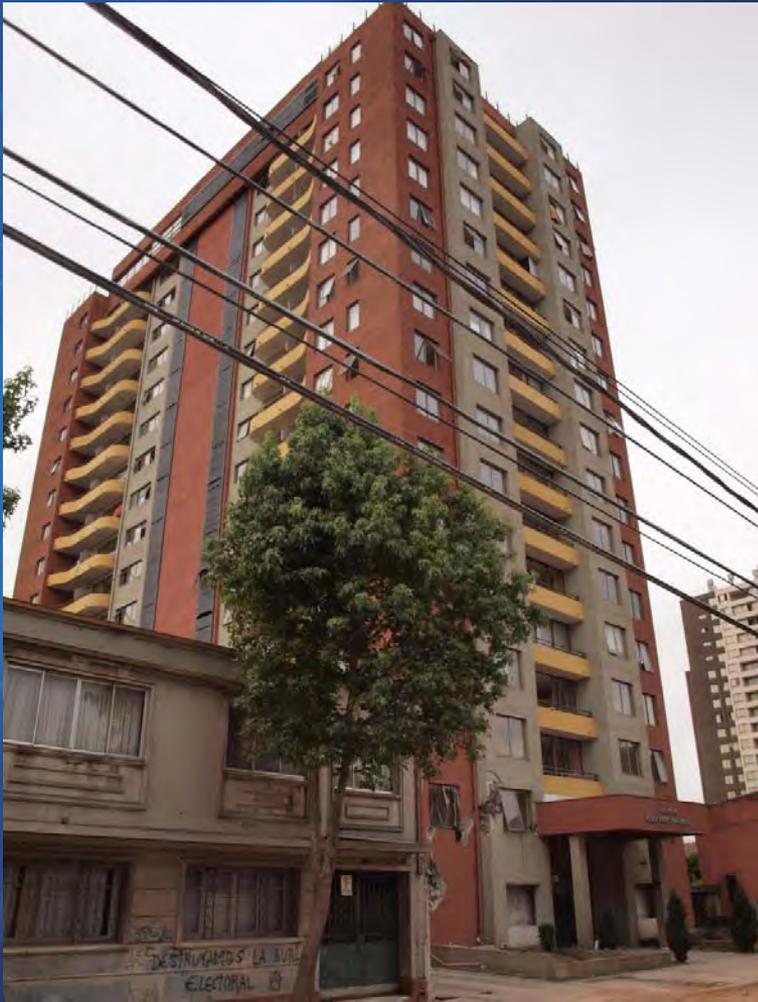
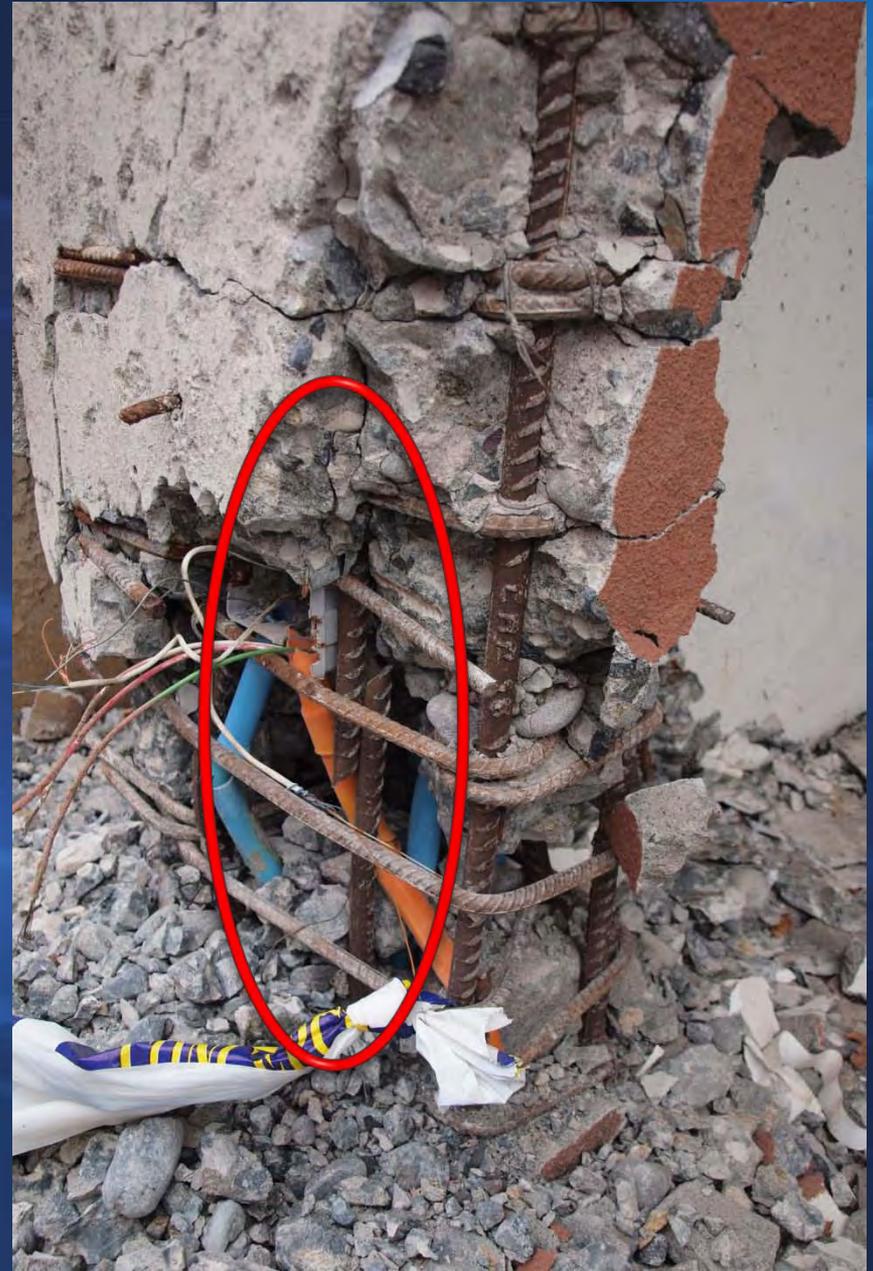
- Lightly-reinforced and poorly-detailed walls

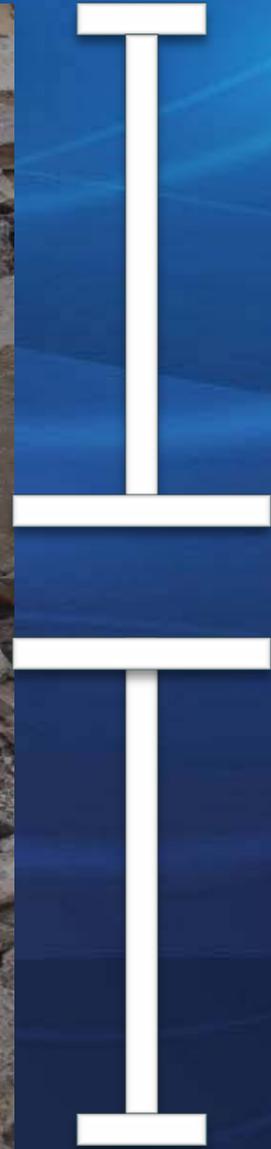
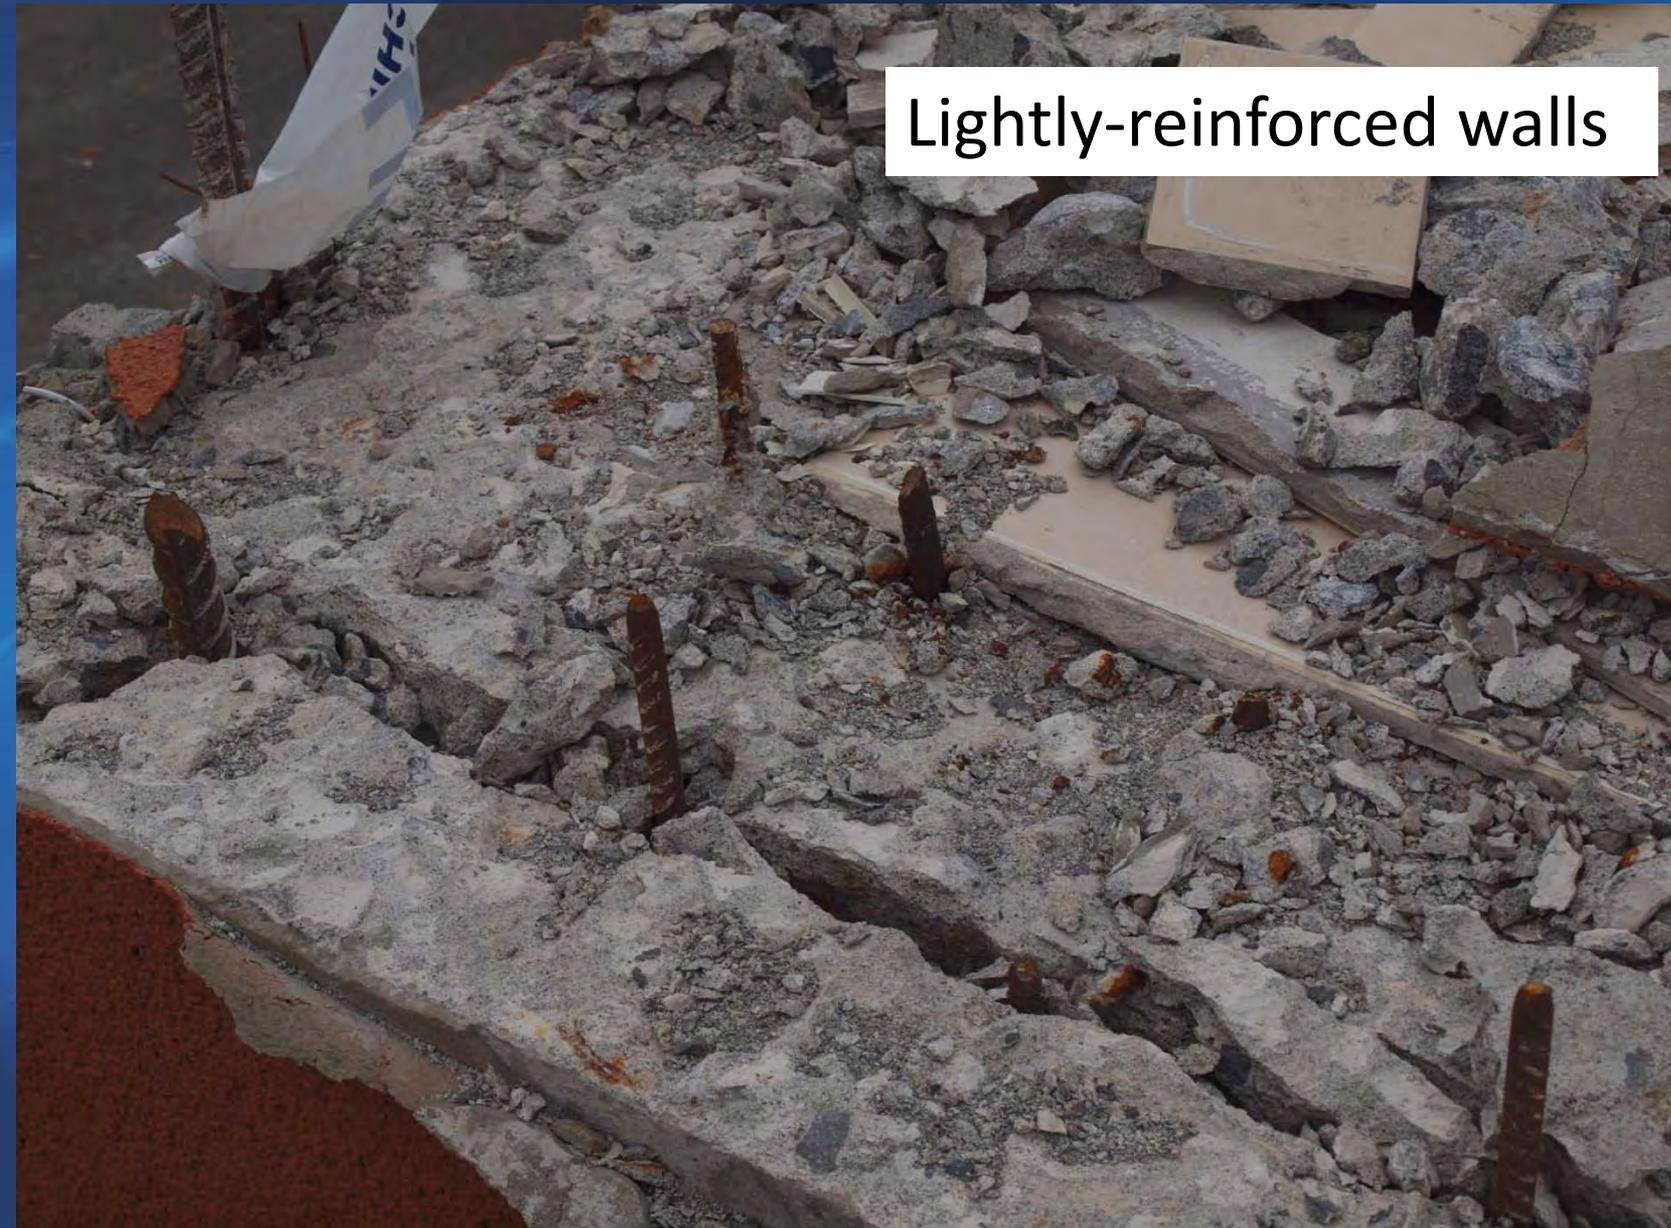
Lightly-reinforced walls

- Lightly-reinforced or poorly-detailed walls
  - Tension fracture [lightly-reinforced]
  - Tensile yielding, followed by buckling and concrete spalling, followed by fracture [poorly-detailed]
  - Concentration of nonlinear deformation over short length or at a single crack
  - Potential for unzipping of wall

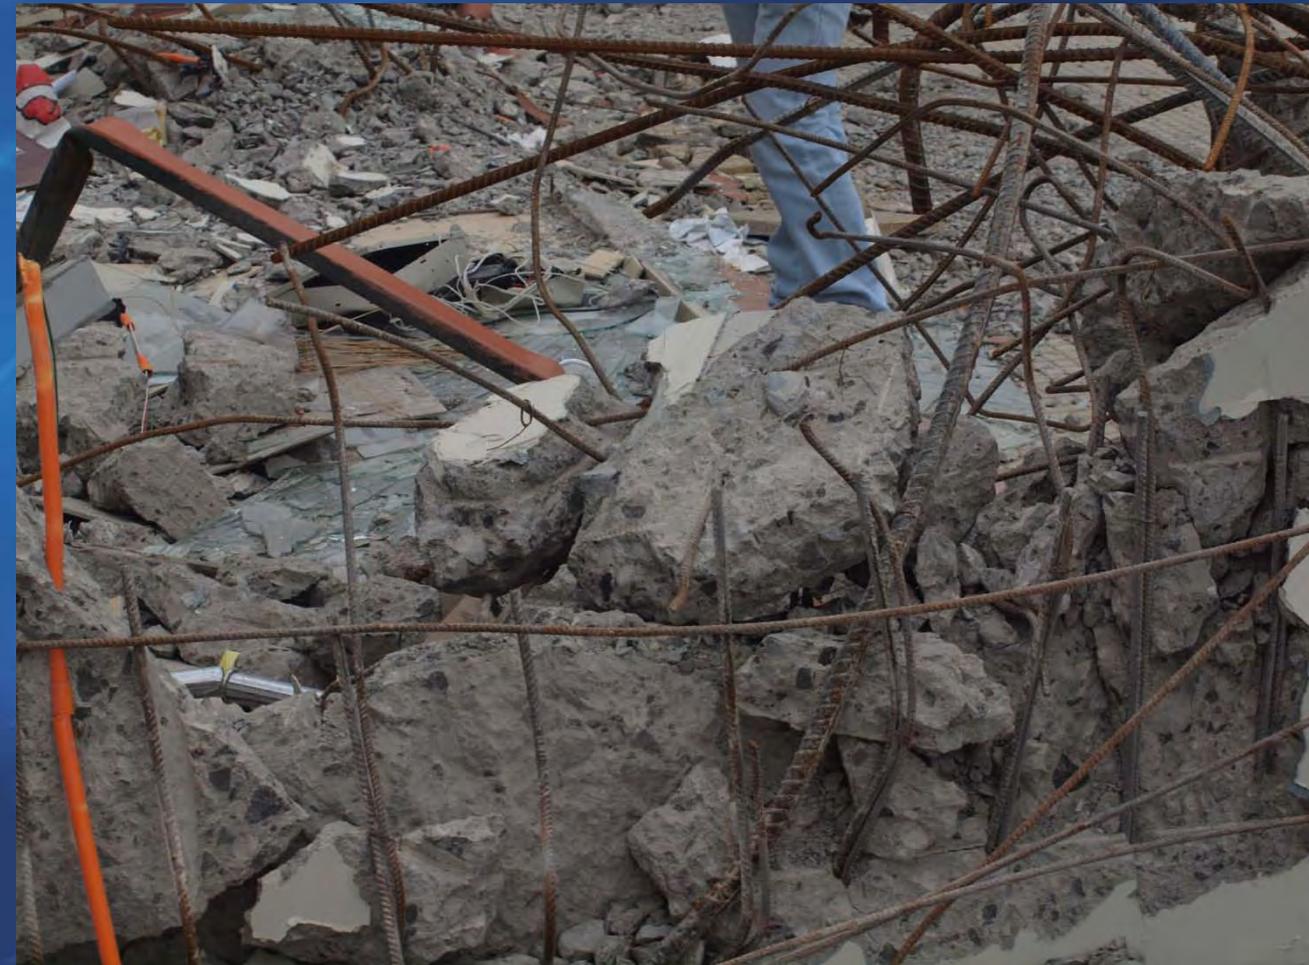
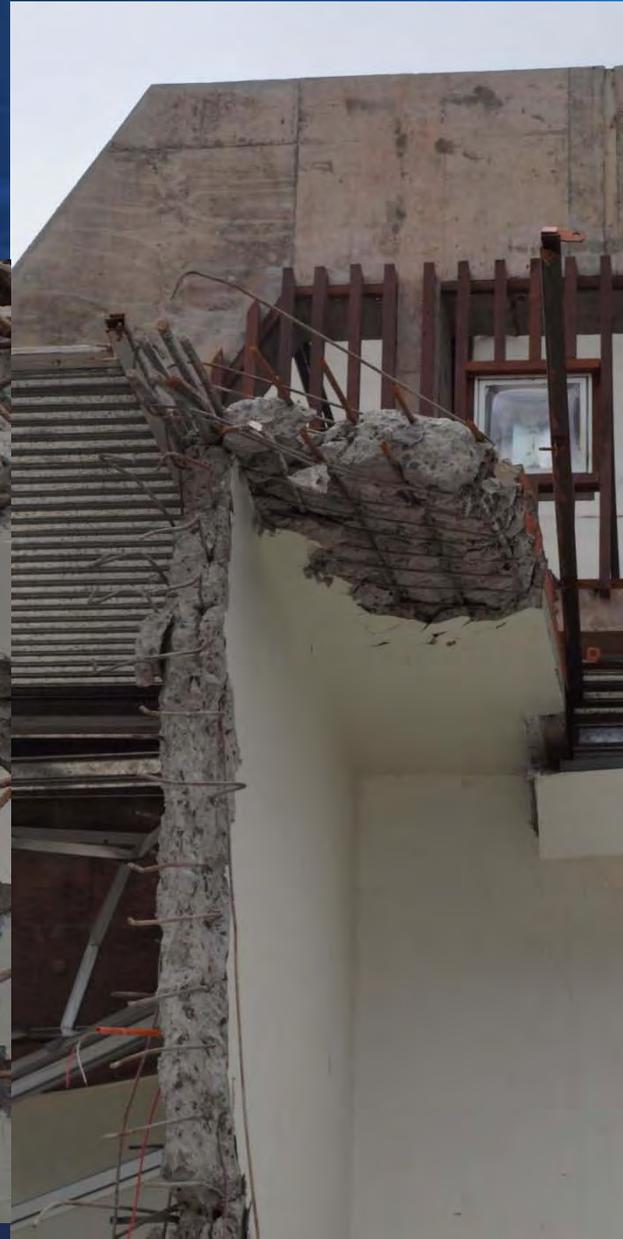
- “Unconfined Splices”

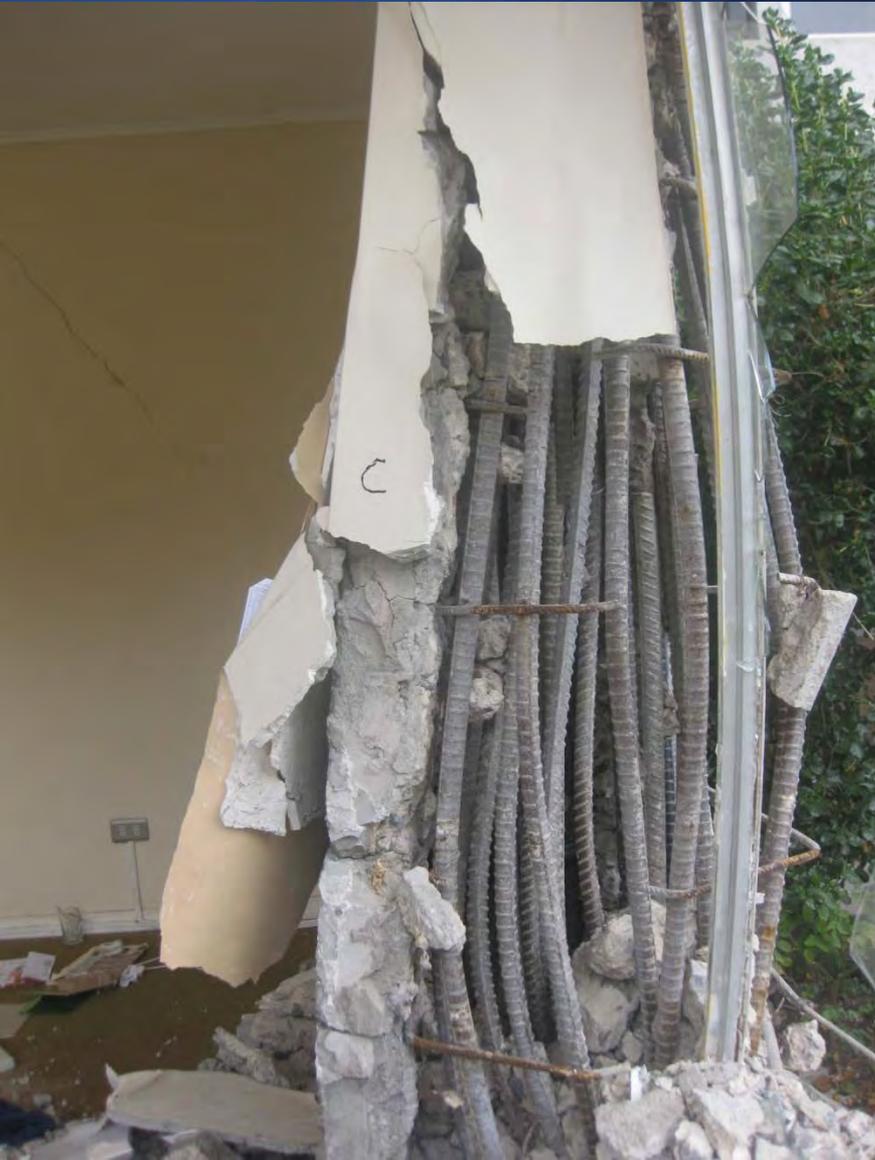
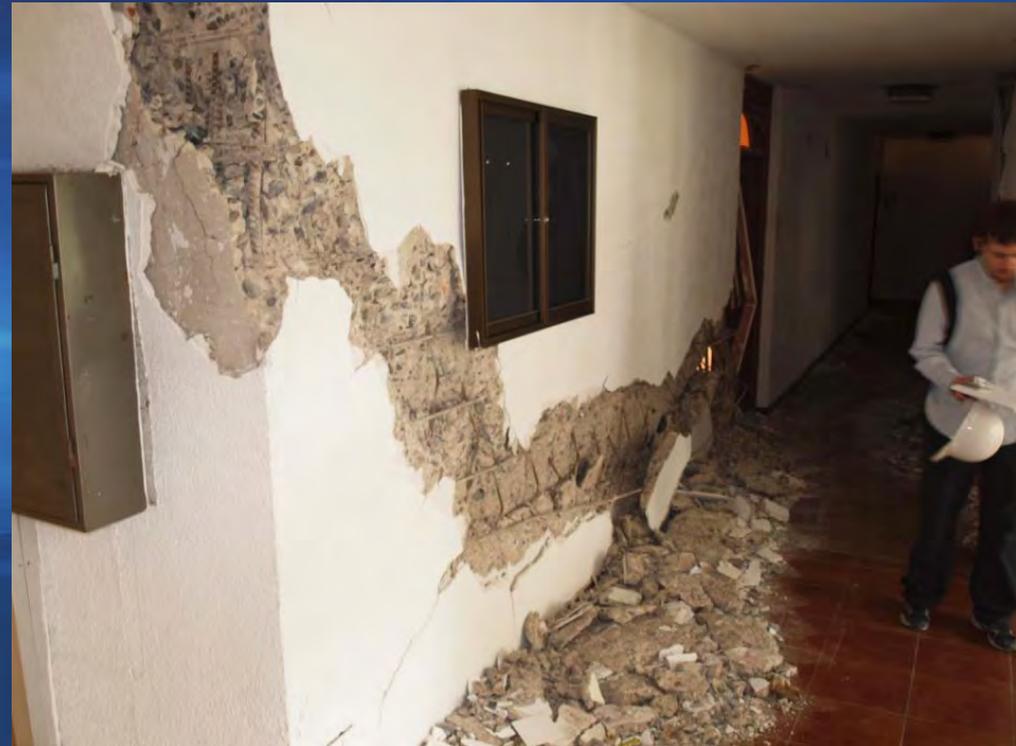
Post-1985 study indicated shear stress of about  $1.3V_n$

Demands (spectral) similar for 1985 and 2010 earthquake
