NIST GCR 14-917-25

Recommendations for Seismic Design of Reinforced Concrete Wall Buildings Based on Studies of the 2010 Maule, Chile Earthquake

NEHRP Consultants Joint Venture
*A partnership of the Applied Technology Council and the
Consortium of Universities for Research in Earthquake Engineering*

March 2014

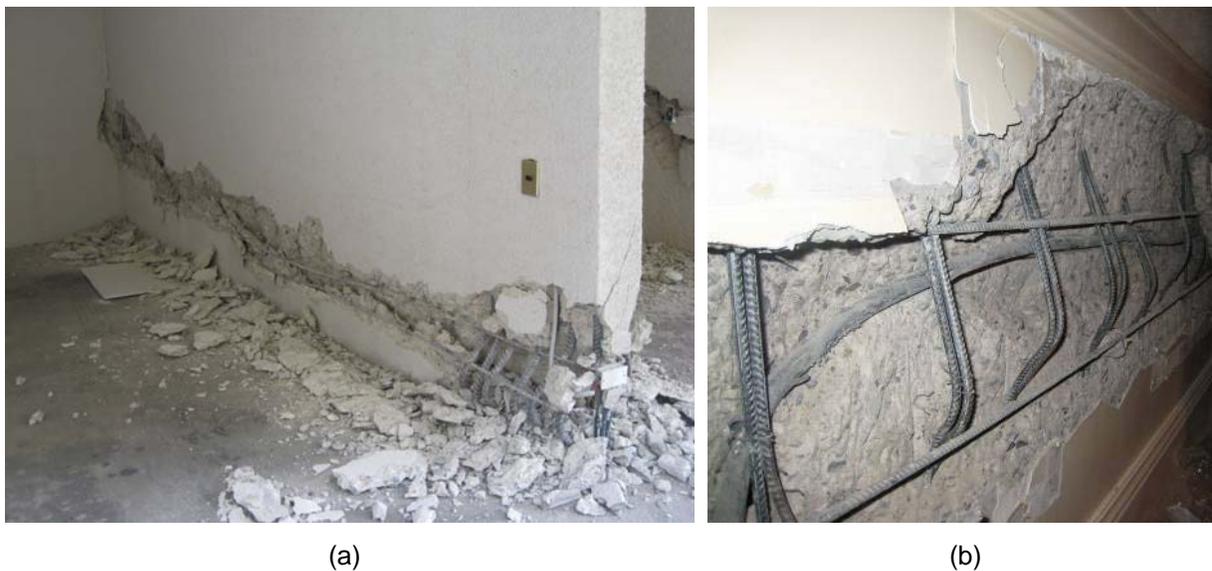
Figure 1-5 Concrete crushing and buckling of longitudinal reinforcement initiating at wall boundaries and propagating along the length of wall segments: (a) photo courtesy of Patricio Bonelli; (b) photo courtesy of Joseph Maffei.

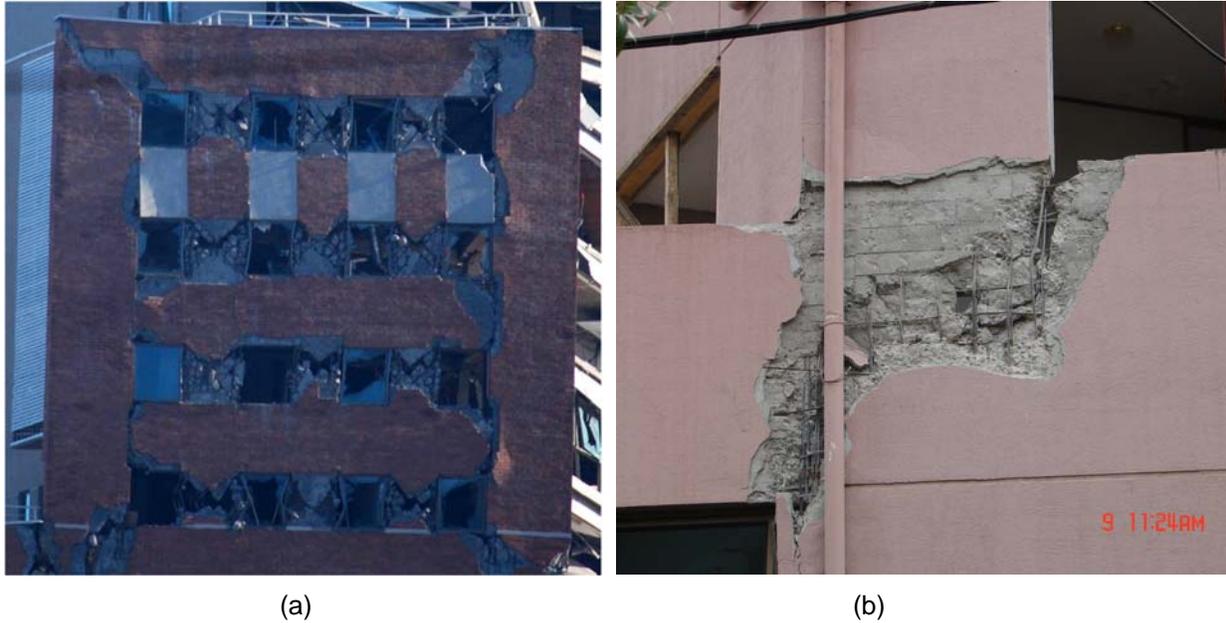
Figure 1-6 Shear failures in vertical and horizontal wall segments: (a) photo courtesy of PEER; (b) photo courtesy of ASCE.

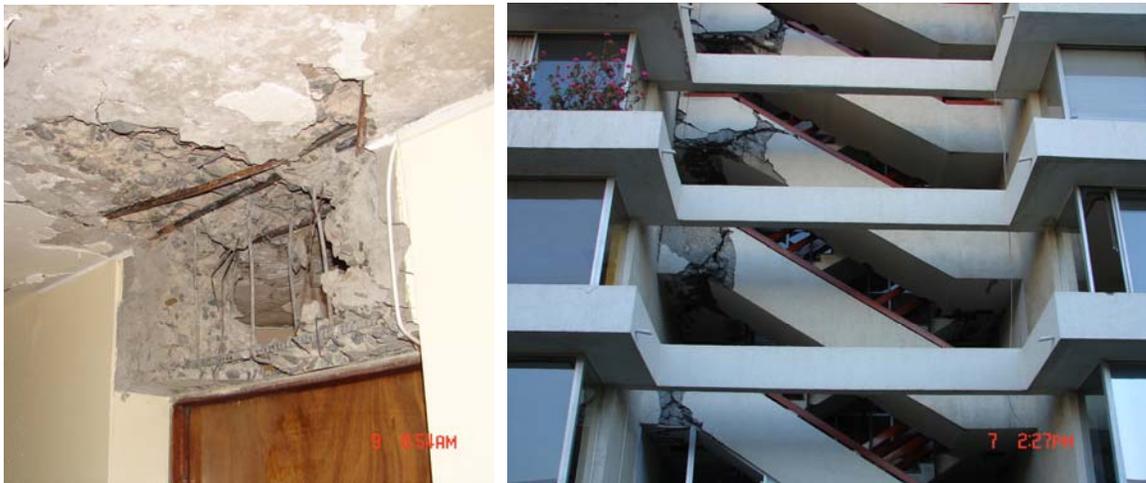
Figure 1-8 Concentrated damage at: (a) wall discontinuities (photo courtesy of Joseph Maffei); and (b) structural irregularities (photo courtesy of Joseph Maffei).

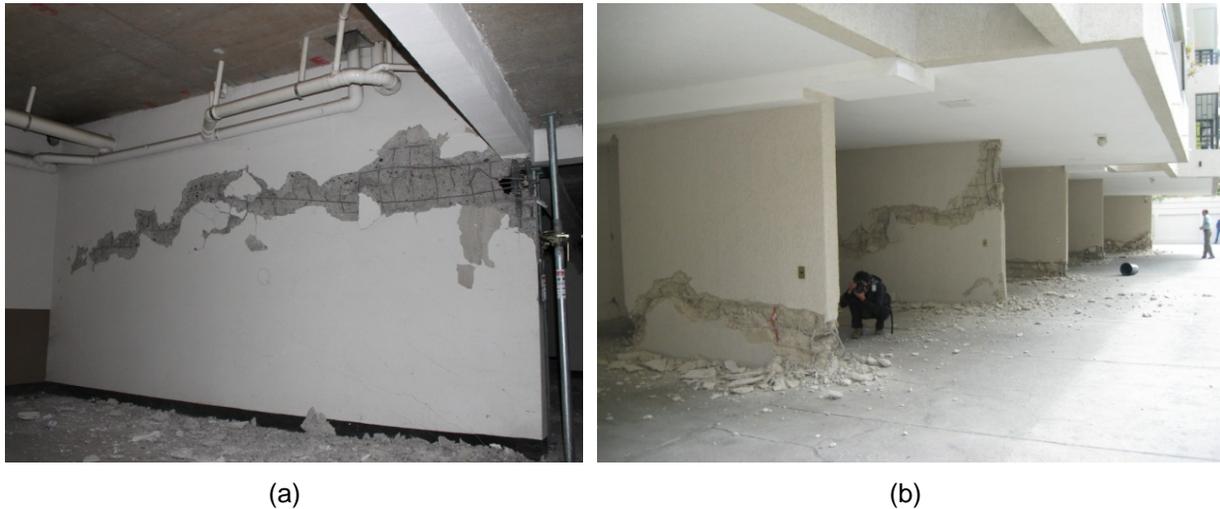
of cover concrete on each side results in about a 25% reduction in wall thickness. Once the cover concrete spalls, 90-degree hooks used to anchor transverse reinforcement at the wall boundaries are susceptible to opening, which makes them ineffective at confining the concrete core and providing stability to the vertical bars. Large spacing of transverse reinforcement and the use of 90-degree hooks likely contributed to buckling of vertical reinforcement, which led to the observed concentration of damage in shear walls.

Figure 2-1 Typical reinforced concrete shear wall damage in the 2010 Maule earthquake: (a) first subterranean level of an 18-story building in Santiago (photo courtesy of Jack Moehle); and (b) ground floor level of a 10-story building in Viña del Mar (photo courtesy of Patricio Bonelli).

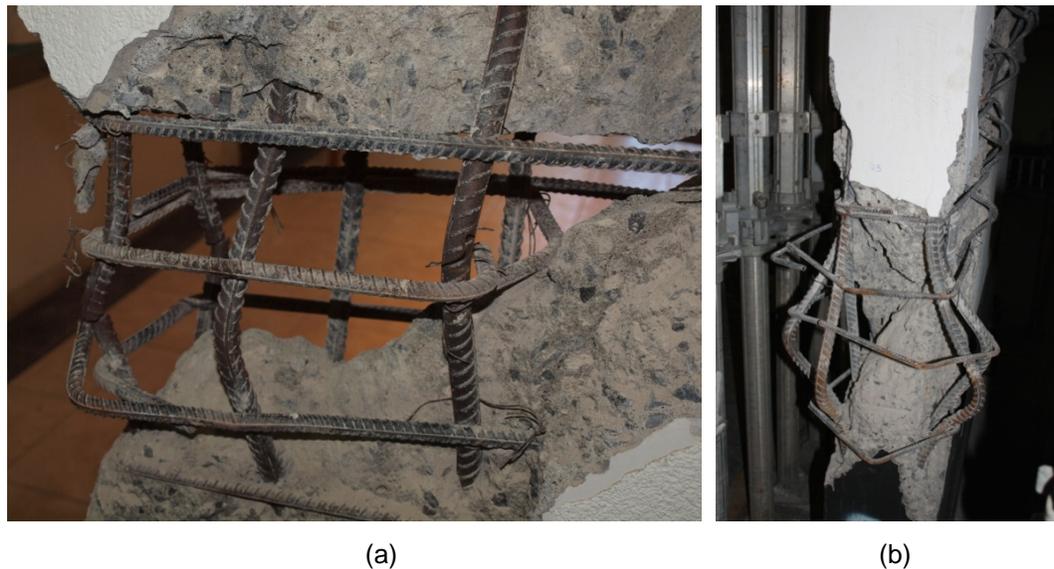
Figure 2-2 Typical detailing and observed damage to wall boundary regions: (a) ground floor level of a 23-story building in Coronel (photo courtesy of John Wallace); and (b) first subterranean level of a 20-story building in Santiago (photo courtesy of Jack Moehle).

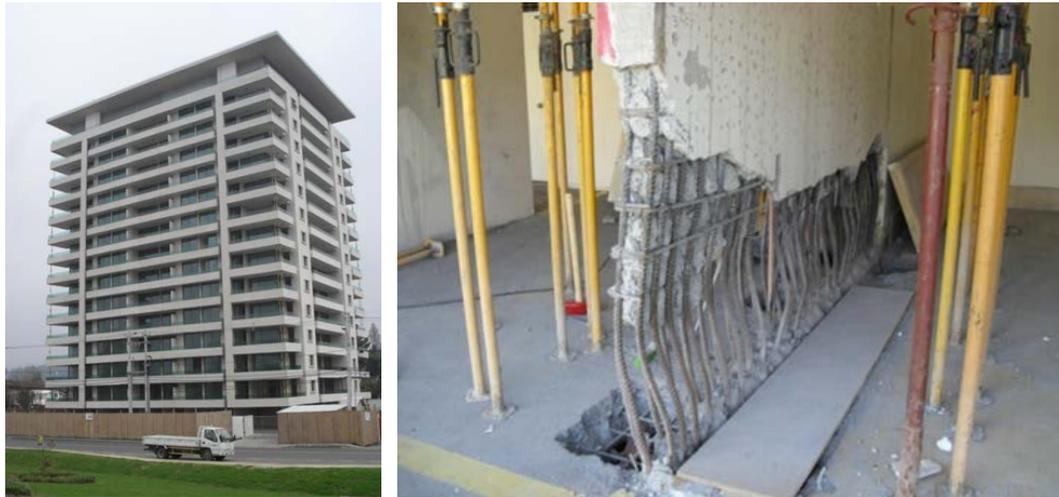
(a) (b)
Figure 3-4 Alto Huerto building: (a) East elevation; and (b) wall crushing and apparent wall buckling along Line Ñ (DICTUC, 2010d).

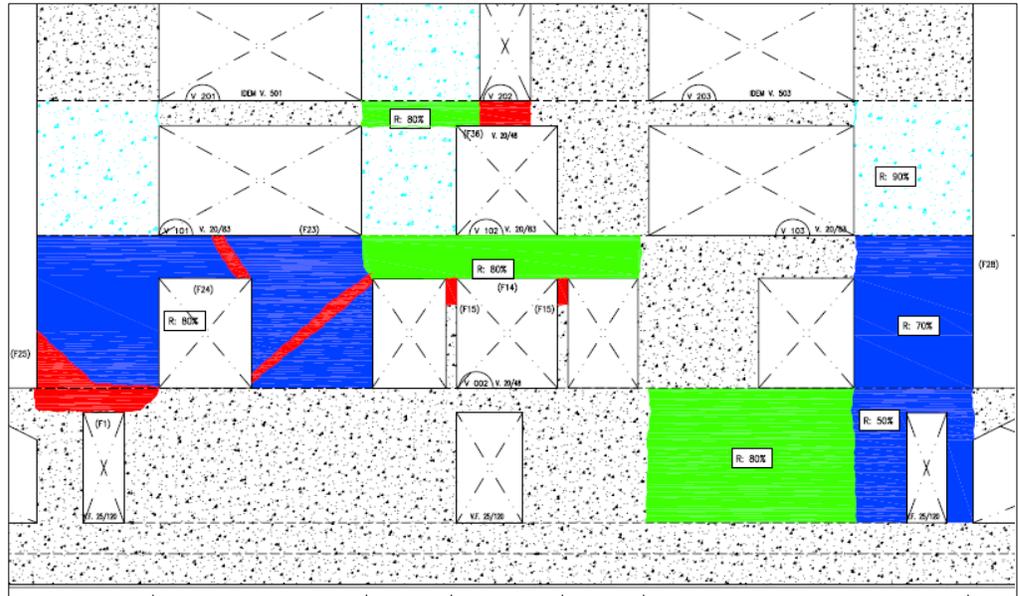
Figure 4-6 Sketch of building section, including the region shown in Figure 4-5, showing location and severity of damage (green indicates minor damage; blue indicates moderate damage; red indicates severe damage).

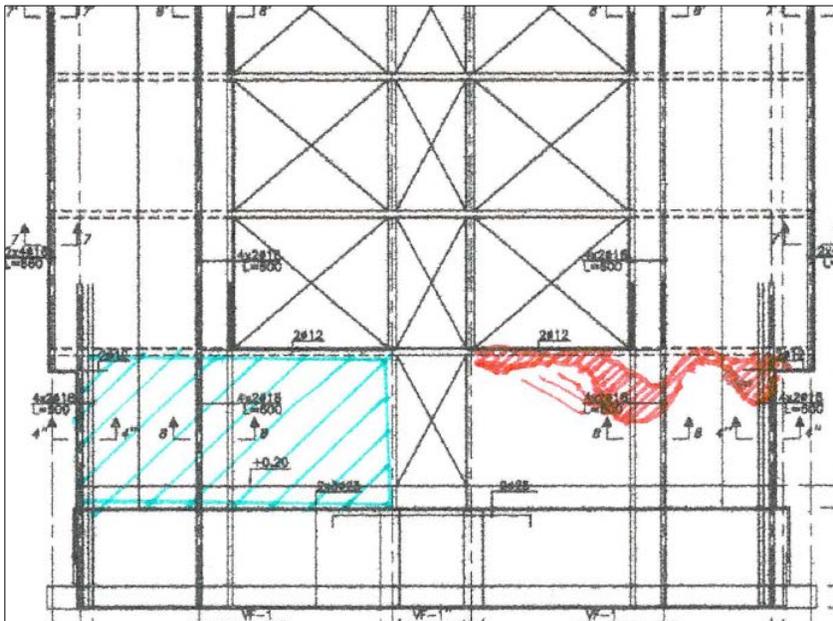
Figure 4-9 Sketch of damaged region in Plaza del Rio Building A; blue hatched region indicates moderate cracking and red hatched region indicates severe damage.

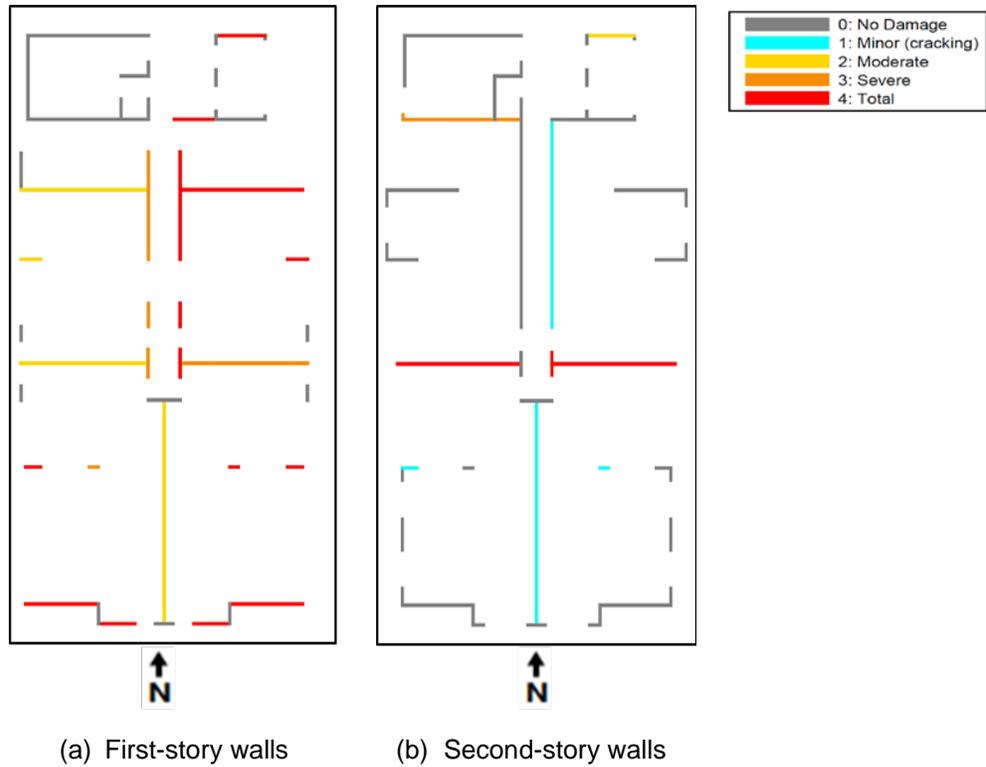
Figure 4-21 Layout of walls in the lower two stories of Plaza del Rio Building A (colors indicate level of observed damage).

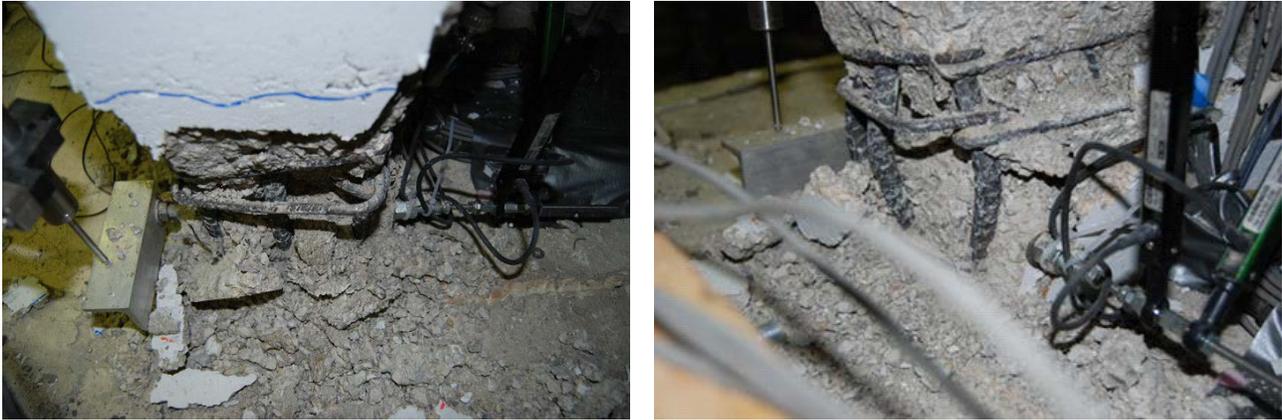
Figure 5-8 Failed toe of specimen PW4 at 0.75% drift (Lowes et al., 2011).

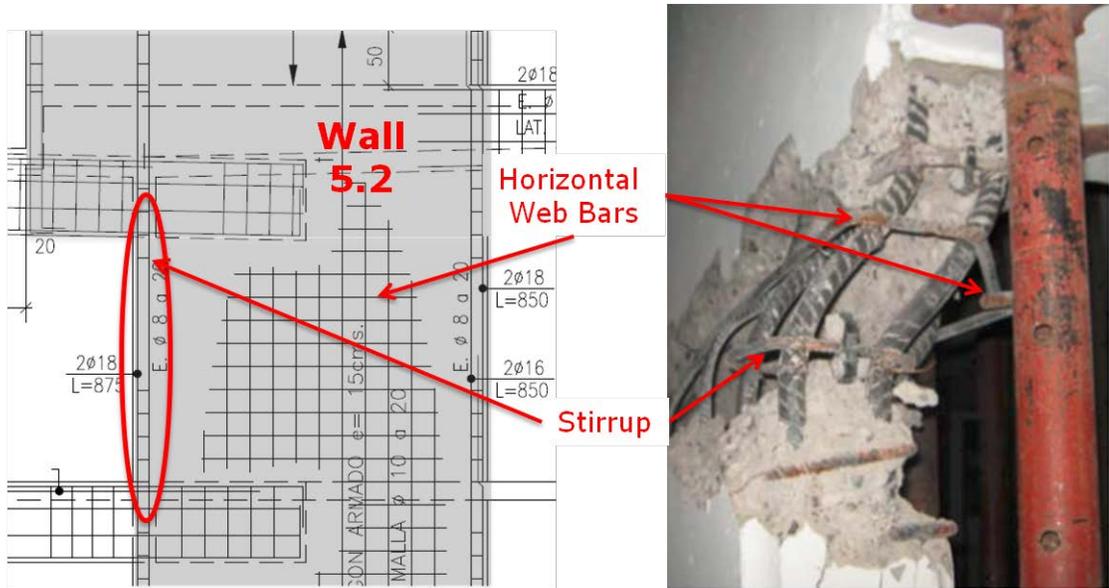
Figure A-11 Undisclosed Building A (Building No. 5) – wall reinforcing details and observed damage at the wall boundary (photo courtesy of Carl Luders).

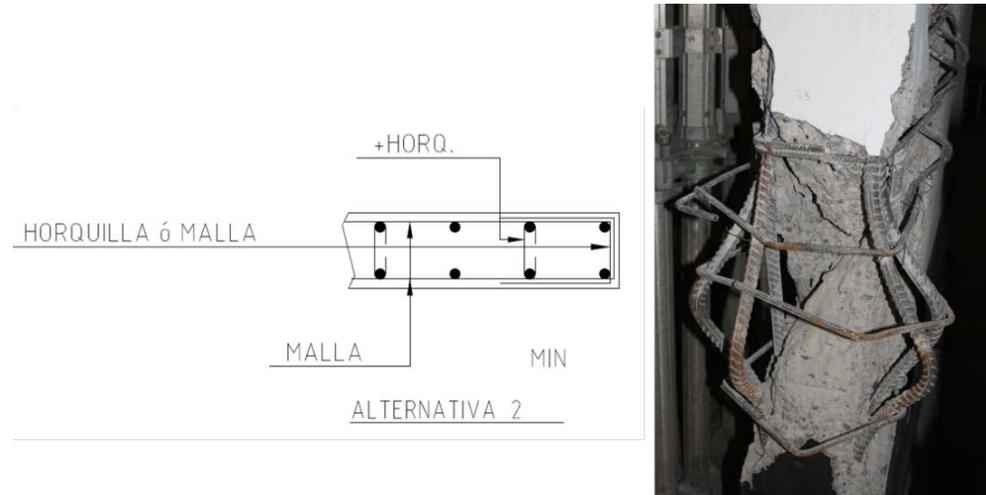
Figure A-13 Undisclosed Building B (Building No. 6) – typical wall boundary detail and photo of exposed reinforcement in the boundary of a damaged wall (photo courtesy of Jack Moehle).

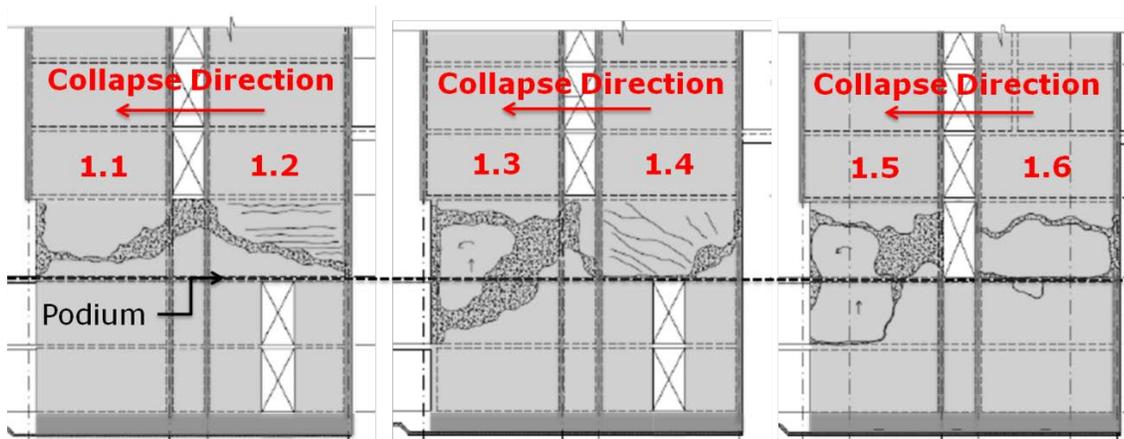
Figure A-26 Illustration of damage reported in walls of Alto Rio (Building No. 1) (IDIEM, 2010).

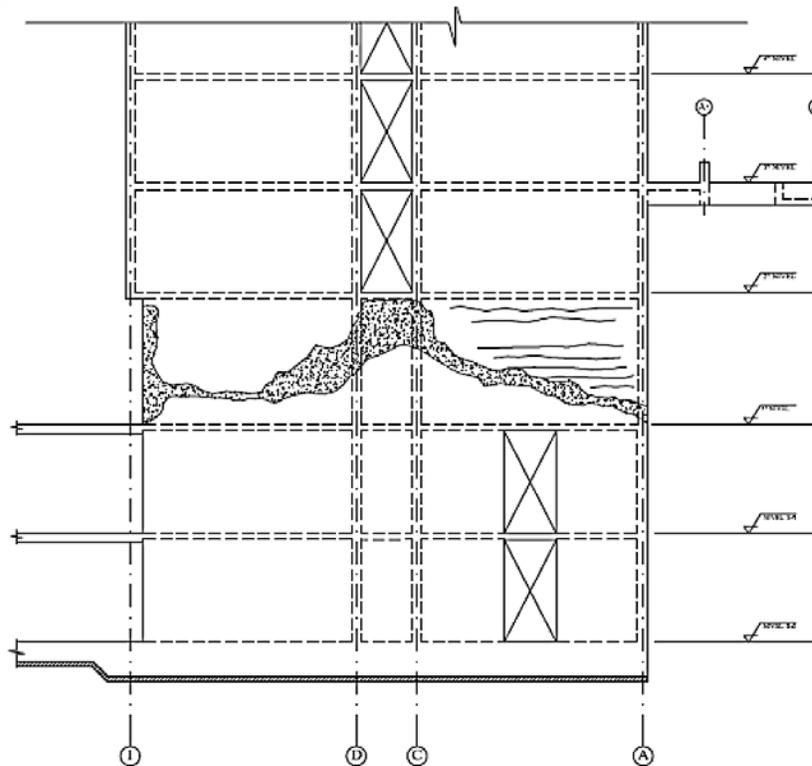
Figure C-2 Damage map of the Alto Rio Building in Concepción, Chile following the 2010 Maule earthquake at Grid 8 (IDIEM, 2010).

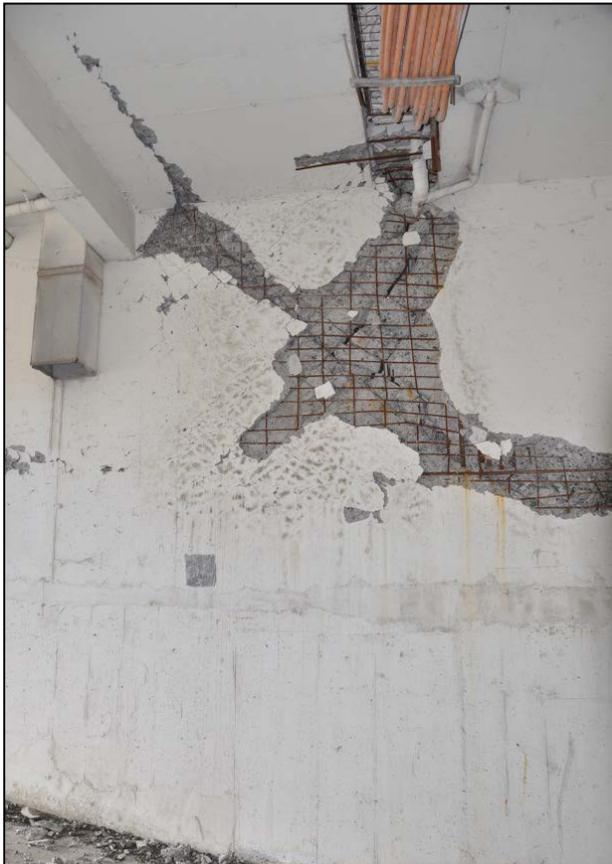
Figure C-4 Damage observed in solid panel at the bottom of a stack of openings in the Centro Mayor building in Concepción, Chile following the 2010 Maule earthquake (photo courtesy of EERI Chile earthquake reconnaissance team).

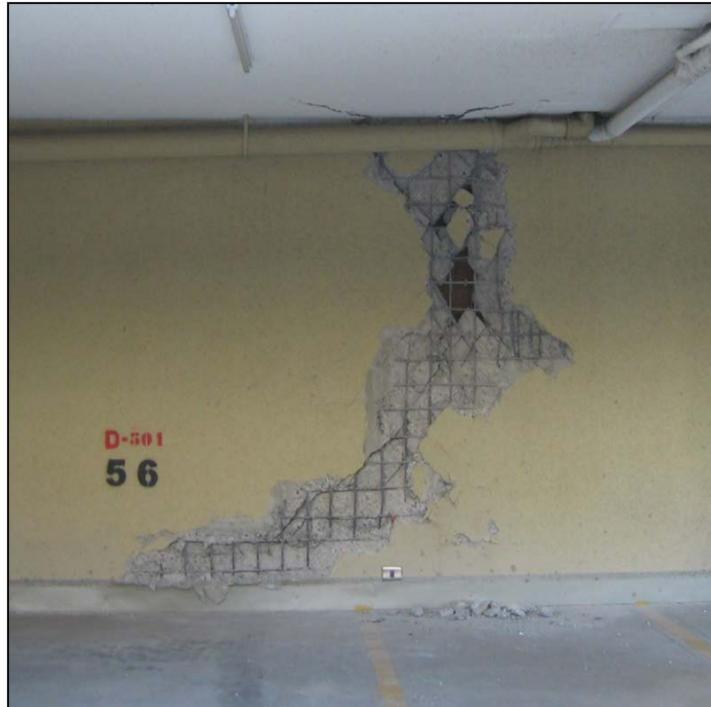
Figure C-5 Damage observed in solid panel at the bottom of a stack of openings in the Marina del Sol building in Viña del Mar, Chile following the 2010 Maule earthquake (photo courtesy of Patricio Bonelli).

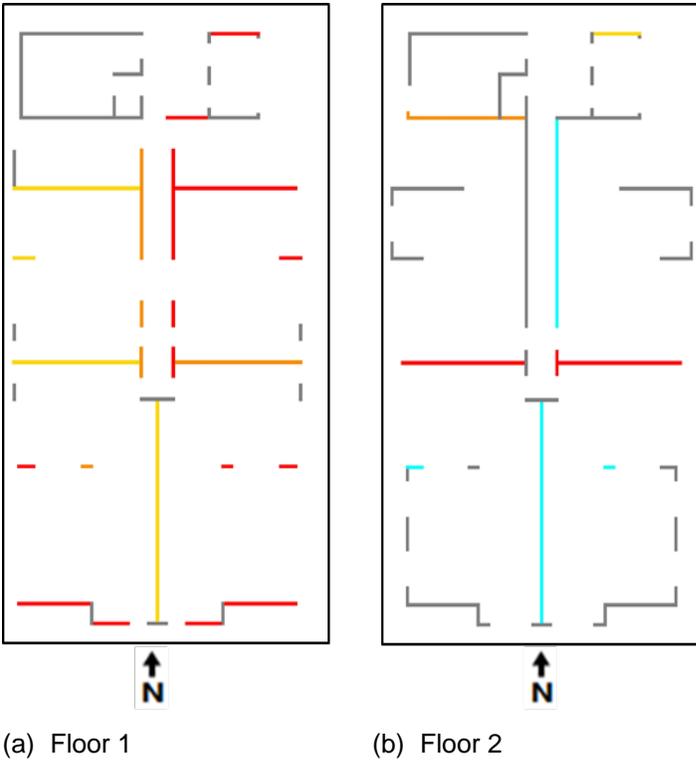
Figure D-2 Layout of first and second story walls of Plaza del Rio Building A (beams and slabs are not shown). Color indicates the level of damage.

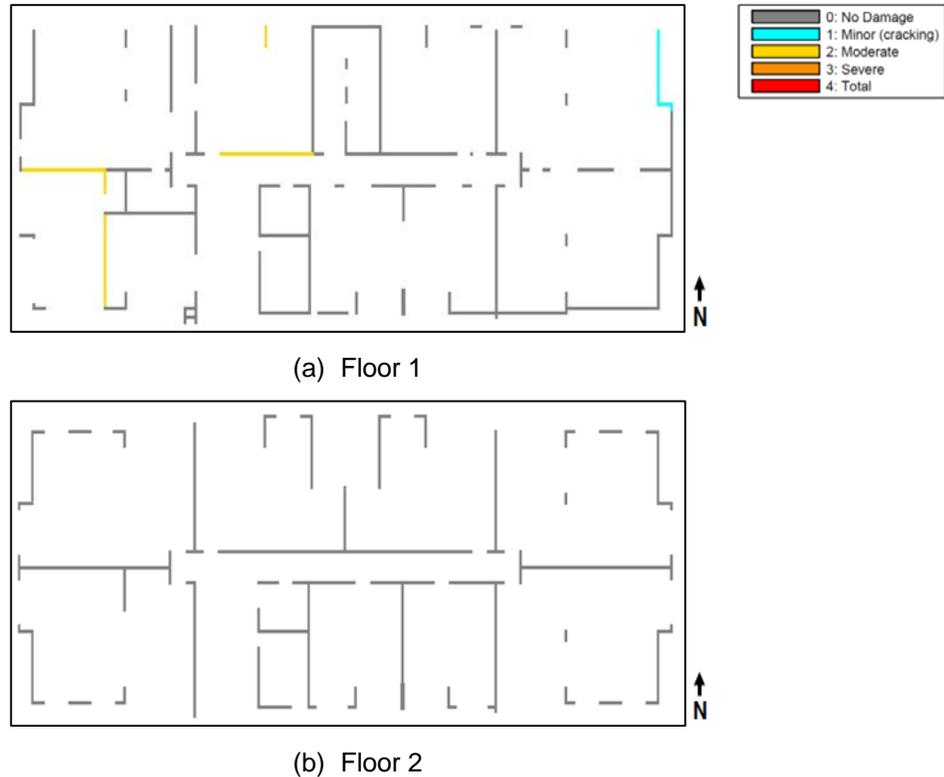
Figure D-3 Layout of walls for lower two floors of Plaza del Rio Building B (beams and slabs are not shown). Color indicates the level of damage.

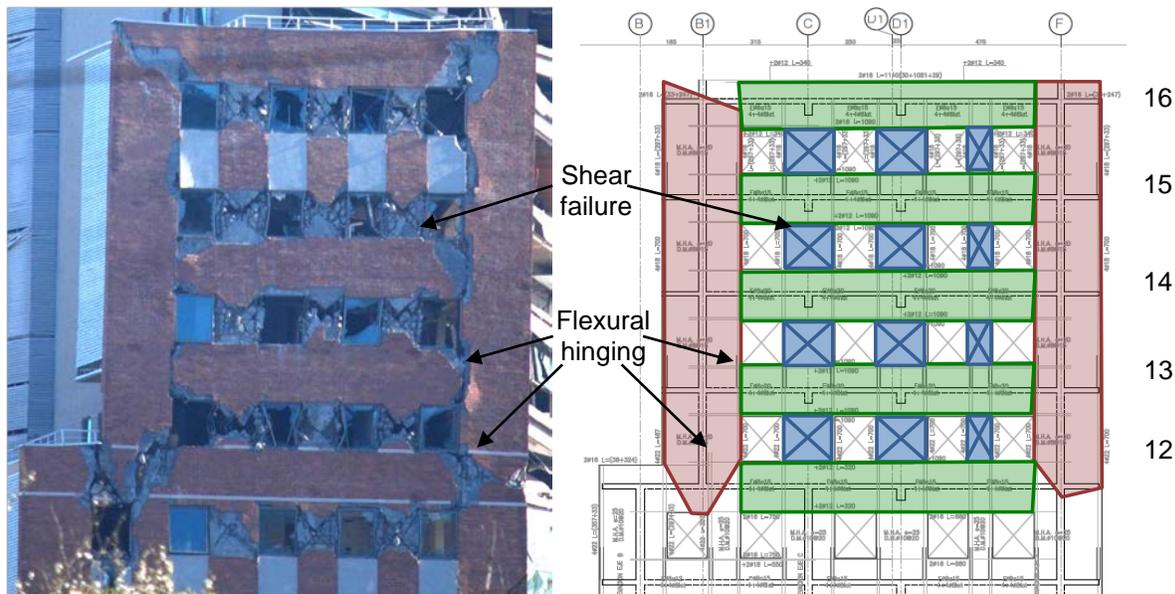
Figure E-1 Exterior elevation of the O'Higgins building after the 2010 Maule earthquake (photo courtesy of PEER), and idealized pier spandrel system.
