# **Brief Review of Building Damage by The 2011 Tohoku Japan Earthquake and Following Activities for Disaster Mitigation**

Masanori Iiba<sup>1</sup>, Isao Nishiyama<sup>2</sup>, Hiroshi Fukuyama<sup>3</sup>, Izuru Okawa<sup>1</sup> and Yasuo Okuda<sup>4</sup>

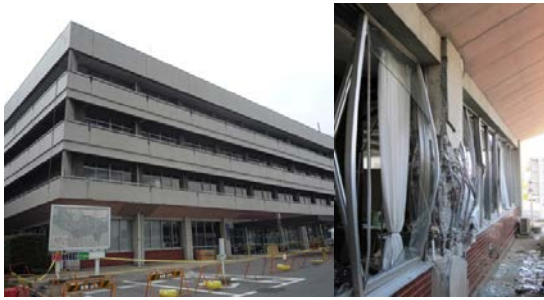
Fig. 6 Survived but not functional

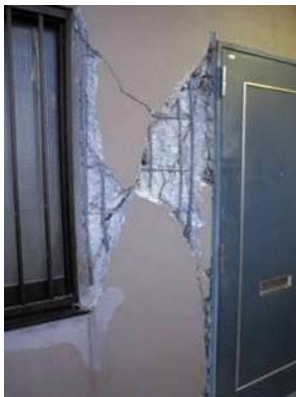
Fig. 7 Nonstructural wall failure

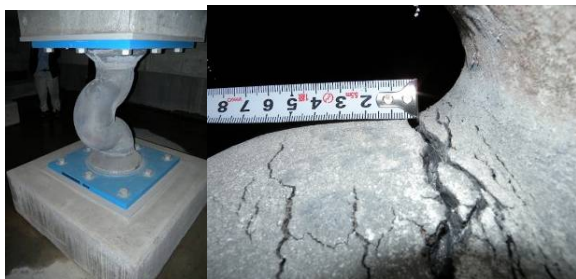
4) Seismically isolated buildings: Sixteen seismically isolated buildings in Miyagi prefecture and one in Yamagata prefecture were surveyed in which three buildings were instrumented and recorded strong motions. All of these buildings performed structurally very well and the steel dampers absorbed earthquake energy by the plastic deformation. However, the lead dampers suffered cracks due to many cycles of small amplitude of reversed deformation as shown in Fig. 8. Damage to the expansion joint was also seen quite frequently, which can be improved as early as possible.

Fig. 8 Lead damper cracked

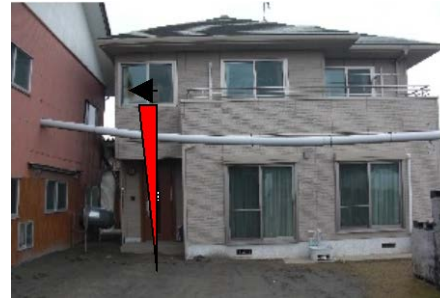
extensive damage such as sand boiling or ground transformation associated with liquefaction was confirmed. Highly tilted residential houses were seen, but visual cracks on the foundations were not observed as shown in Fig. 9. In Sendai city, the ground transformation by sliding of the housing site embankment was observed just like the one after the 1978 Miyagi-Ken-Oki earthquake.

Fig. 9 Tilted house by liquefaction

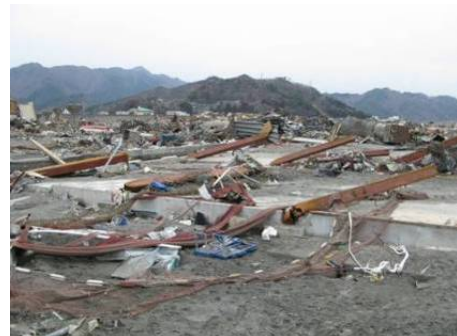
Fig. 10 Complete washed away

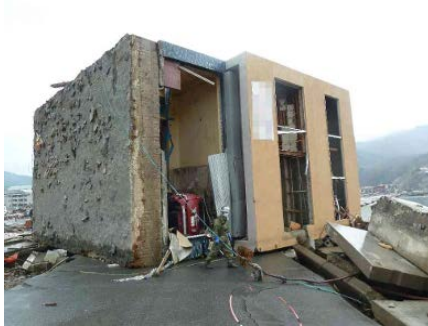
Fig. 11 Overturning

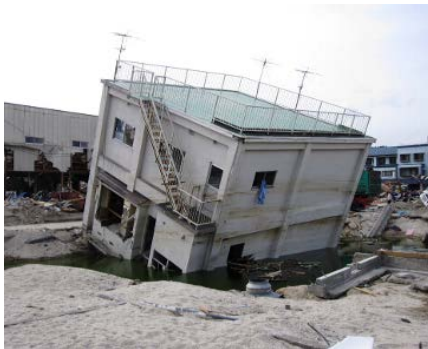
Fig. 12 Tilting by scouring

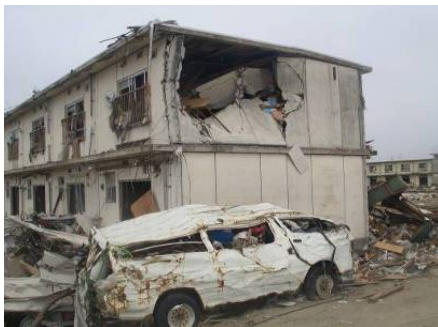
Fig. 13 Debris impact

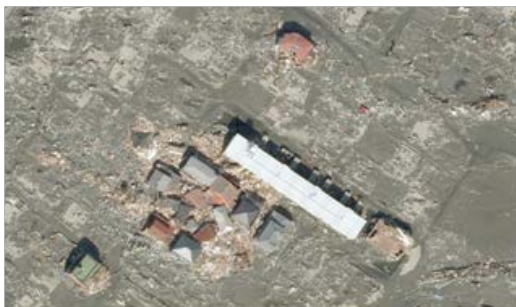
Fig. 14 Shading effect by front building

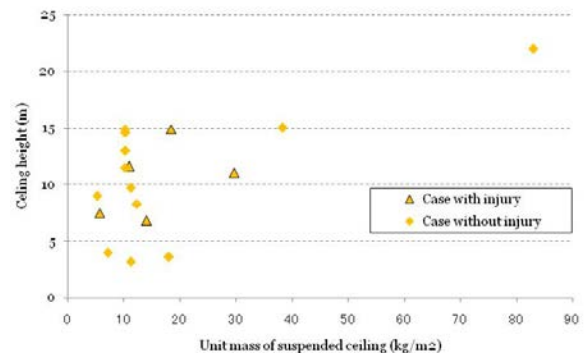
hanging bolts and to keep appropriate clearance between ceiling and surrounding structure have been recommended from the MLIT, the BRI and the NILIM. In the Tohoku Japan earthquake, huge numbers of large space ceilings (about 2,000) fell down and even casualties occurred. Therefore, extensive detailed survey on the ceiling damages was conducted, where 151 damaged ceilings are collected and 11 of them were studied in detail. Based on this study in addition to the previous knowledge, the current qualitative technical advice is planned to be modified into much quantitative one. Fig. 19 compares the ceiling height and unit mass of the fallen ceiling with the cases of with and without injury.

Fig. 19 Fallen ceilings with/without injury

After the earthquake, the NILIM and the BRI started to the countermeasure for improve the earthquake resistance of ceilings against the earthquake. The discussion items for improvement are specification for ceiling materials and setting, and the appropriate methods for calculating seismic response of ceiling and conditions for safety.

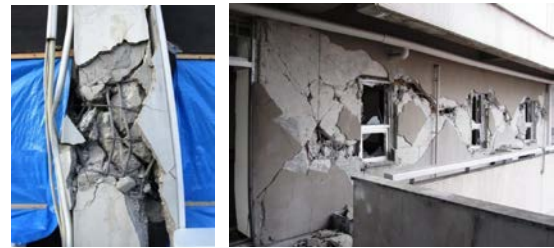
must be an emergency base and assist refugees and citizens just after earthquakes. But more than 10 local government buildings suffered from the 2011 Tohoku Japan Earthquake. There were damages of structural and non-structural member as shown in Fig. 23. They could not keep their function because staffs were prohibited to continuing to work inside. All of damaged buildings are designed by old building structural code, the judgment for safety or not depends greatly on the damage of non-structural members.

Fig. 23 Structural and non-structural damage of local government building

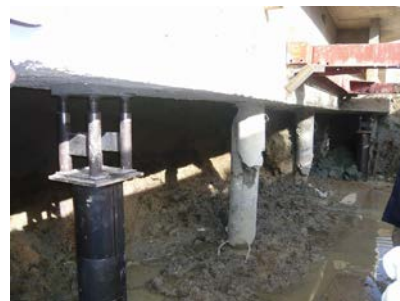
Because the damage on pile head of foundation as shown in Fig. 24, the super-structure tilted and the inhabitants could not continue to live in the building. The damage for buildings whose superstructure was retrofitted or strengthened was founded. These buildings will be demolished or jacked up after underpinning of piles.

Fig. 24 Structural damage of pile head
