**High Resolution Imagery Collection  
Utilizing Unmanned Aerial Vehicles (UAVs) for Post-Disaster Studies**

**UJNR 44th Joint Panel Meeting on Wind and Seismic Effects  
National Institute of Standards and Technology Feb 21st, 2013**

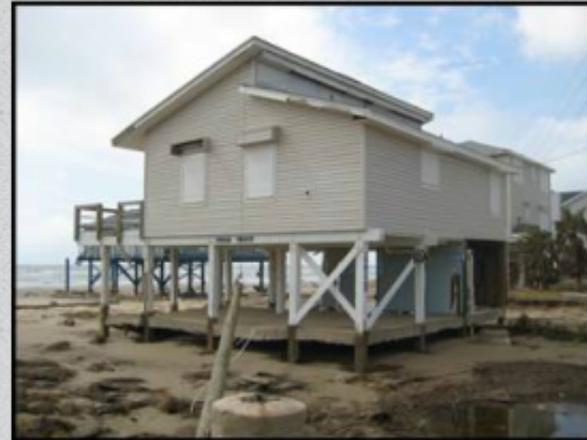
**Pictometry**  
GSD:15cm

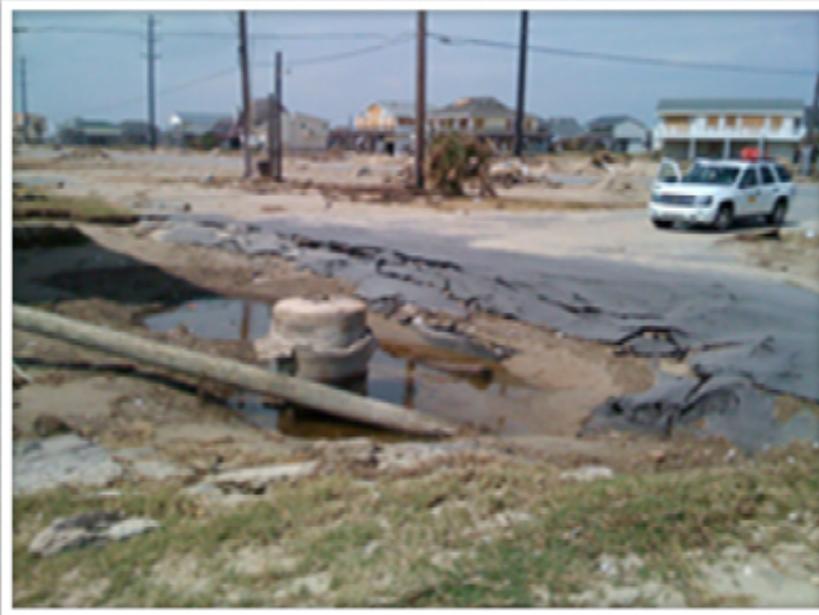
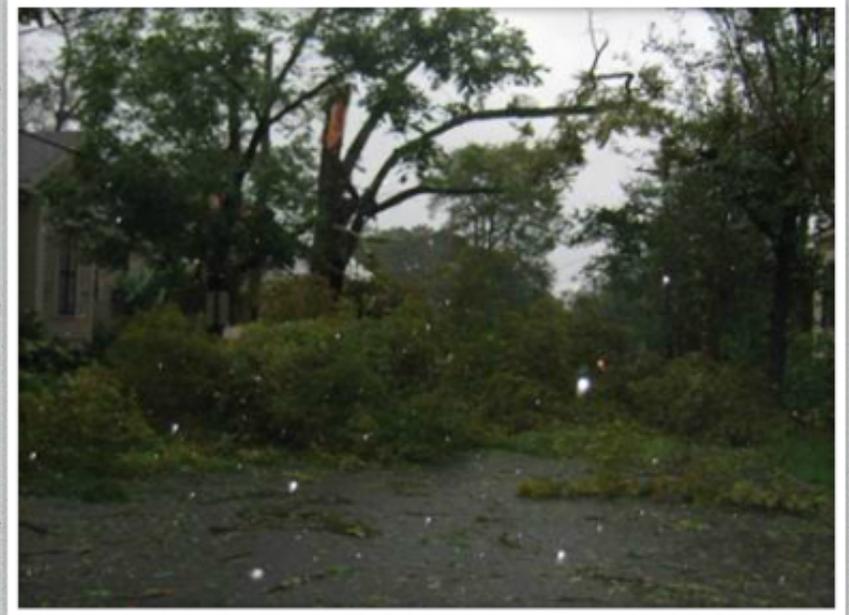
## *Ground-Based Imagery Collection Access Limitations*

Common limitations include (Adams, Levitan and Friedland, 2012)

- Access

- Blocked or washed out roads
  - Downed trees and power lines, water, debris, etc.
- Post-disaster security roadblocks
- Fences
- Private property considerations
- Safety considerations

- Image

- Limited view of roofs
- Sometimes can see only street view

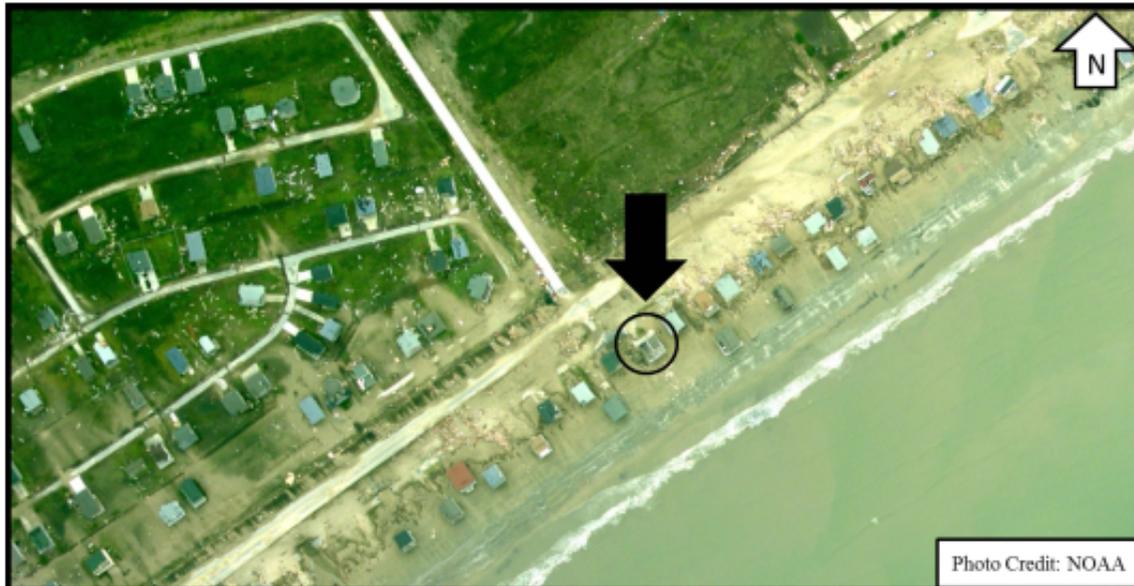
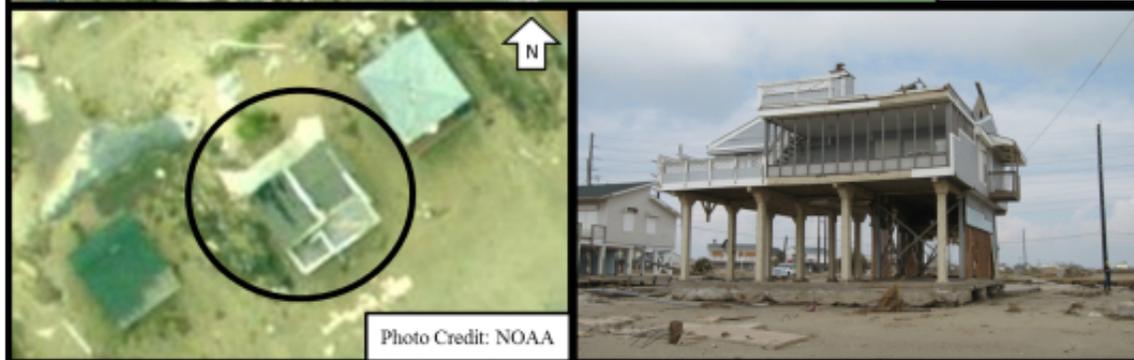
Neighborhood level NOAA aerial imagery (GSD= 50cm)

Per-building zoom of the NOAA imagery

- Roof damage as the southwest portion of the roof is discolored
- Degree of damage is difficult to determine for this multi-level roof
- Photograph provides no information on the façade damage.

Ground-based image of the Structure

- Details of wind damage to the roof not visible from the ground
- Storm surge has destroyed the stairs (Limited Access)

Hurricane Ike in Galveston, Texas (2008)

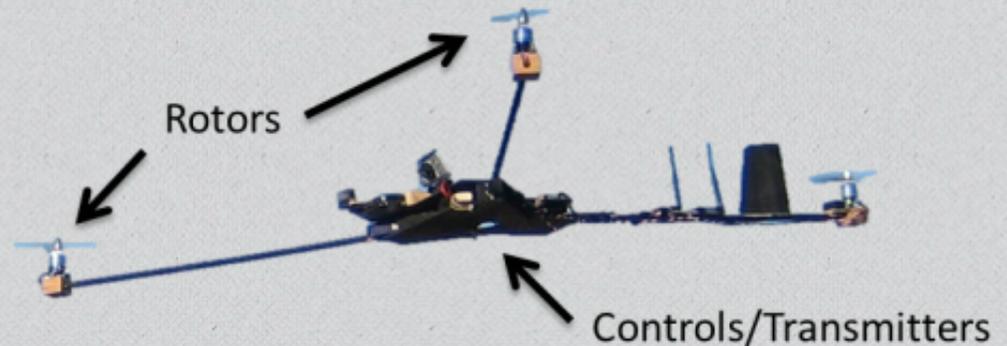
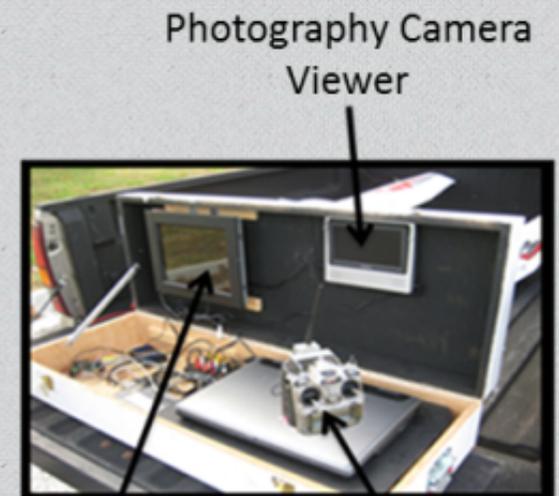
In-Flight Camera Viewer

Remote Control

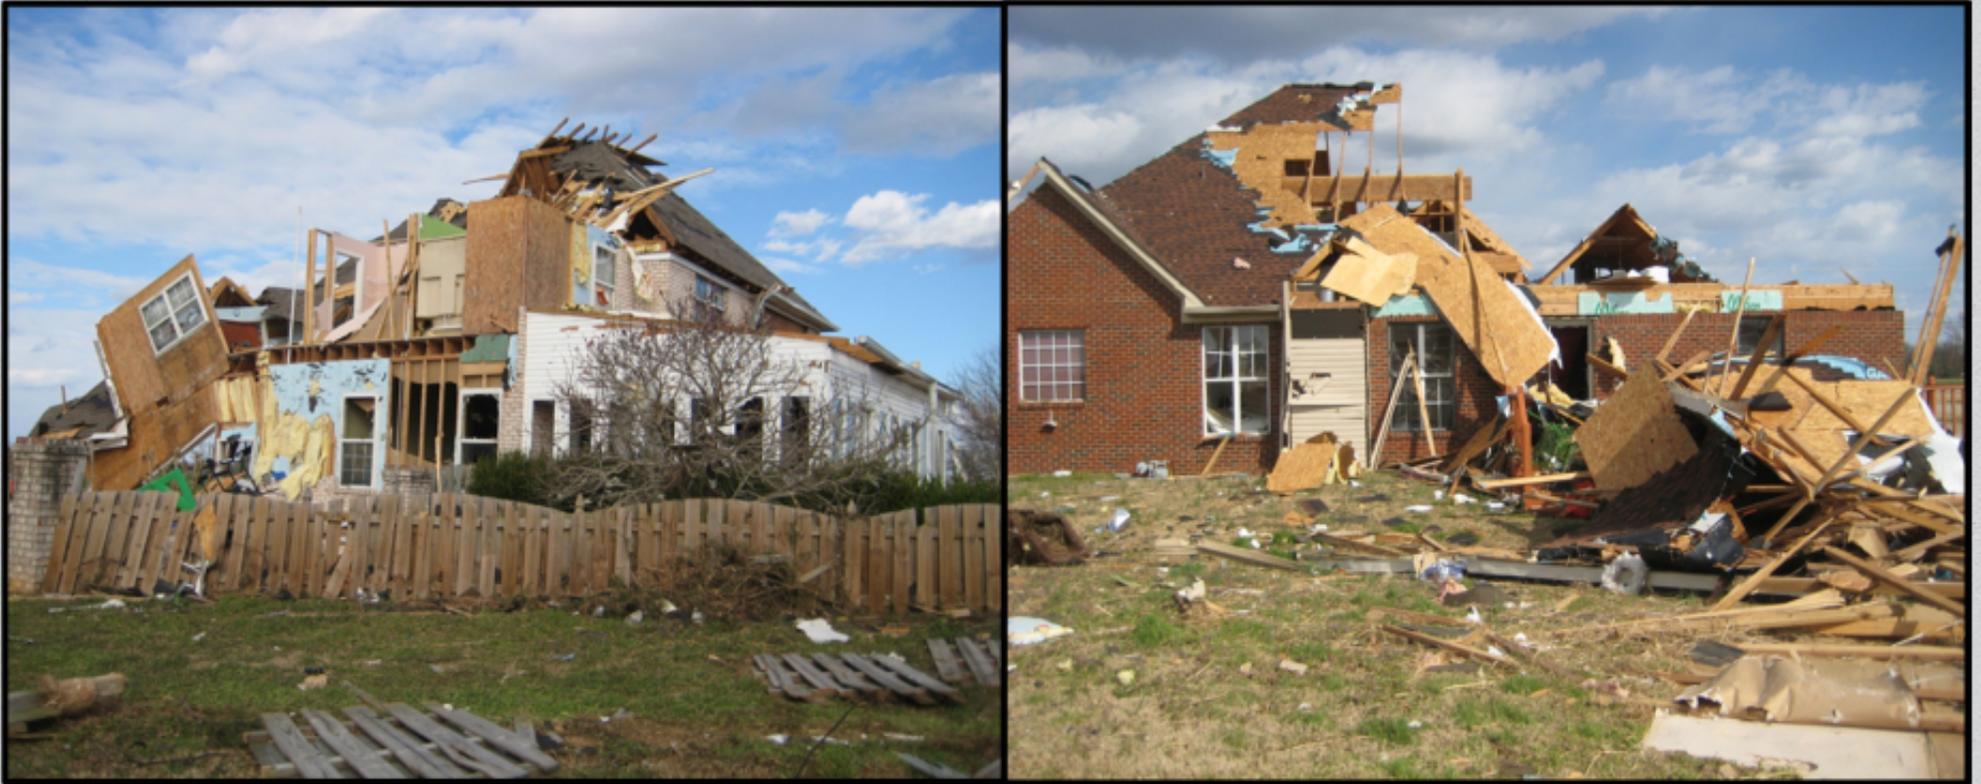
EF 3 tornado in Athens, AL on March 2, 2012

Close approach for ground-based photos limited by:

- Fences
- Unstable nature of damaged structure
  - Particularly due to 30mph wind gusts the day of investigation

Extent of damage beneath roof lines are difficult to quantify based on ground-based imagery

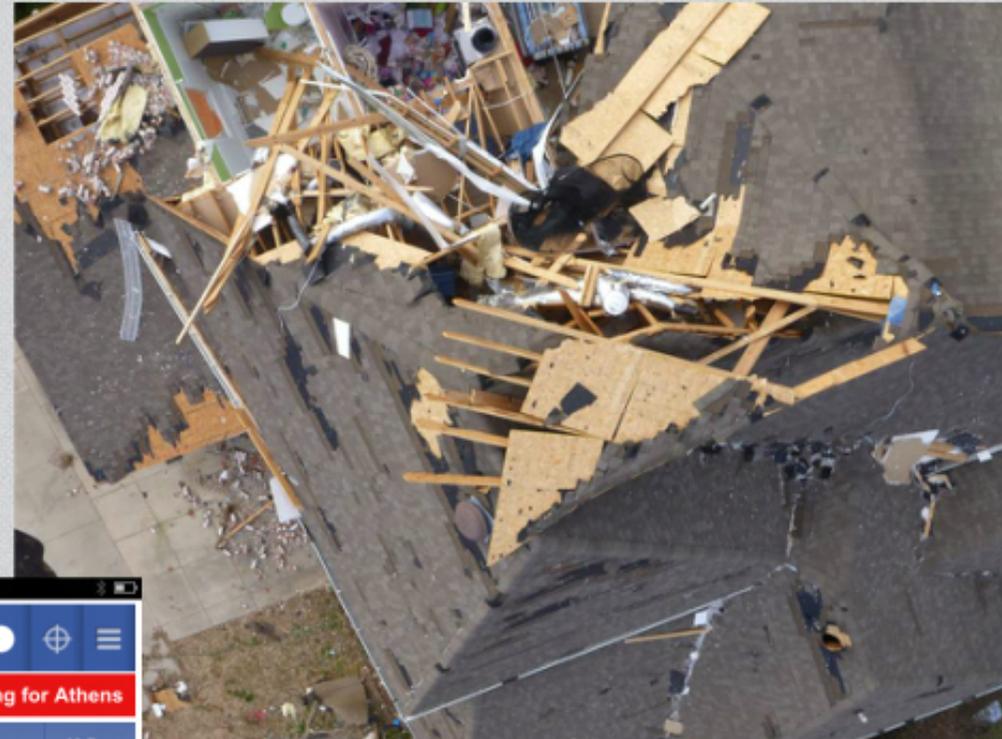
- Tri-Copter UAV used for aerial imagery acquisition
- Wind gusts up to 30mph
- Manually controlled
- Semi and fully autonomous flight capabilities

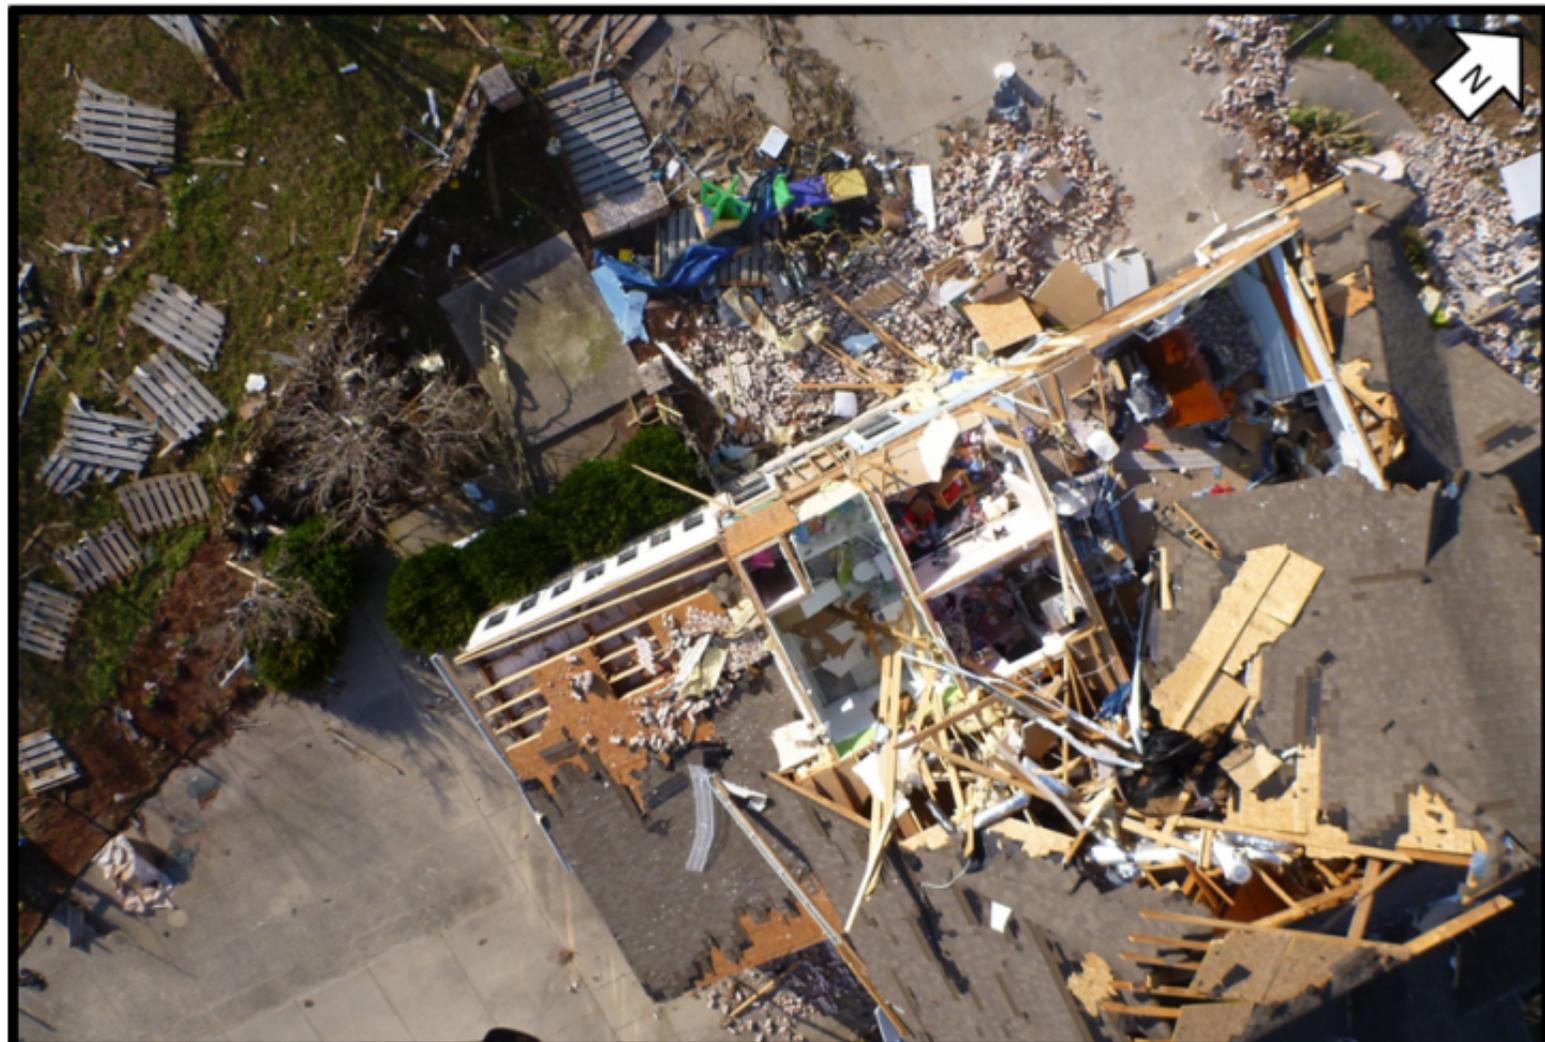
UAV-based still image of Structure 1 taken by the nadir-mounted digital camera, with GSD approximately 0.7 cm.

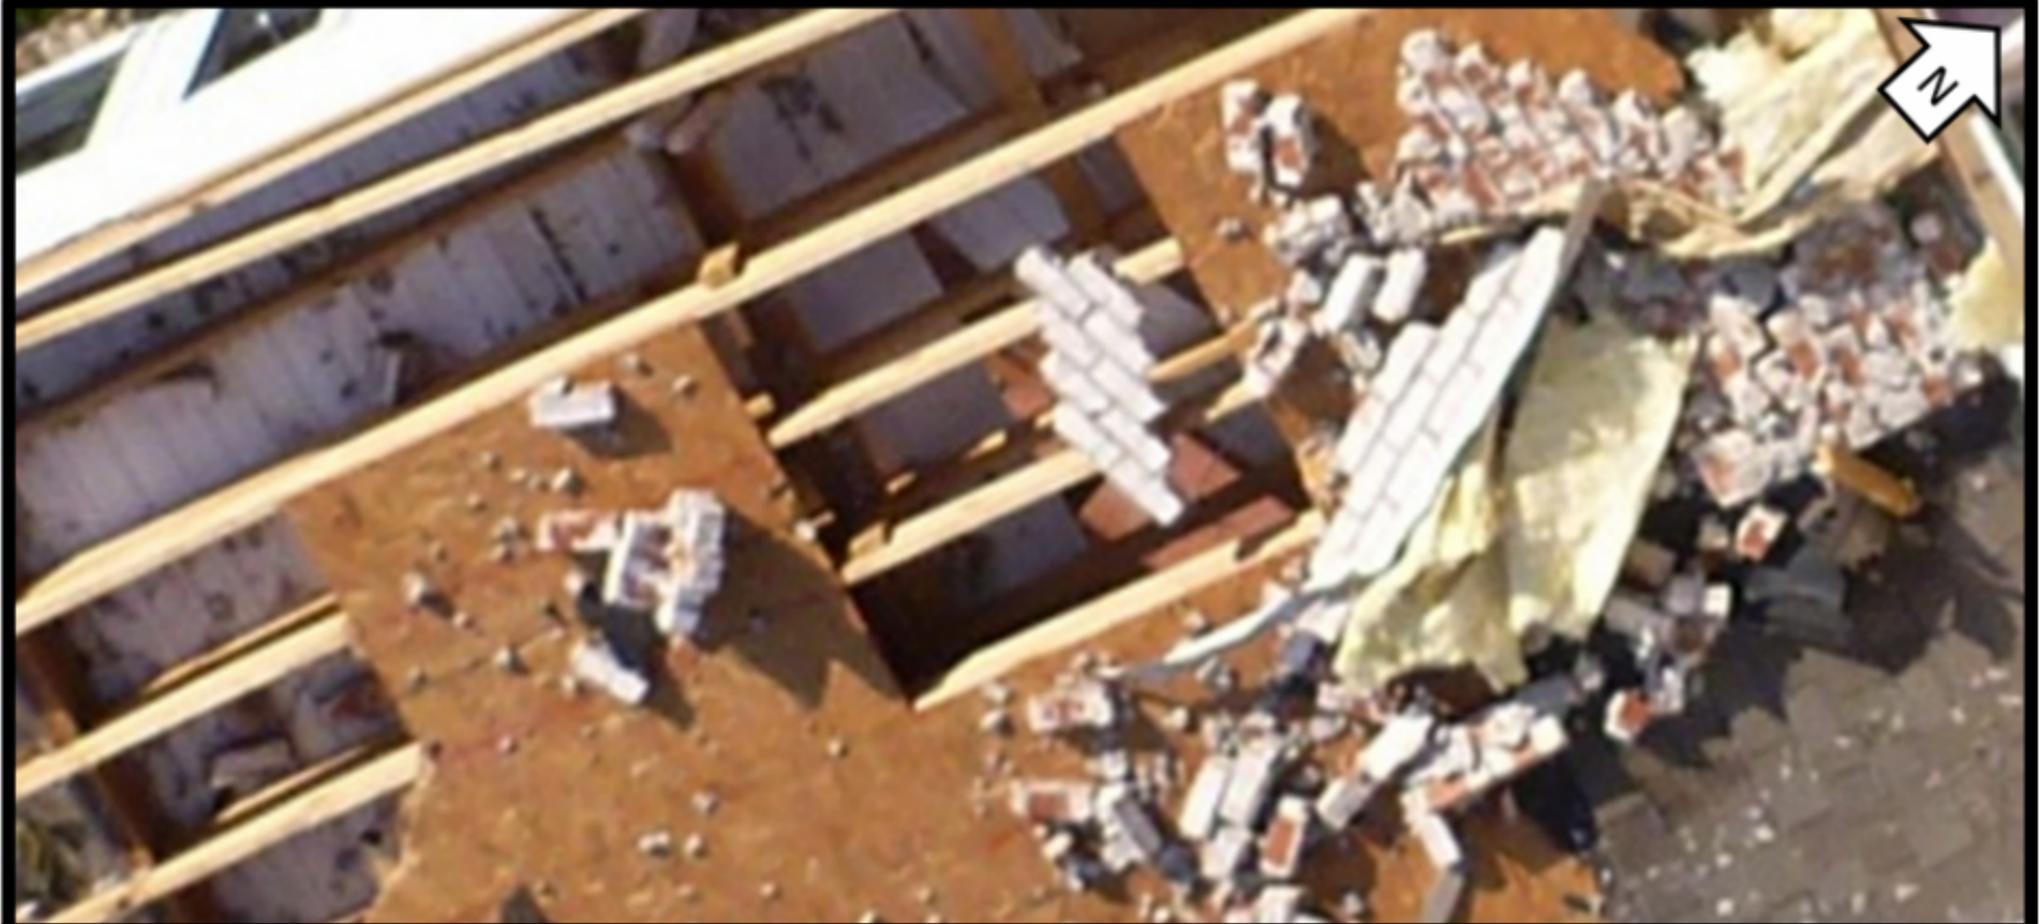
Further close-up of the southwest corner of Structure 1. This demonstrates the full resolution capabilities of the UAV-mounted camera. Construction materials and damage to the roof covering, roof sheathing, and ceiling beneath the roof joists are clearly visible.

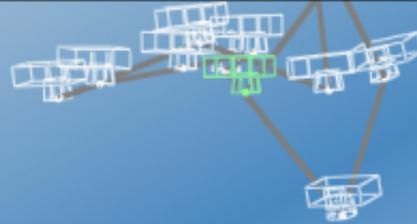
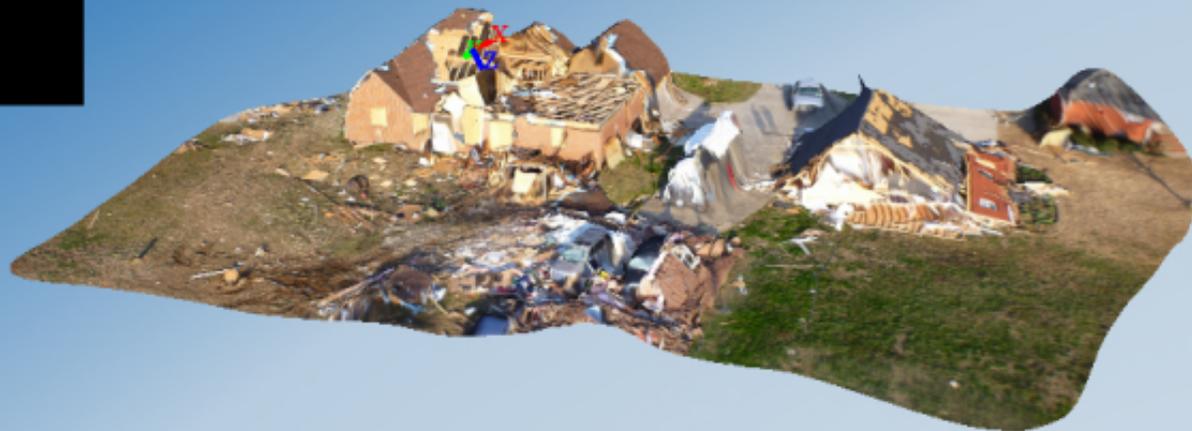
- Spatial representation of nadir imagery acquisition
- 10 images used to construct 3D mesh
- Point cloud export available for further analysis including measurements using photogrammetry principals

- 3D model creation for visualization constructed from multiple nadir images
  - Dimensional measurements (plan dimensions and heights) using overlapping nadir images and photogrammetric tools

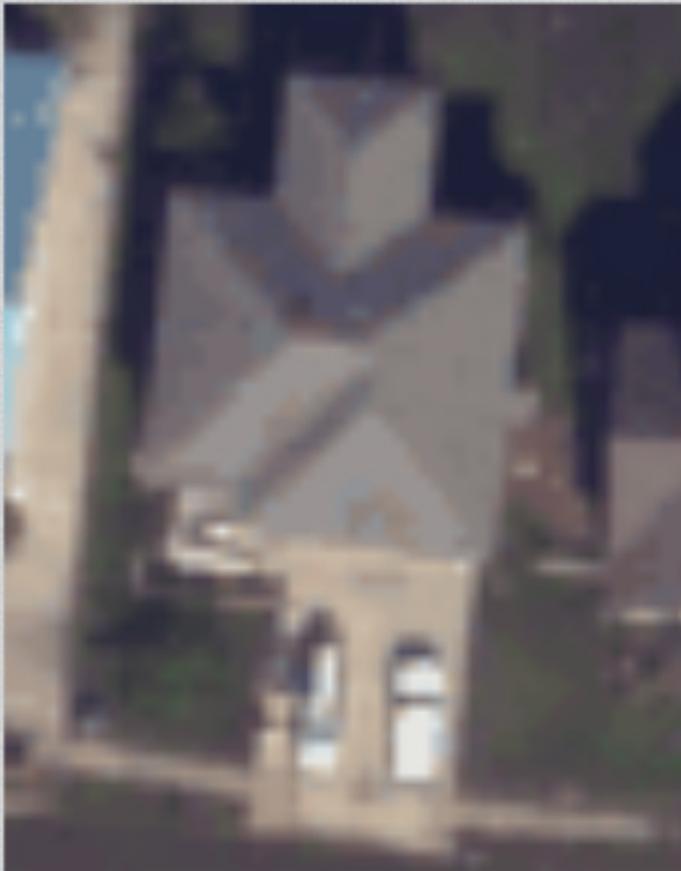
NOAA Imagery  
GSD ~25cm

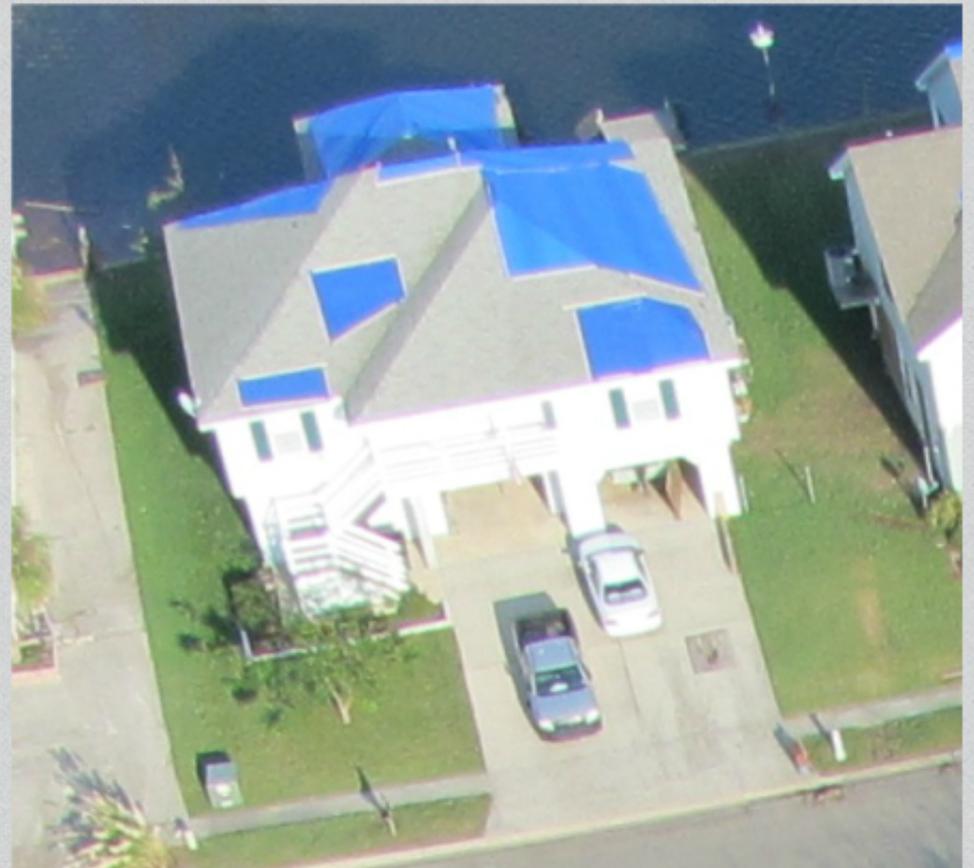
UAV Imagery  
GSD <10cm

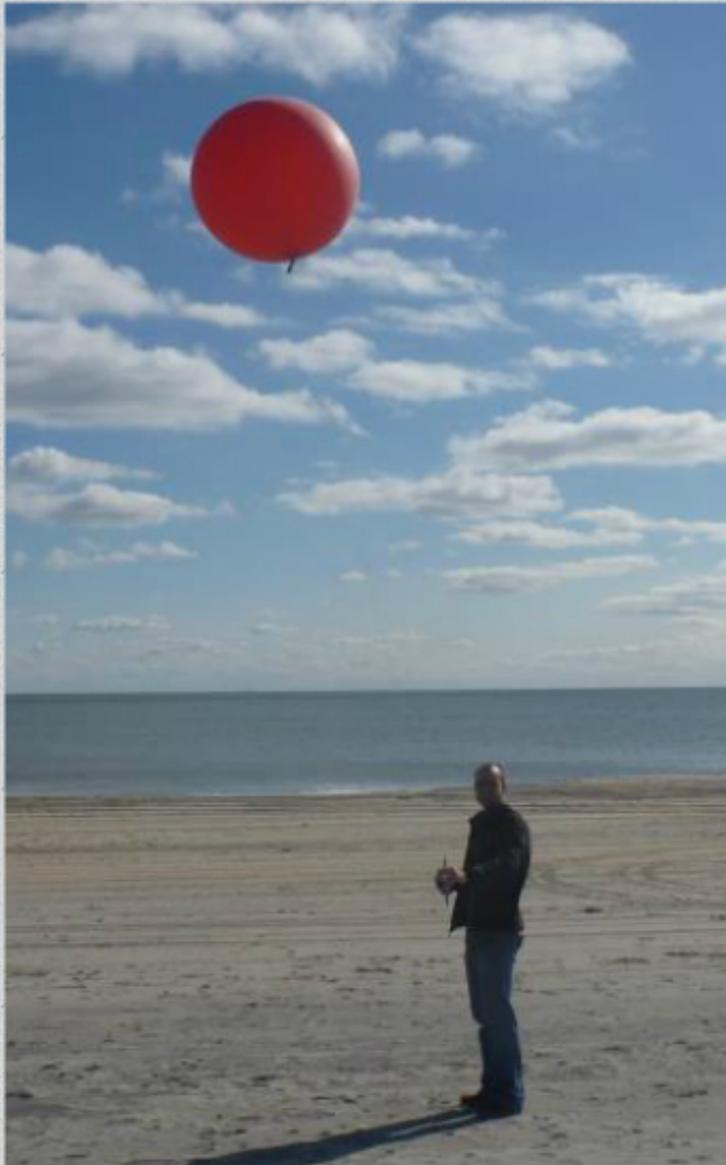
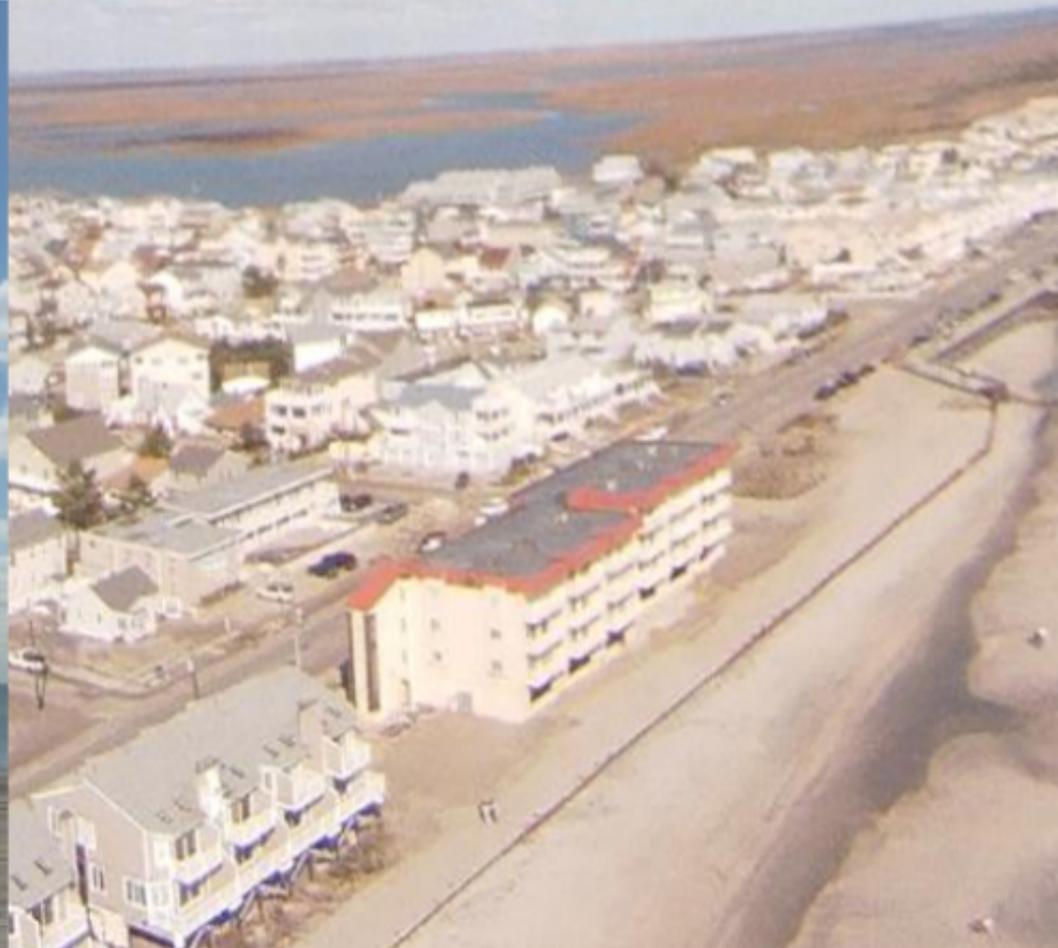
Tethered Balloon-based Imagery
