A Policy Guide to Steel Moment-Frame Construction

A Policy Guide to Steel Moment-frame Construction

SAC Joint Venture

November, 2000

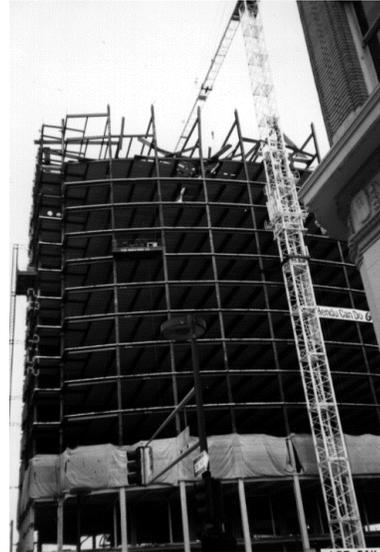
Construction of a modern steel frame building in which the ends of beams are rigidly joined to columns by welded connections.

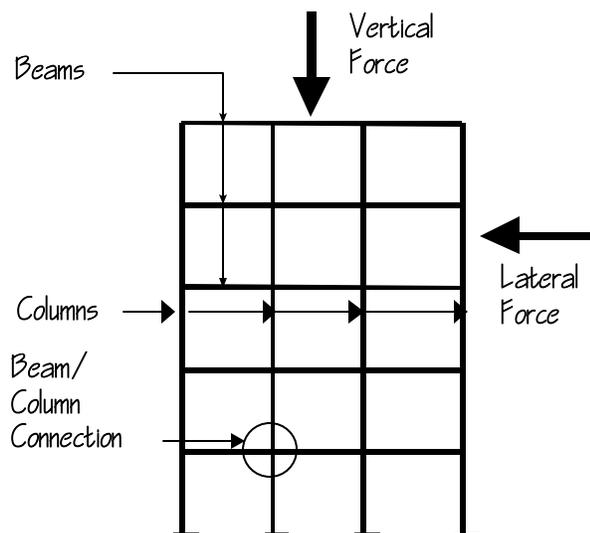
A steel moment-frame is an assembly of beams and columns, rigidly joined together to resist both vertical and lateral forces.

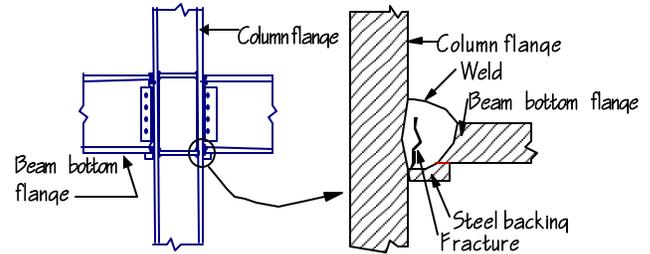
Damage consists of fractures or cracks that initiate in the welded joints of the beams to columns.

The damage discovered in WSMF buildings consists of a fracturing, or cracking, of the welded connections between the beams and columns that form the frame, or skeleton, of the structure. This damage occurs most commonly at the welded joint between a column and the bottom flange of a beam. Once a crack has started, it can continue in any of several different patterns and in some cases has been found to completely sever beams or columns.

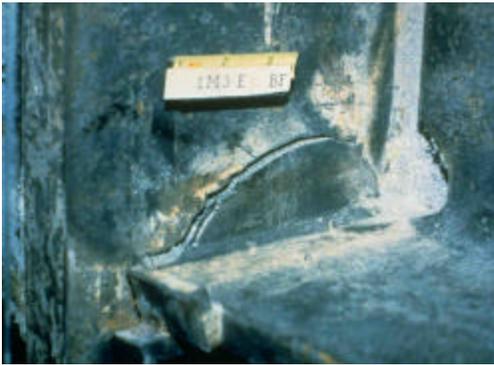
Damage ranges from small cracks that are difficult to see, to much larger cracks. Here, a crack began at the weld and progressed into the column flange, withdrawing a divot of material.

There are several common types of damage, each of which looks somewhat different. The most common cracks initiate in the weld itself or just next to the weld. These cracks often are very thin and difficult to see. In a few cases, cracks cannot be seen at all. In some cases, cracks cause large scoop-like pieces of the column flange, called divots, to be pulled out. In still other cases, the cracks run across the entire column, practically dividing it into two unconnected pieces.

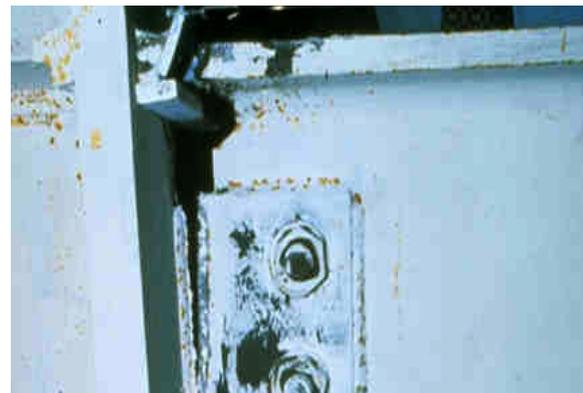
Fracturing of welded connections can lead to damage to the bolted connections that hold the beams onto the columns, creating potential for localized collapse.

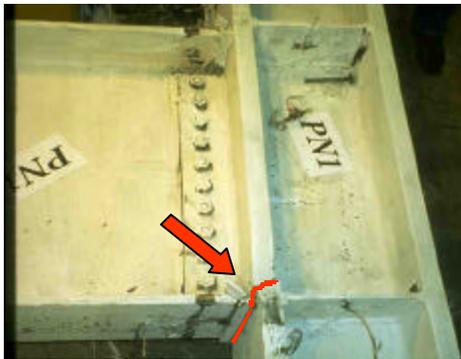
Fractures commonly initiate at the welded joint of the beam bottom flange to column.

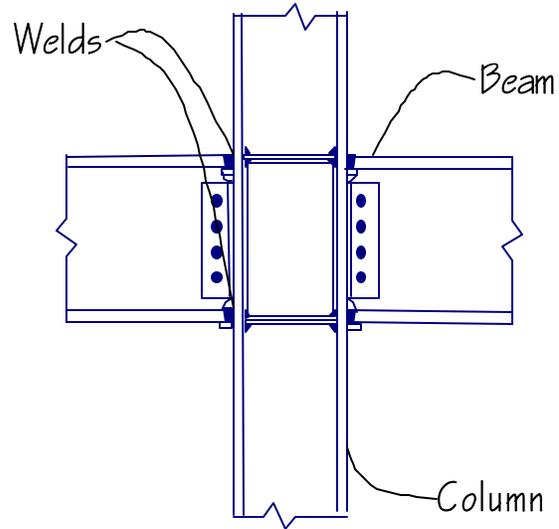
The typical connection used prior to 1994. Severe stress concentrations inherent in its configuration were not considered in the design.

We now understand that the vulnerability of WSMF structures is a result of a number of inter-related factors. Early research, conducted in the 1960s and 70s suggested that a particular style of connection could perform adequately. Designers then routinely began to specify this connection in their designs. However, the particular style of connection tends to concentrate high stresses at some of the weakest points in the assembly, and in fact, some of the early research showed some potential vulnerability. As the cost of construction labor increased, relative to the price of construction materials, engineers adopted designs that minimized the number of connections in each building, resulting in larger members and increased loads on the connections. At the same time, the industry adopted a type of welding that could be used to make these connections more quickly, but sometimes resulted in welds that were more susceptible to cracking. Although building codes required that inspectors ensure the quality of this welding, the inspection techniques and procedures used were often not adequate. Finally, the steel industry found new ways to economically produce structural steel with higher strength. Although the steel became stronger, designers were unaware of this and continued to specify the same connections. Often, these connections did not have adequate strength to match the newer steel material and were therefore, even more vulnerable. In the end, the typical connections used in WSMF buildings were just not adequate to withstand the severe demands produced by an earthquake.

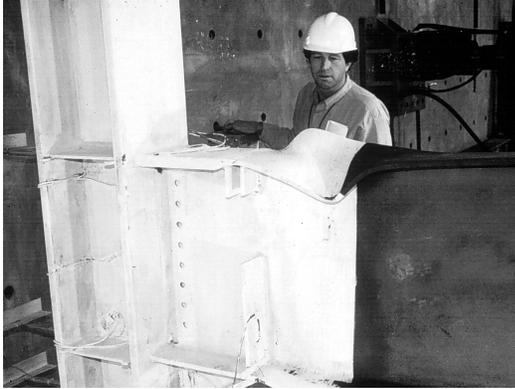
Engineers expect steel to be ductile, capable of extensive bending and deformation without fracturing, as shown in this test specimen. The development of cracks in the steel at relatively low levels of loading was unexpected.

In its basic form, steel is a very ductile material, able to undergo extensive deformation and distortion before breaking. This is the type of behavior desired for earthquake resistance, so engineers believed WSMF buildings would be quite earthquake resistant. Following the 1971 San Fernando earthquake, the 1987 Whittier Narrows earthquake, and the 1989 Loma Prieta earthquake, there were few reports of significant damage to steel buildings, especially as compared to other types of construction, confirming this general belief. However, relatively few WSMF buildings were subjected to severe ground motion in these events. As the industry's confidence in the ability of WSMF buildings to resist earthquake damage grew, design practice, material production processes and construction techniques changed, adding unexpected vulnerability. The 1994 Northridge earthquake was the first event in which a large number of recently constructed WSMF buildings were subjected to strong ground motion.

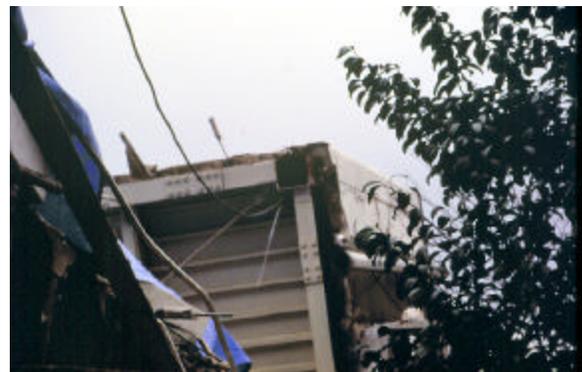
Many steel moment-frame buildings were damaged in the 1995 Kobe earthquake. The building shown here, lying on its side, is one of more than 50 older steel buildings that collapsed.

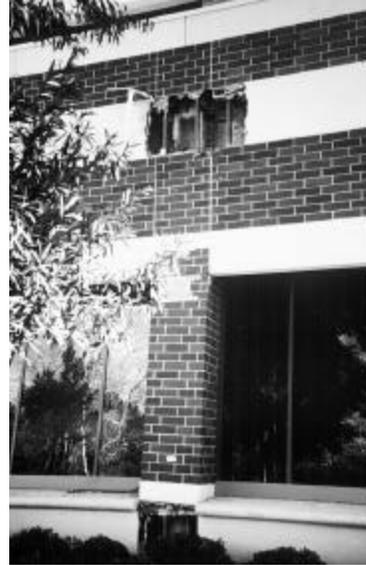
The most severely damaged buildings will often lean to one side. However, there may be no obvious indications of the damage in some buildings.

Some damaged WSMF buildings permanently lean to one side after an earthquake and have severe damage to finishes, providing a clear indication that the building has sustained structural damage. However, many WSMF buildings do not exhibit any obvious signs of damage. To determine if these buildings are damaged, it is necessary to conduct an engineering inspection of the framing and connections. To conduct these inspections, it is necessary first to remove building finishes and fireproofing. These inspections can be disruptive of occupancy and very expensive, ranging from a few hundred dollars to more than one thousand dollars per connection. Large buildings may have several thousand connections. The presence of asbestos, sometimes used in fireproofing in buildings constructed prior to 1979, substantially increases the inspection costs.

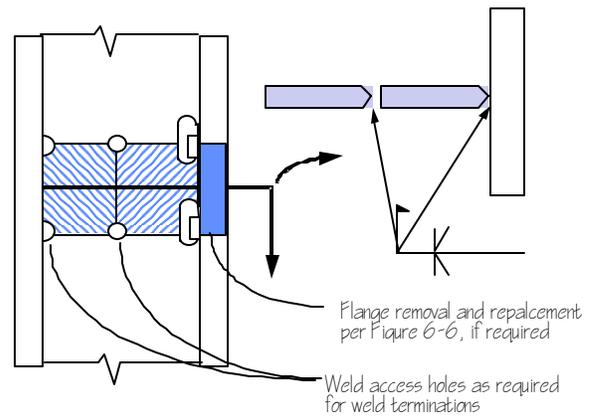
FEMA 352 provides detailed repair procedures for different types of damage. One repair procedure is shown here as an example.

Each type of fracture requires a somewhat different repair procedure. *FEMA 352* provides recommendations for many types of repair. Generally, repairs consist of local removal of the damaged steel using cutting torches or electric arcs, and welding new, undamaged material back in its place. To do this cutting and welding safely, it is necessary first to remove any combustible finishes from the work area and also to provide ventilation to remove potentially harmful fumes. In some cases, it may be necessary to provide temporary shoring of the damaged element while the repair work is done. These operations are disruptive to normal occupancy of the immediate work area and also quite costly. Typical connection repair costs can range from \$10,000 to \$20,000. Additional costs are associated with the temporary loss of use of floor space during repair operations.

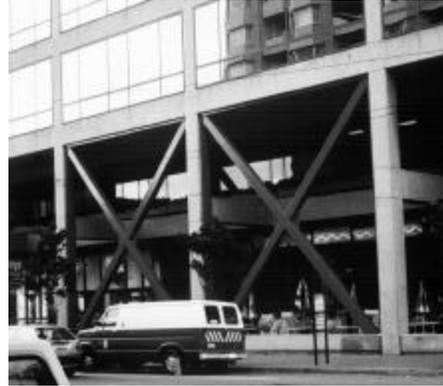
Buildings can be upgraded by modifying connections, adding braces and other methods.

It is technically feasible to upgrade an existing steel moment-frame building and improve its probable performance in future earthquakes. The most common methods are upgrades of the individual connections, addition of steel braces, concrete or masonry walls, or addition of energy dissipation systems. Each of these approaches may offer advantages in particular buildings.

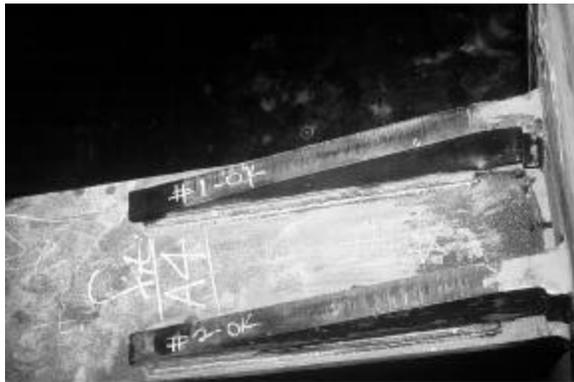
Connections can be upgraded by welding or bolting new plates onto the beams and columns to change the connection shape and reduce stress concentrations. In some cases, it may also be appropriate to replace defective welds and welds with low toughness with welds with improved toughness and workmanship.

Connection upgrades are the most direct approach to improving the seismic performance of an existing steel moment-frame structure. As previously discussed, existing connections can fracture because their shape results in the development of large stress concentrations; some welds have large defects that reduce their strength and the weld metal itself may be of low toughness and unable to resist the large stresses imposed on it. Connection upgrades address these problems directly by modifying the shape of the connection to reduce the stress concentrations. In addition, depending on the approach used, the upgrade may include replacement of defective welds and welds with low toughness with new welds that have improved toughness and better workmanship. FEMA 351 provides information and design criteria for a number of alternative methods of upgrading connections.

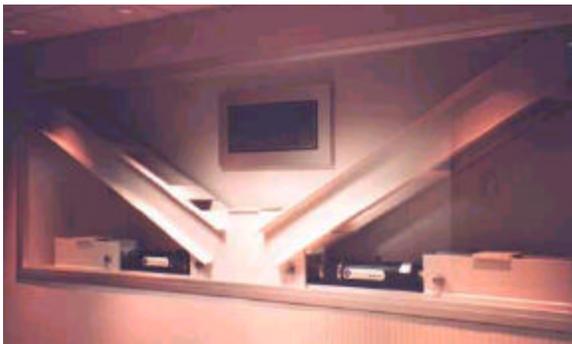
Energy dissipation systems are typically installed in buildings as part of a vertical bracing system that extends between the building's floors.

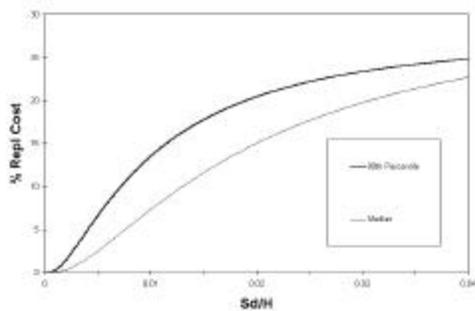
The Simplified Loss Estimation Methodology uses a series of graphs to relate probable earthquake losses to ground motion intensity.

The Simplified Loss Estimation Methodology contained in *FEMA 351* consists of a series of graphs that indicate the probability that WSMF buildings will experience various levels of damage if they are subjected to certain levels of ground motion. These graphs were compiled from data obtained for buildings in the Los Angeles area following the 1994 Northridge earthquake. To use these graphs, an engineer must estimate an intensity of ground motion to which a building will be subjected. Using the graph, an engineer can obtain an estimate of the percentage of the building's connections that will be damaged and the probable cost of connection repairs, if the building experiences an earthquake of a certain intensity. These graphs do not take into account the individual characteristics of a building, except in an approximate manner and, therefore, do not provide precise estimates. Rather, they provide an indication of the potential range of damage and repair costs and the probability that damage and repair costs will exceed certain amounts, based on the behavior of the buildings that were affected by the Northridge earthquake.

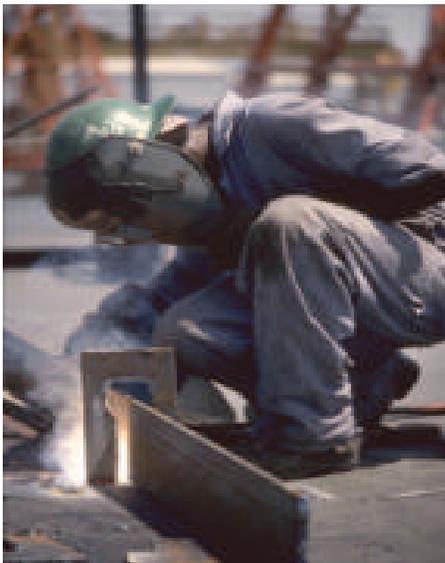
If inadequately constructed, welded joints in moment-frames can be weak links that fail prematurely. FEMA 350 recommends careful control of the materials, workmanship and procedures used to make these joints and verify their adequacy.

FEMA 350 and its companion document, FEMA 353, present extensive new recommendations for welding of moment-resisting connections in frames designed for seismic applications. The new recommendations address the types of materials that may be used for this work, the welding processes and procedures that should be followed, the environmental conditions under which welding should be performed, and the level of training and workmanship required of welders and inspectors engaged in this work. In addition, FEMA 353 provides detailed recommendations for quality control, quality assurance and inspection procedures that should be put into place to assure that this critical work is properly performed. These new recommendations affect all segments of the design and construction process and require designers, producers, fabricators, welding electrode manufacturers, welders and inspectors, among others, to adopt new practices. These recommendations have been submitted to the American Welding Society for incorporation into the structural welding code.

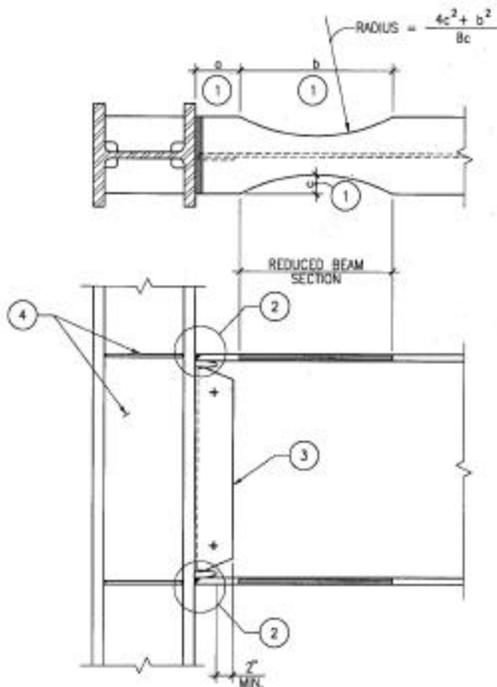
The Reduced Beam Section, or “dog bone” connection is one of 12 different types of prequalified connections that engineers can specify without project-specific testing.

FEMA 350 contains design criteria for twelve different types of prequalified, welded and bolted beam-to-column connections. Each prequalification includes specification of the limiting conditions under which the connection design is valid, the materials that may be used, and the specific design and fabrication requirements.

The new prequalified connections contained in *FEMA 350* are based on extensive laboratory and analytical investigations including more than 120 full-scale tests of beam-to-column connection assemblies and numerous analytical studies of the behavior of different connection types. Connections were prequalified only after their behavior was understood, analytical models were developed that could predict this behavior and laboratory testing demonstrated that the connections would behave reliably.
