State of the Art Report on Past Performance of Steel Moment-Frame Buildings in Earthquakes

SAC Joint Venture

September 2000

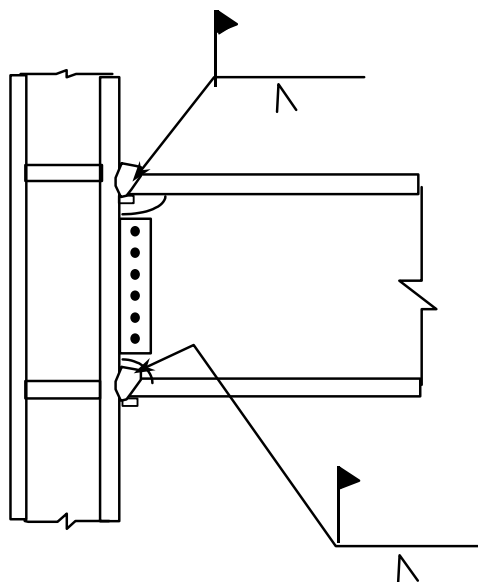
Observation of damage sustained by buildings in the 1994 Northridge earthquake indicated that contrary to the intended behavior, in many cases brittle fractures initiated within the connections at very low levels of plastic demand, and in some cases, while the structures remained essentially elastic. Typically, but not always, fractures initiated at the complete joint penetration (CJP) weld between the beam bottom flange and column flange (Figure 1-2). Once initiated, these fractures progressed along a number of different paths, depending on the individual joint conditions.

Figure 1-1 Typical Welded Moment-Resisting Connection Prior to 1994

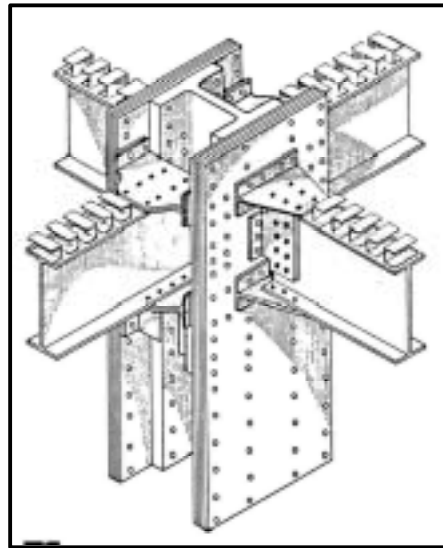
The third building was Torre Latino Americana, a 44-story structure built in 1956 with large built-up wide-flange columns and I-beams. Moment connections were made with all riveted T-flange and web tabs as shown in Figure 5-3. No structural damage was noted in the building, which according to Osteraas and Krawinkler came “as no surprise [considering the building was] a well designed long-period structure.” This tower also experienced earthquakes in 1957 and 1962, apparently without any damage obvious or remarkable enough to have been noted in a 1962 presentation on its instrumentation (Zeevaert, 1962).

Figure 5-3 Typical Undamaged Joint in Torre Latino Americana, Mexico City Earthquake, 1985

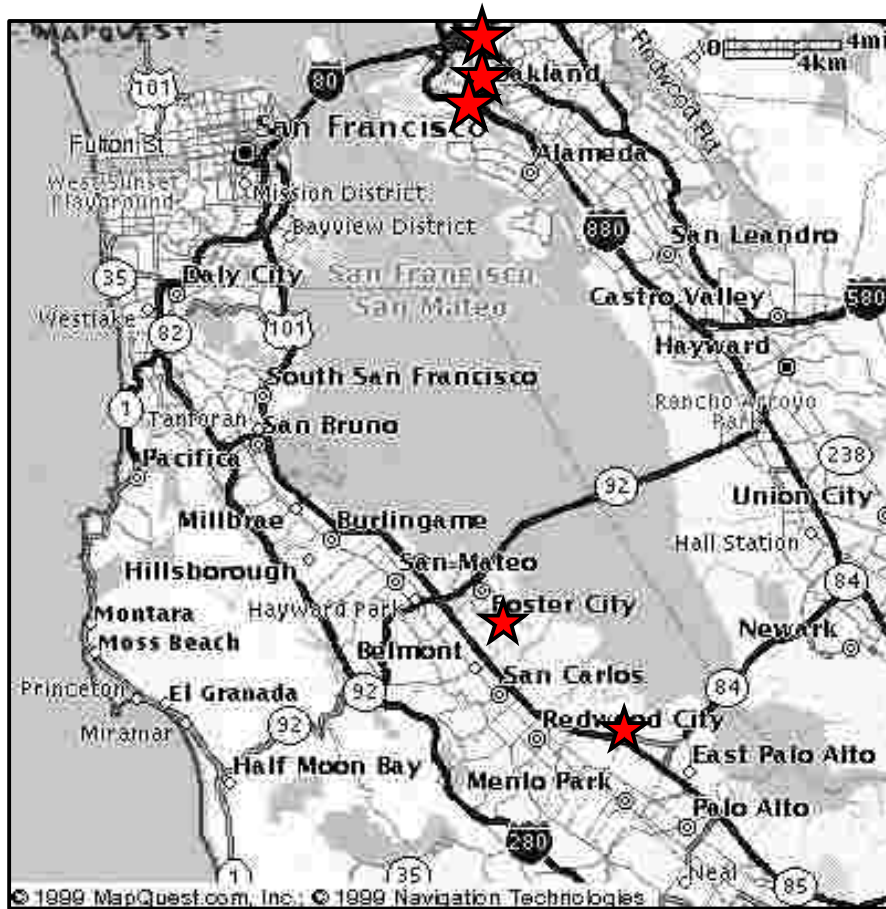
Of the buildings inspected, five were found to have damage. The three most heavily damaged buildings are all located on soft soil where ground accelerations exceeded 0.20g. Each of the five buildings is at least 35 miles from the epicenter of the earthquake (Phipps, 1998).

Figure 5-4 Location of WSMF Buildings with Known Connection Damage, Loma Prieta Earthquake, 1989

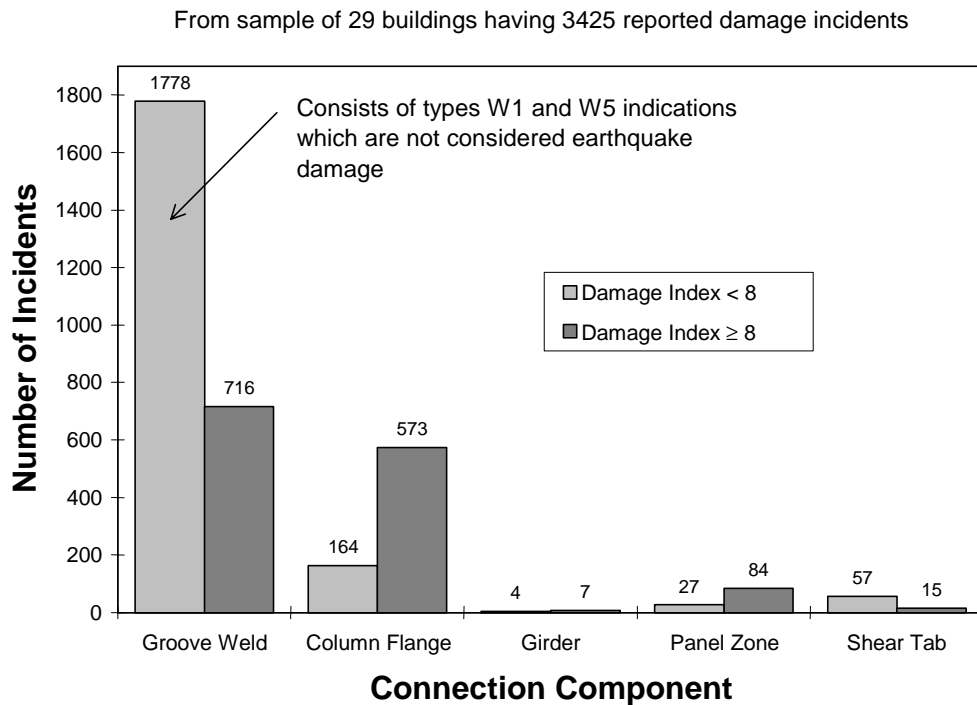
Typical components of pre-Northridge moment connections are depicted in Figure B-1. Building surveys revealed different numbers of damage incidents associated with each component, and Figure B-2 illustrates the distribution found in 29 Northridge damaged buildings (Dames and Moore, 1998). A connection can suffer multiple incidents so that the number of damage incidents is greater than the number of damaged connections. Damage to girder groove welds and column flanges are the predominant damaged components.

Figure B-2 Distribution of Component Damage

Note that fully one-half of the total (1778 out of 3425 reported incidents) are groove weld types having damage indices < 8. These are weld root (W1) indications and non-rejectable UT detectable indications (W5) which were classified as possible damage by FEMA 267, but are now considered by SAC as pre-earthquake existing defects (SAC 90% Draft, 1999, Paret and Attalla, 1998). This reclassification sharply reduces the amount of connection damage attributed to the Northridge earthquake.

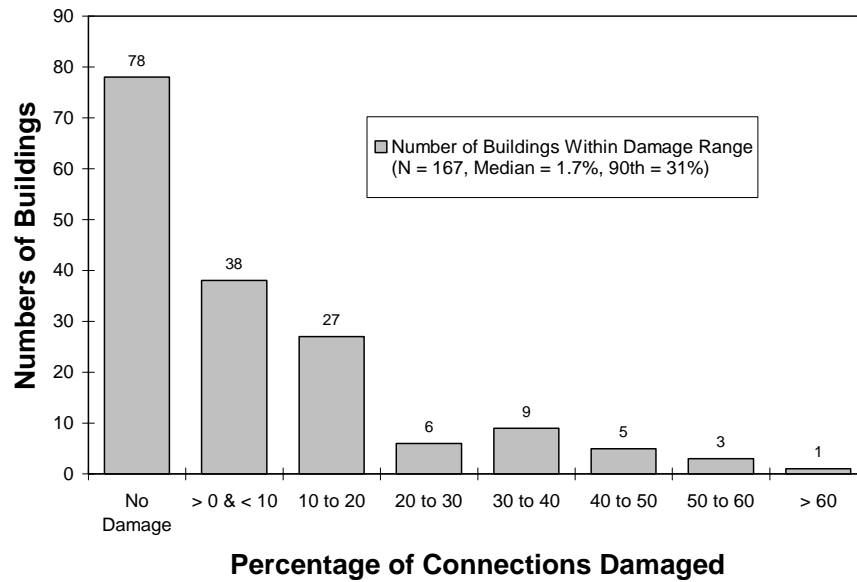
Figure B-10 shows the distribution of connection damage rates. Damage rate is defined as the number of damaged connections discovered divided by the number of moment connections in the inspection sample, expressed as a percentage. A striking observation is that only about one-half (53%) of the buildings suffered damage, and of these only about 1 in 3 (27%) had rates greater than 20%. The median and 90th percentile rates are 1.7% and 31%, respectively. This suggests that initial post-Northridge impressions about the amount and severity of building damage were overstated in large part due to consideration of types W1 as damage. The damage picture changes significantly when these are excluded. Paret and Attalla (1998) have previously noted this as well.

Figure B-10 Distribution of Connection Damage Rates

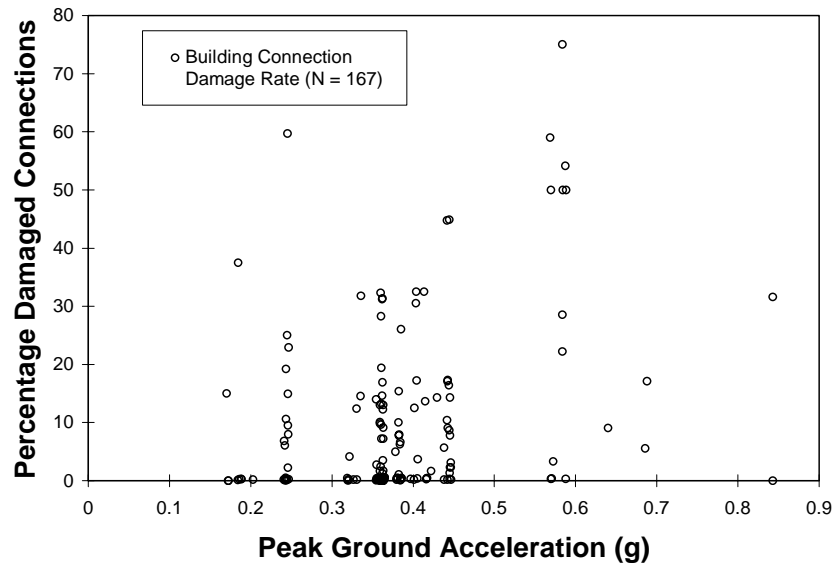
Figure B-11 shows a plot of damage rates versus PGA. There is large scatter but a trend of higher damage rates with increasing PGA is apparent. By inspection, at about 0.6g the median rate is about 50% whereas below about 0.45g there are so many buildings with no damage (cluster of points about 0% damage rate) that it causes the median rate to be very small in this range. In any event, the correlation between damage rate and PGA is weak. Further statistical analysis of the database was performed to create a methodology for rapid loss estimation. The results of this work can be found elsewhere (Maison and Bonowitz, 1999).

Figure B-11 Damage Rates Versus PGA

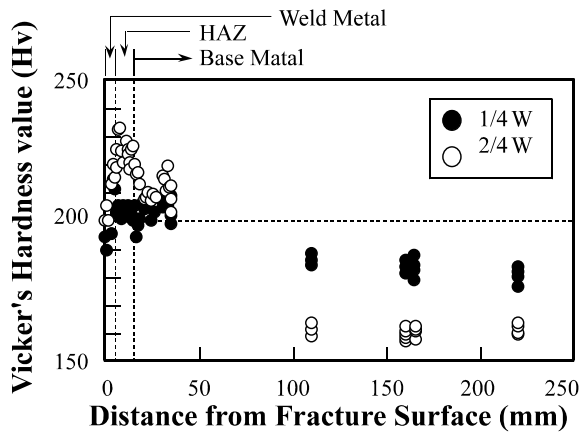
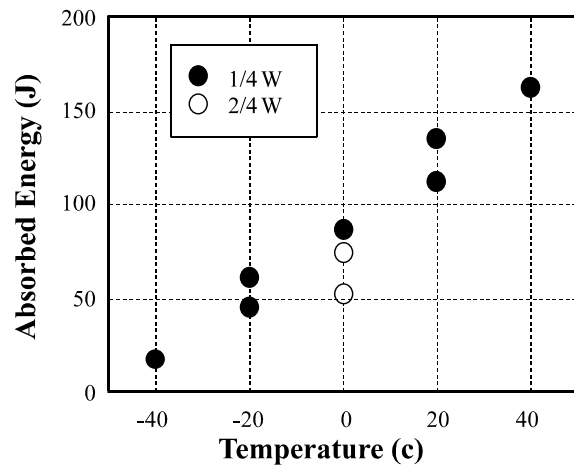
Figure C-14 Material Properties of Base Metal Near Fractured Surface; (a) Charpy V-Notch Test; (b) Hardness Test

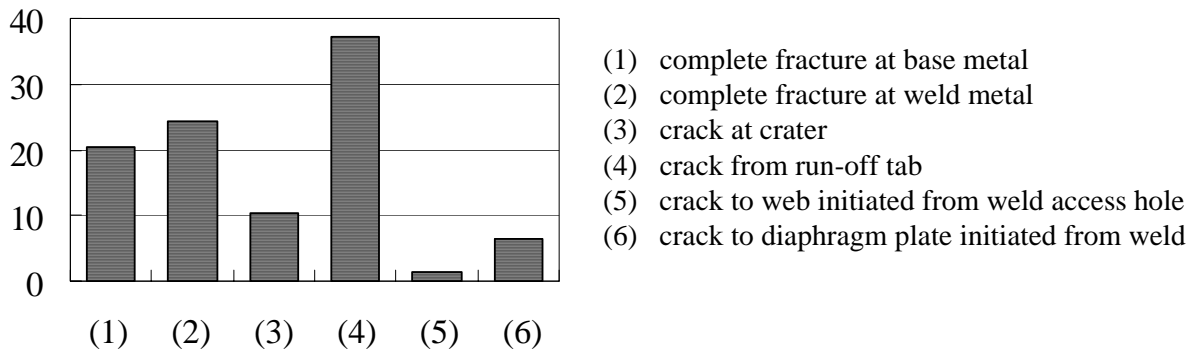
Figure C-15 Distribution of Damage To Beam-To-Column Connections with Respect to Type and Location

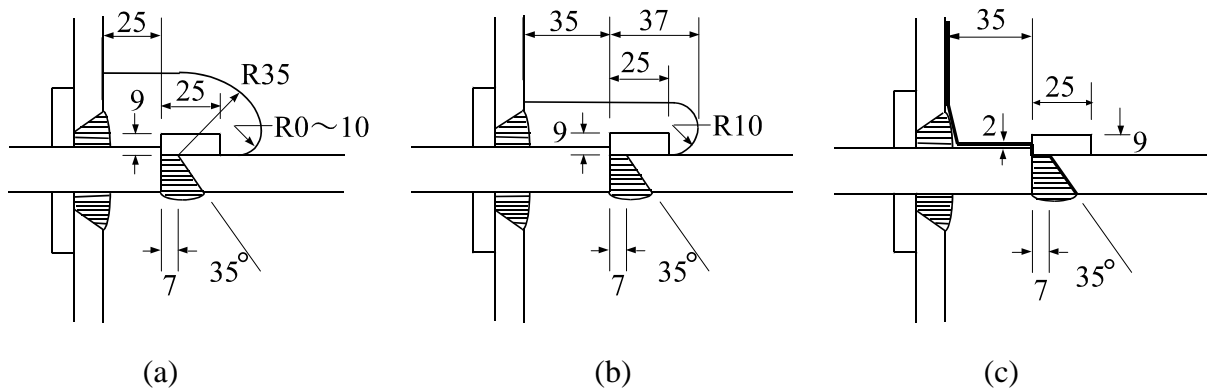
Figure C-17 Weld Access Hole Details Proposed after Kobe Earthquake; (a) Pre-Kobe Standard Detail; (b) Modified Detail with Smaller Hole; (c) No-Hole Detail

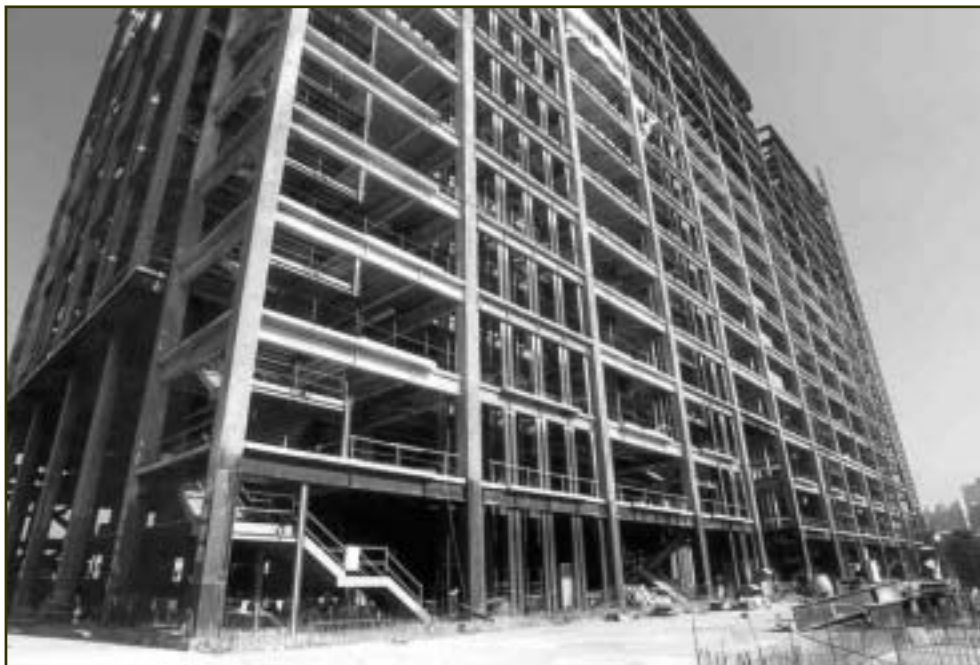
Figure D-2 Typical Taiwanese High-Rise Structure under Construction in Tiachung

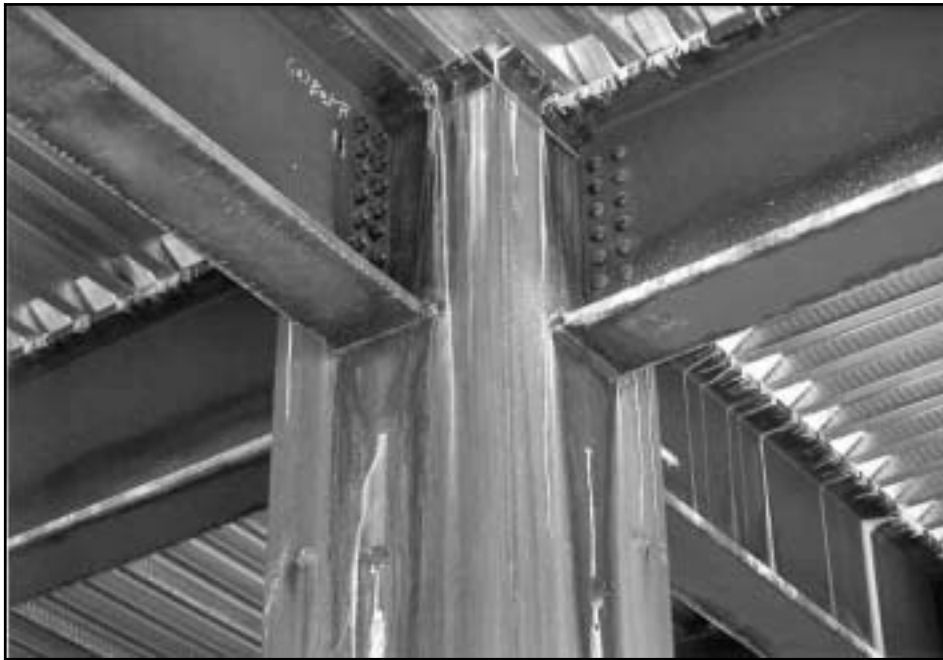
Figure D-3 Welded Connection Detail of Beams to Box Column
