NIST GCR 14-917-25

Recommendations for Seismic Design of Reinforced Concrete Wall Buildings Based on Studies of the 2010 Maule, Chile Earthquake

NEHRP Consultants Joint Venture
*A partnership of the Applied Technology Council and the
Consortium of Universities for Research in Earthquake Engineering*

March 2014

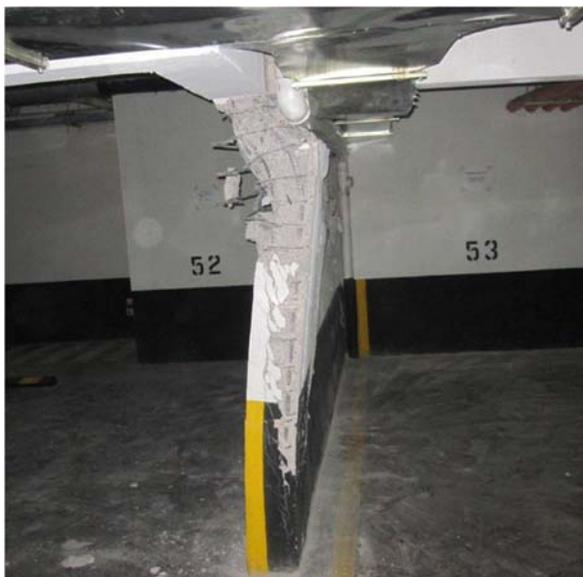
overall wall buckling behavior (Figure 1-7). Localized damage attributed to building configuration issues was concentrated at locations of wall discontinuities and structural system irregularities (Figure 1-8), or unintended coupling of walls through slabs and other elements (Figure 1-9).

Figure 1-7 Overall wall buckling behavior (DICTUC, 2010e).

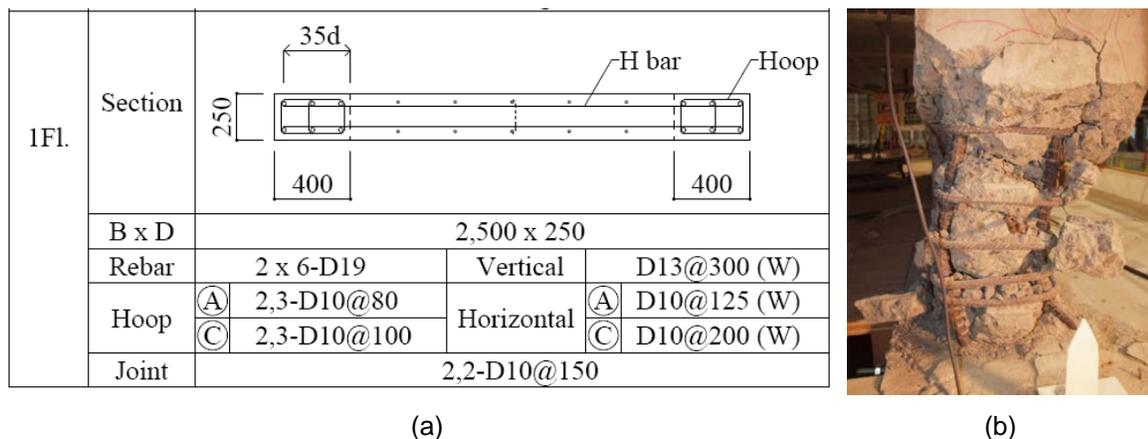
Tests of conventional reinforced concrete wall sections are shown in Figure 2-8. In these tests, the transverse reinforcement provided at the wall boundaries was 1.4 and 2.1 times that required by ACI 318-11 Section 21.9.6.4, however, concrete crushing and lateral instability (Figure 2-8b) were observed to occur early in the tests. Inspection of the damaged boundary zone revealed that relatively large clear cover was used, on the order of 40 mm (1.5 inches), which is larger than ACI 318 code minimum of 19 mm (0.75 inches), suggesting that the amount of transverse reinforcement provided was incapable of maintaining stability of the compression zone following loss of concrete cover.

Figure 2-8 Tests on conventional reinforced concrete walls: (a) test specimen details; and (b) observed damage (Nagae et al., 2011). Note that in the table dimensions are given in mm.

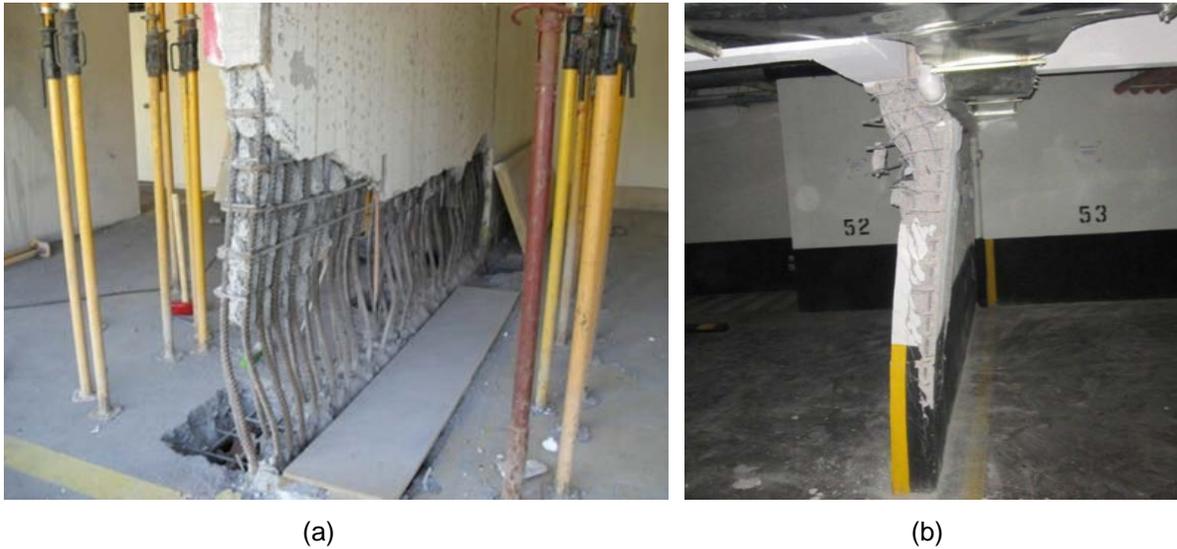
Overall wall buckling refers to the lateral instability of the entire wall section over a portion of the wall length and height. Figure 3-1 illustrates two examples from buildings investigated after the 2010 Maule earthquake. Prior to this earthquake, overall wall buckling had been observed in experimental tests (Chai and Elayer, 1999; Thomsen and Wallace, 2004), but had not been reported in an actual earthquake. Since the 2010 Maule earthquake, overall wall buckling has been observed in at least one building (following the 2011 Christchurch earthquake in New Zealand). Relative to other types of wall damage that occurred in the 2010 Maule earthquake, cases of documented overall wall buckling behavior are relatively few, and were often associated with significant residual drift in the building.

greater, are not unusual. According to one theory (Corley et al., 1981; Paulay and Priestley, 1993), wall buckling is exacerbated by reduced sectional stiffness due to residual tensile strains in previously yielded walls. Alternatively, buckling may simply be an outcome of increased slenderness and eccentricities introduced when a thin boundary crushes under moment and axial force.

Figure 3-1 Examples of overall wall lateral buckling from the 2010 Maule earthquake: (a) Alto Huerto building, Concepción (DICTUC, 2010d); and (b) Undisclosed Building B, Santiago (DICTUC, 2010e).

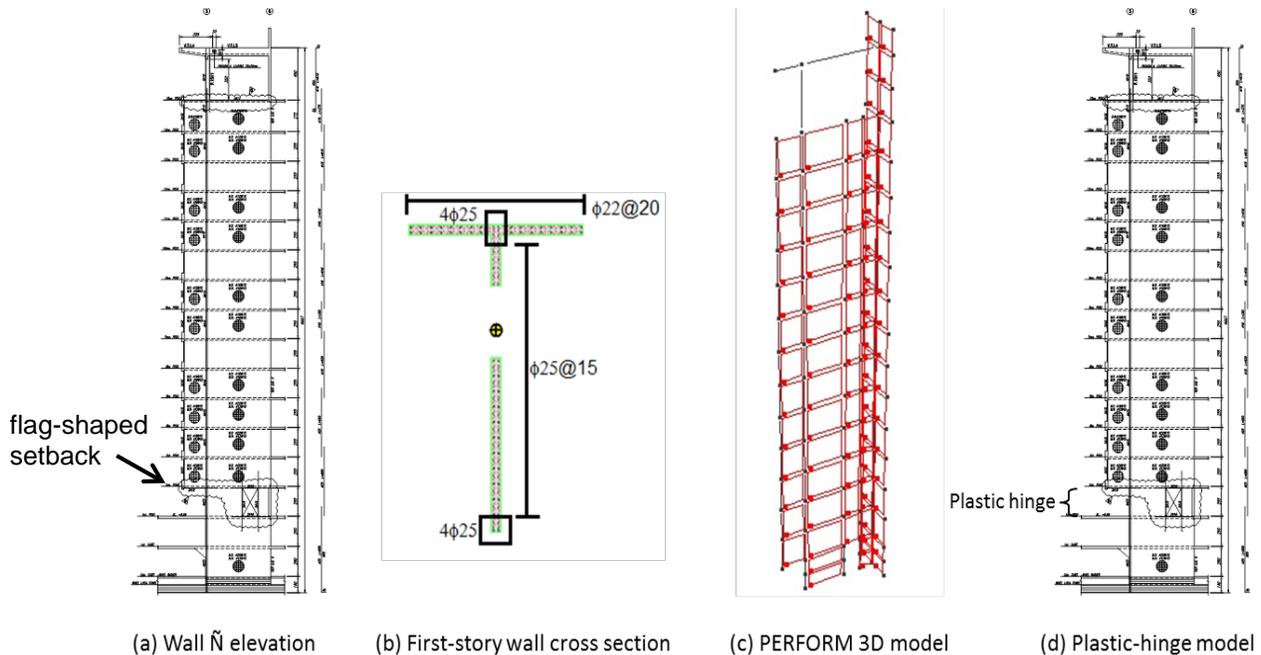
The wall on Line Ñ exhibited the most obvious case of apparent lateral buckling in the building. This wall has a T-shaped cross-section with a 2 m (6 feet) setback in the first story above grade. Figure 3-7a shows the wall in elevation, and Figure 3-7b shows a plan section of the wall in the first story.

Figure 3-7 Alto Huerto building – wall Line Ñ elevation, cross-section, and nonlinear analysis models.

Using Equation 3-1 to investigate wall buckling, a prior peak tensile strain of $e_{sm} \approx 0.03$ in the wall is necessary before out-of-plane buckling is likely to occur. This tensile strain would be reached at a roof drift ratio of approximately 0.014. Given the potential upper bound displacements calculated using the displacement response spectrum, this drift ratio is plausible, but it is also approximately three times the drift ratio that is expected to cause concrete crushing in the wall. Therefore, it seems more likely that the wall crushed first from loading with the stem in compression, and the damaged section then buckled out of plane. If it is assumed that spalling of the concrete cover leaves an intact core with a thickness of $b \approx 4.4$ inches, Equation 3-1 indicates that the reduced section would be prone to out-of-plane buckling at a roof drift ratio of 0.005.

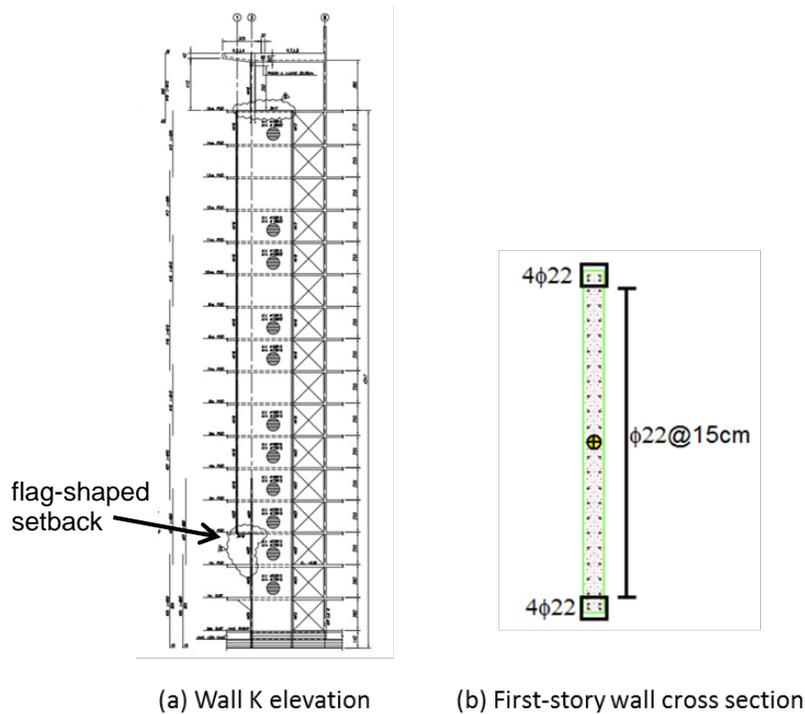
The wall on Line K (Figure 3-8) is located immediately adjacent to the wall on Line Ñ. This wall also has a flag-shaped setback in the first story, but unlike the wall on Line Ñ, it has a rectangular cross-section. The wall on Line K experienced minor failure in the boundary, apparently due to compression. Because the wall lines are adjacent to each other, it is reasonable to infer that the walls were subjected to nearly identical displacement histories.

Using the same approach applied to the wall on Line Ñ, simplified models integrating curvature over height, including a plastic-hinge model, were used to study the likely strain demands in the first story of the wall on Line K. According to these models, crushing of the wall boundary is expected at a roof drift ratio of 0.006 (slightly larger than the drift ratio required for crushing at Line Ñ). At this drift ratio, the maximum tensile strain in the wall is approximately 0.008, which is much less than the value $e_{sm} \approx 0.03$ from Equation 3-1 that is likely to cause out-of-plane buckling to occur after spalling. This result indicates that concrete crushing would be expected to precede out-of-plane buckling, which matches the observed behavior of the wall on Line K.

Limited damage observed in the wall boundary on Line K suggests that the wall did not experience drifts that significantly exceeded the drift corresponding to the onset of concrete crushing (roof drift ratio ≈ 0.006). Therefore, it seems even less likely that the Alto Huerto building experienced roof drift ratios on the order of 0.014 that

Figure 3-8 Alto Huerto building – wall Line K elevation and cross-section.

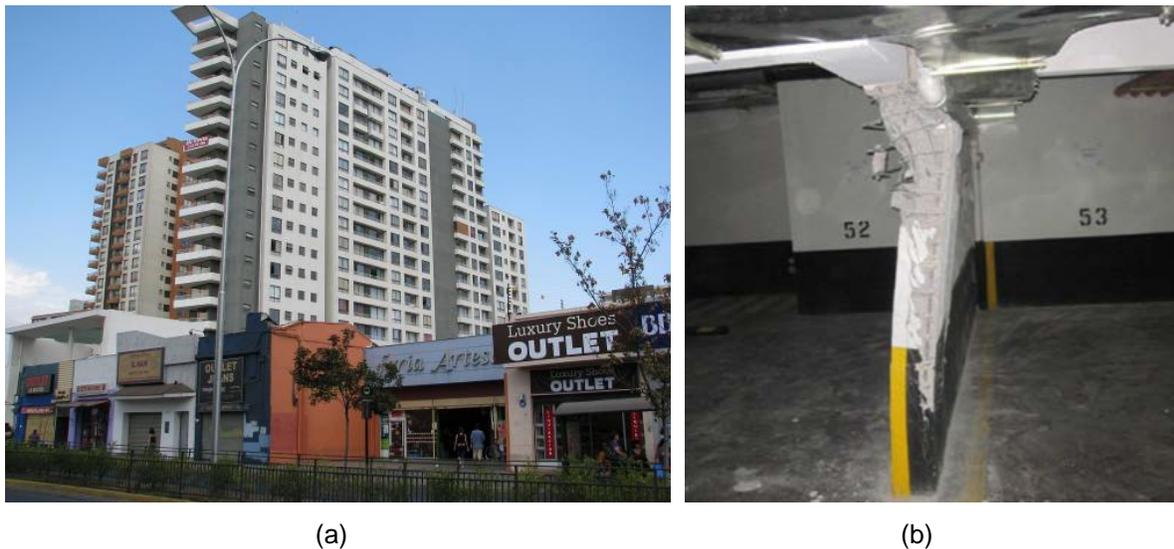
Undisclosed Building B is a 20-story structure with four basement levels located in Santiago (Figure 3-9a). The building sustained damage as a result of the 2010 Maule earthquake that was characterized by overall buckling in six walls in the transverse (East-West) direction, concentrated in the first subterranean level below-grade. Damage to the wall on Line O is shown in Figure 3-9b.

Figure 3-9 Undisclosed Building B: (a) exterior elevations; and (b) wall buckling in the first subterranean level along transverse Line O (DICTUC, 2010e).

Using Equation 3-1 to investigate wall buckling, a prior peak tensile strain of $e_{sm} \approx 0.02$ in the wall is necessary before out-of-plane buckling is likely to occur. Because the drift ratio associated with concrete crushing is smaller than the drift ratio associated with out-of-plane buckling, it seems much more likely that the failure mode associated with wall crushing will occur before wall buckling.

If it is assumed that wall crushing and spalling of the cover concrete leaves a core with a reduced thickness, Equation 3-1 indicates that the reduced wall section would be prone to out-of-plane buckling at a peak tensile strain of $e_{sm} \approx 0.008$. At a roof drift ratio of 0.003, at which crushing is expected to occur, the maximum tensile strain in the wall would be approximately 0.005 (close to e_{sm}), which indicates that it is possible that buckling could be triggered. Similar conclusions were obtained for the other damaged walls in the building. Thus, the likely sequence of damage observed in the transverse walls is crushing and spalling of concrete cover, followed by out-of-plane buckling of the reduced wall section.

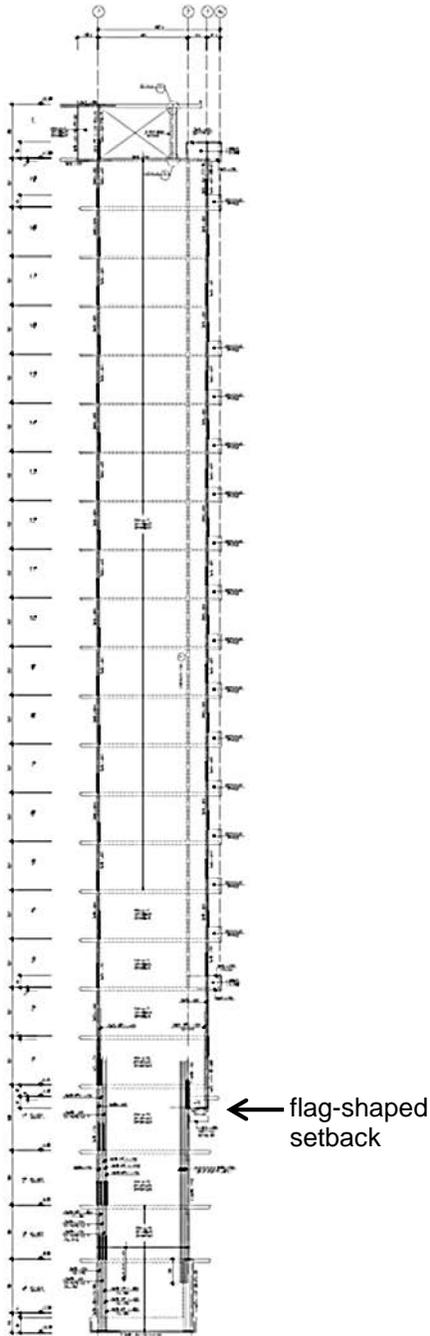
The building was designed in 2006 and constructed in 2009. The gravity and seismic force-resisting systems consist of reinforced concrete bearing walls with a typical thickness of 170 mm (6.7 inches). A typical floor plan is shown in Figure 3-10. The typical story height is 2.52 m (8 feet 3 inches). Transverse walls in subterranean levels have flag-shaped setbacks relative to the walls in upper stories (Figure 3-11).

Figure 3-11 Undisclosed Building B – elevation of wall Line O.

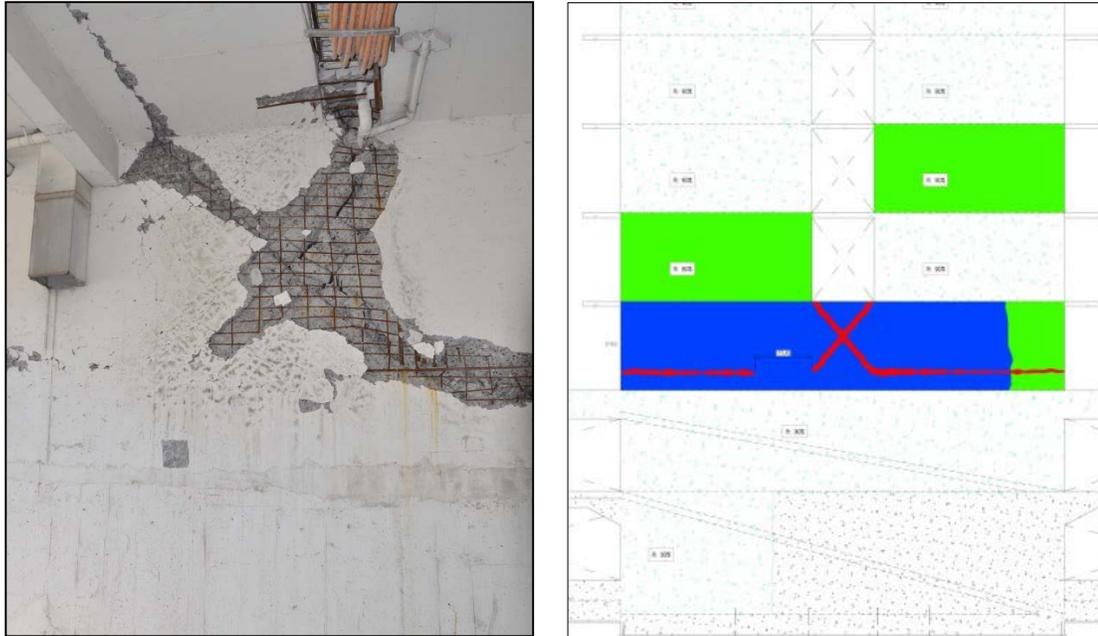
Figure 4-2 shows damage to a solid wall located below a vertically aligned stack of openings. This configuration issue is investigated in Section 4.3.

(a) Photograph of damaged wall.

(b) Sketch of building section shown in (a). Green regions suffered minor damage; blue, moderate damage; red, severe damage.

Figure 4-2 Photograph and sketch of damage below stacked openings where coupled walls above frame into solid wall below at the Centro Mayor building, Concepción (photo courtesy of EERI).

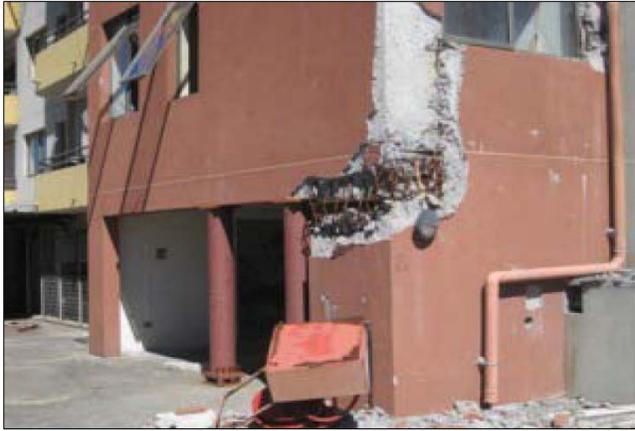
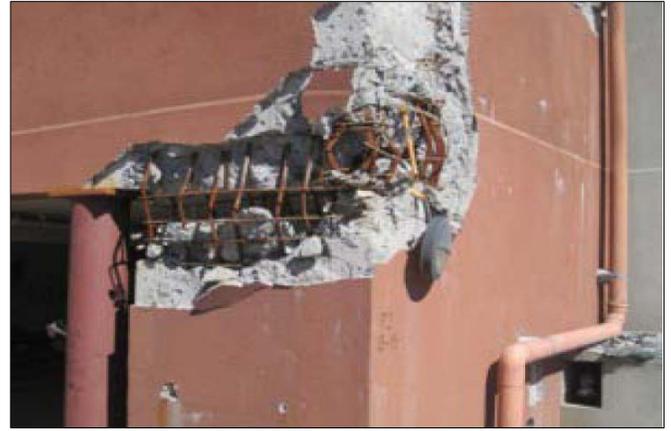
Figure 4-3 Earthquake damage photographs illustrating a geometric wall discontinuity at the Centro Mayor building, Concepción (DICTUC, 2010a).

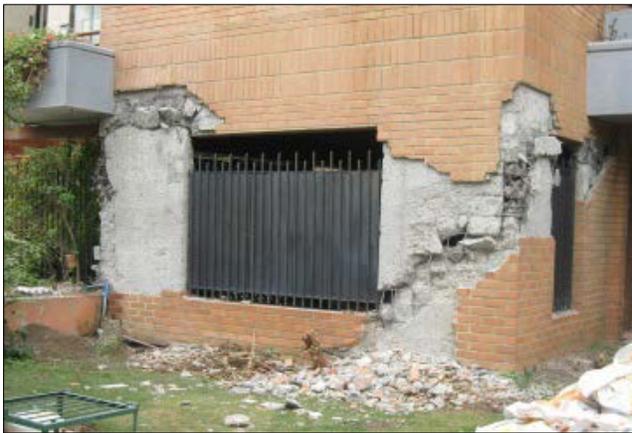
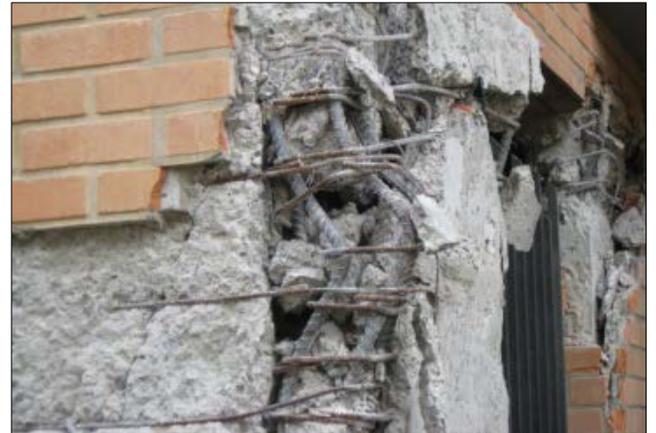
Figure 4-4 Earthquake damage photographs illustrating a geometric wall discontinuity at the Rio Petrohue building, Viña del Mar (photos courtesy of Joseph Maffei).

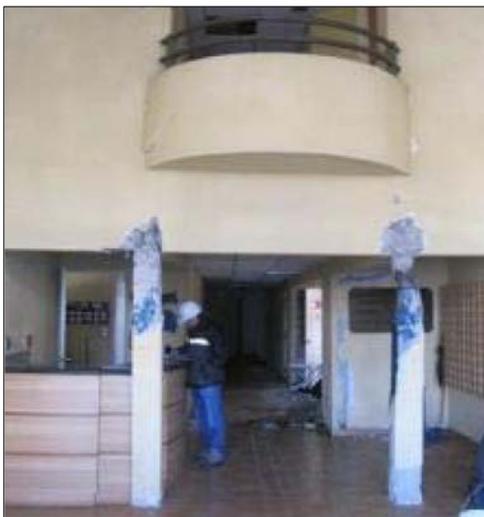
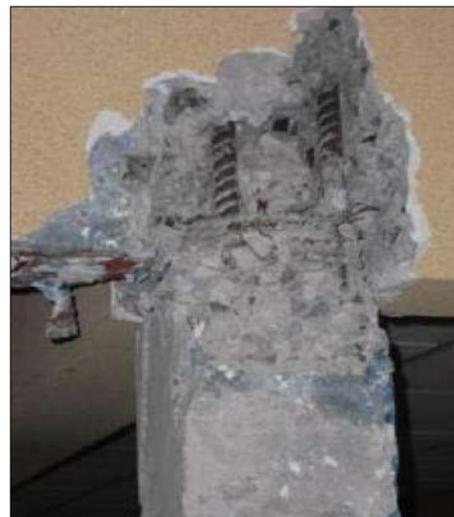
Figure 4-5 Earthquake damage photographs illustrating a geometric discontinuity and geometry change resulting in a wall partially supported on a column in the Centro Mayor building, Concepción (DICTUC, 2010a).

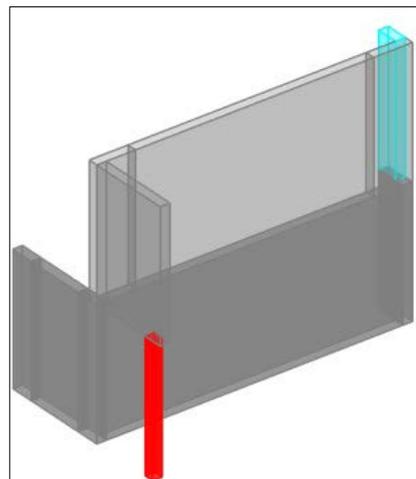
Figure 4-7 Three-dimensional sketch of a wall configuration illustrating geometry change resulting in a wall partially supported on a column at the location of damage shown in Figure 4-5.

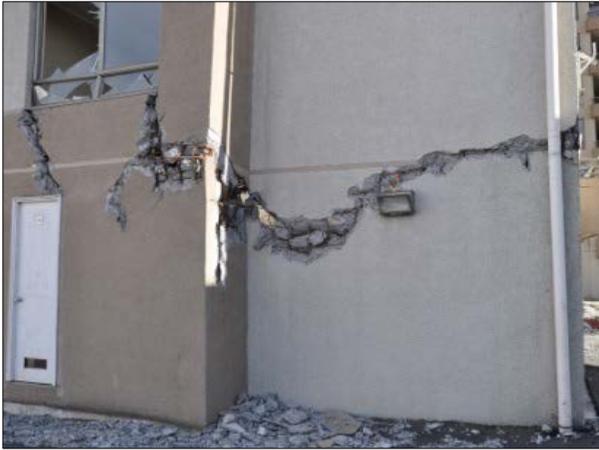
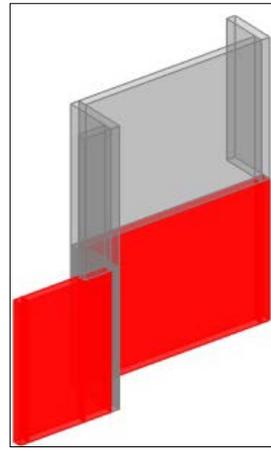
Figure 4-8 Photographs of damage at discontinuities in Z-shaped walls at the south end of Plaza del Rio Building A. Three-dimensional rendering illustrates wall configuration showing that a flange in the second story is not present in the first story. Red regions in the rendering indicate locations of damage (photos courtesy of Jack Moehle).

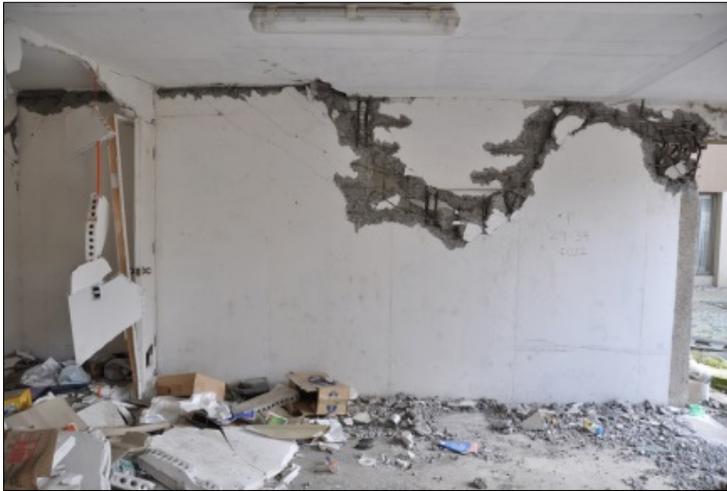
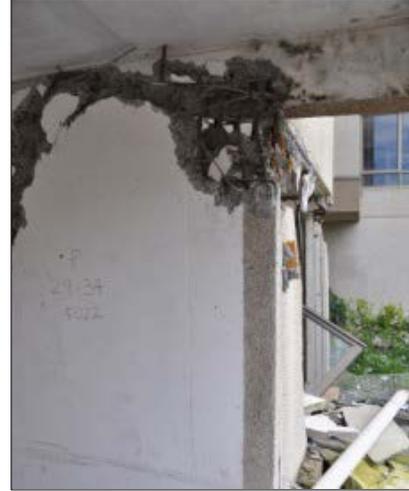
Figure 4-9 shows a sketch of a damaged region of Plaza del Rio Building A. The damage shown is associated with a complex wall configuration in which: (1) the centroid of the wall shifts significantly; (2) reduction of flange occurs from the second to first story; and (3) damage to the adjacent slab indicates significant out-of-plane demands at the top of the wall in the first story despite no portion of the wall existing immediately above. Figure 4-10 shows photographs of the damaged region.

Figure 4-10 Photographs of the damaged section illustrated in Figure 4-9 at wall discontinuity in Plaza del Rio Building A (photos courtesy of Jack Moehle).

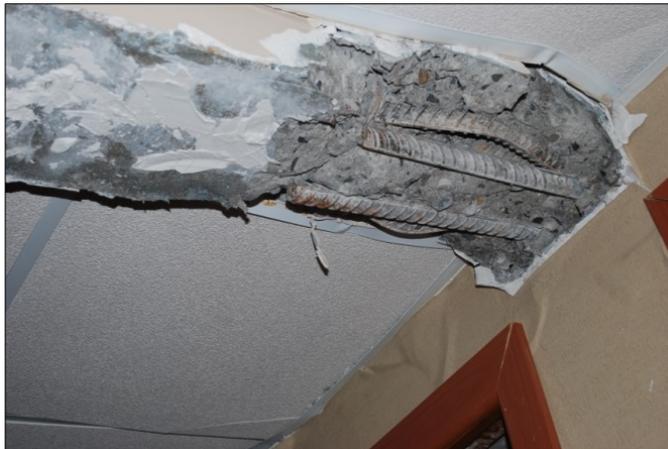
(a) Photo of bar termination (lap splice) in beam hinge region (photo courtesy of Jack Moehle)

Figure 4-11 Two examples showing termination of reinforcement: (a) photograph of damage in a reinforced concrete beam at the face of a connection where lap splices were used in the plastic hinge region of the beam; and (b) wall elevation showing termination of boundary element reinforcement in the O'Higgins building in Concepción.

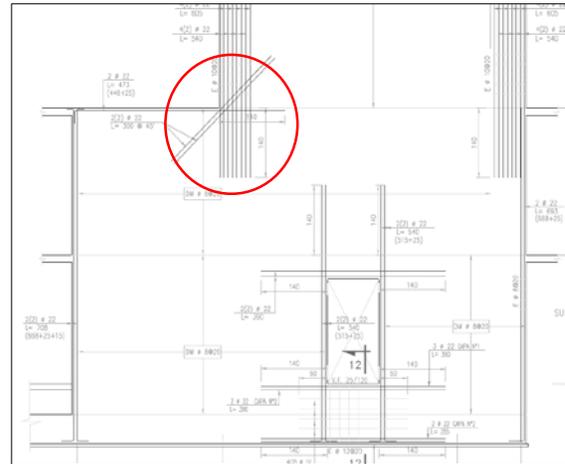
(b) Illustration of abrupt termination of boundary element reinforcement in wall elevation

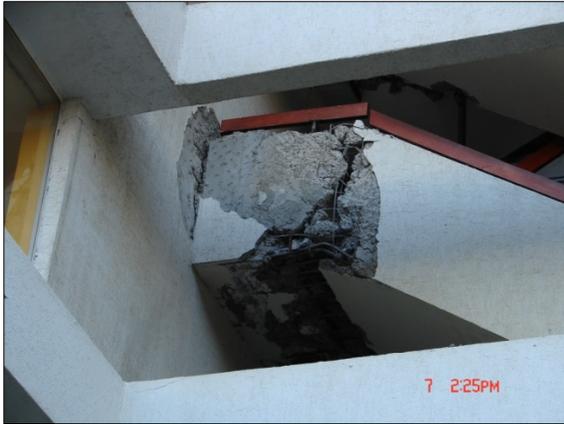
(a) Festival building, Viña del Mar (photo courtesy of ASCE)

Figure 4-12 Damage observed at non-seismic force-resisting components such as stairs (shown here), indicating the possibility of coupling of seismic force-resisting components by non-seismic force-resisting components.

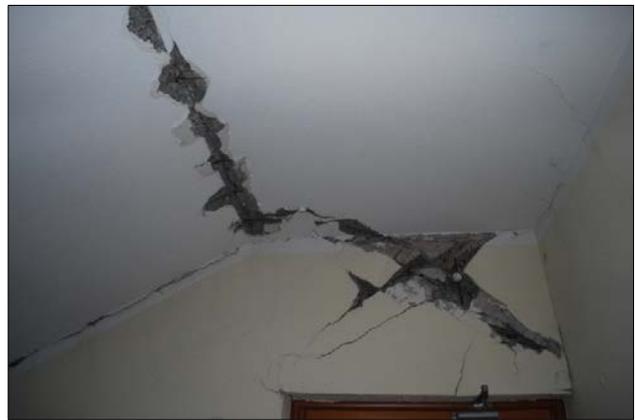
(b) O'Higgins building, Concepción (photo courtesy of Jack Moehle)

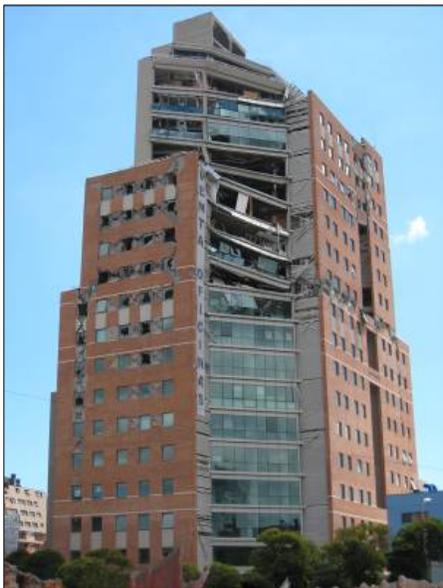
Figure 4-13 shows observed damage at the O’Higgins building which is the subject of the pier-spandrel investigation summarized in Section 4.5.

Figure 4-13 Photograph of damage to the O'Higgins building, Concepción. Damage was attributed, in part, to vertical discontinuities in the building configuration. Significant damage, including partial collapse of upper floors, was observed (photo courtesy of Joseph Maffei).

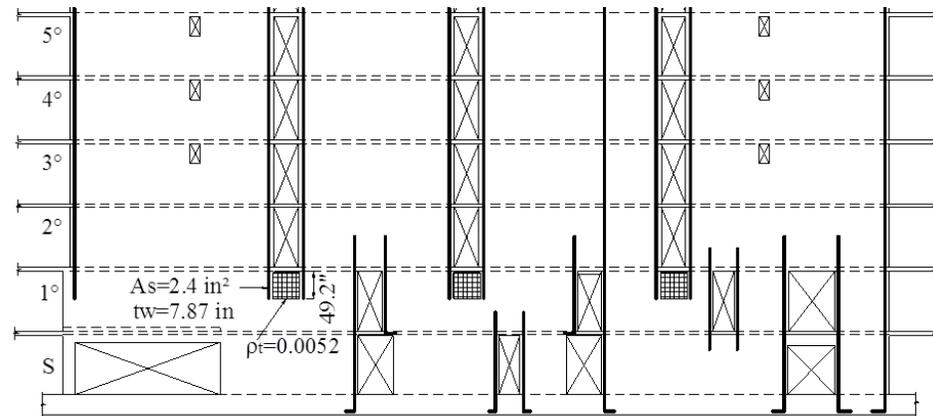
shows an example of a typical reinforcement layout in the vicinity of discontinuities below stacks of openings. Boundary reinforcing bars are terminated 49 inches below the openings in Chile.

Figure 4-15 Typical reinforcement layout around stacks of openings terminating in a solid wall, Torre Mayor building, Chillán (A_s is the area of boundary reinforcement, t_w is the panel thickness, and ρ_t is the steel reinforcement ratio in the panel).

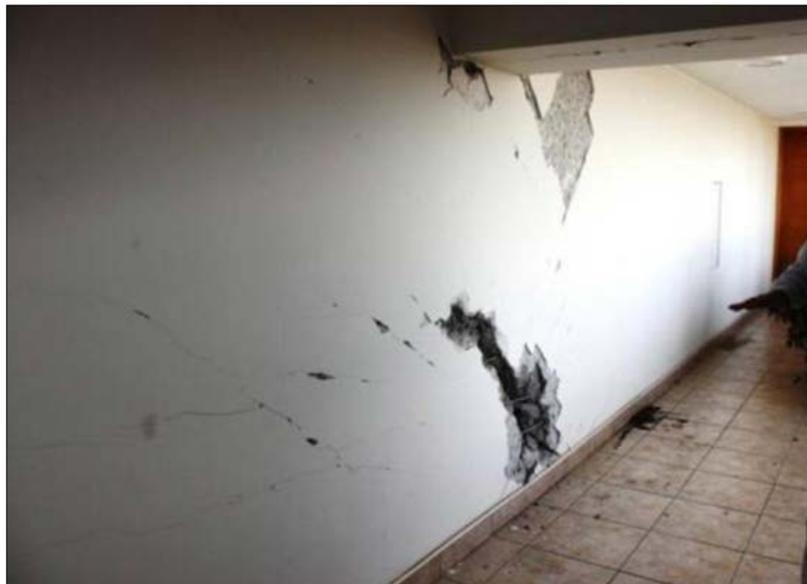
The Torre Mayor building, from which Figure 4-15 was taken, suffered damage in the solid wall panels above and below the openings. Figures 4-16 and 4-17 show damage to solid wall panels in the Torre Mayor building, which is consistent with damage patterns observed in other buildings with similar discontinuities following the 2010 Maule earthquake and the 1989 Loma Prieta earthquake.

Figure 4-16 Damage observed in a solid wall panel above a stack of openings in the Torre Mayor building, Chillán (photo courtesy of EERI).

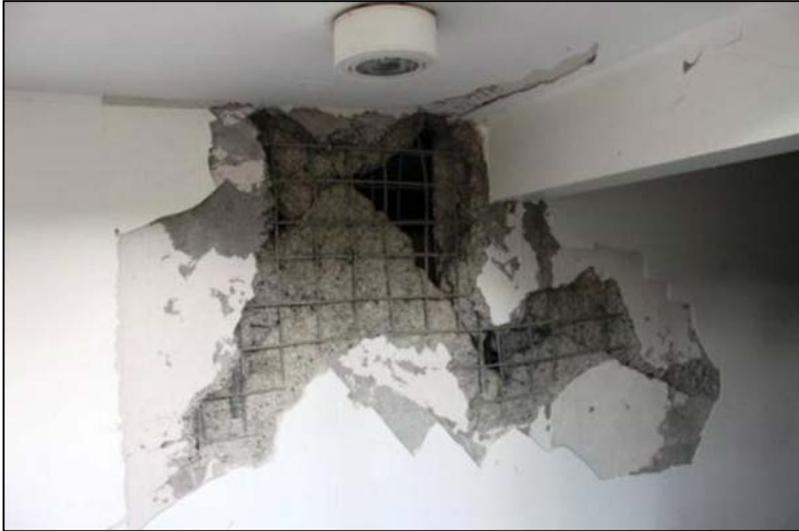
Figure 4-17 Damage observed in a solid wall panel below a stack of openings in the Torre Mayor building, Chillán (photo courtesy of EERI).

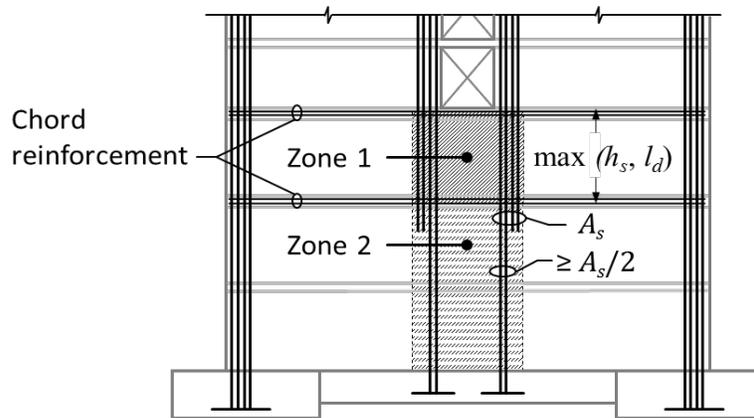
Figure 4-19 Recommended details for reinforcement in wall panels beneath stacks of vertically aligned openings in coupled walls.

Based on case study findings and available research, the following design approach is recommended. Two design zones should be established below (or above) a vertically aligned stack of openings, as illustrated in Figure 4-19:

- Zone 1 extends below the openings a distance equal to the greater of l_d (the anchorage length of the boundary reinforcement as required in ACI 318) and h_s (the story height below the stack of openings), but not less than the length required to transfer shear within acceptable limits on shear stress in the wall.
- Zone 2 is defined as the remaining portion from Zone 1 to the foundation (or roof, if considering the panel above of a stack of openings).

All boundary reinforcement should extend through Zone 1, and at least half of the bars should extend all the way to the foundation (or roof). Zone 1 should be proportioned and reinforced for panel zone shear stresses equal to at least $1.25A_s f_y/2$, where A_s is the area of the boundary element reinforcement, f_y is the nominal yield strength, the factor 1.25 accounts for overstrength, and the factor 2 considers that half of the boundary reinforcement is extended into Zone 2.

Zone 2 should be designed for the remainder of the panel zone shear. It is acceptable to consider the force as being transferred to the foundation where adequate provision is made to develop the force at the foundation level. The amount of chord reinforcement above and below Zone 1 should resist the shear stresses assumed to be within Zone 1. Chord bars can be terminated progressively along the length.

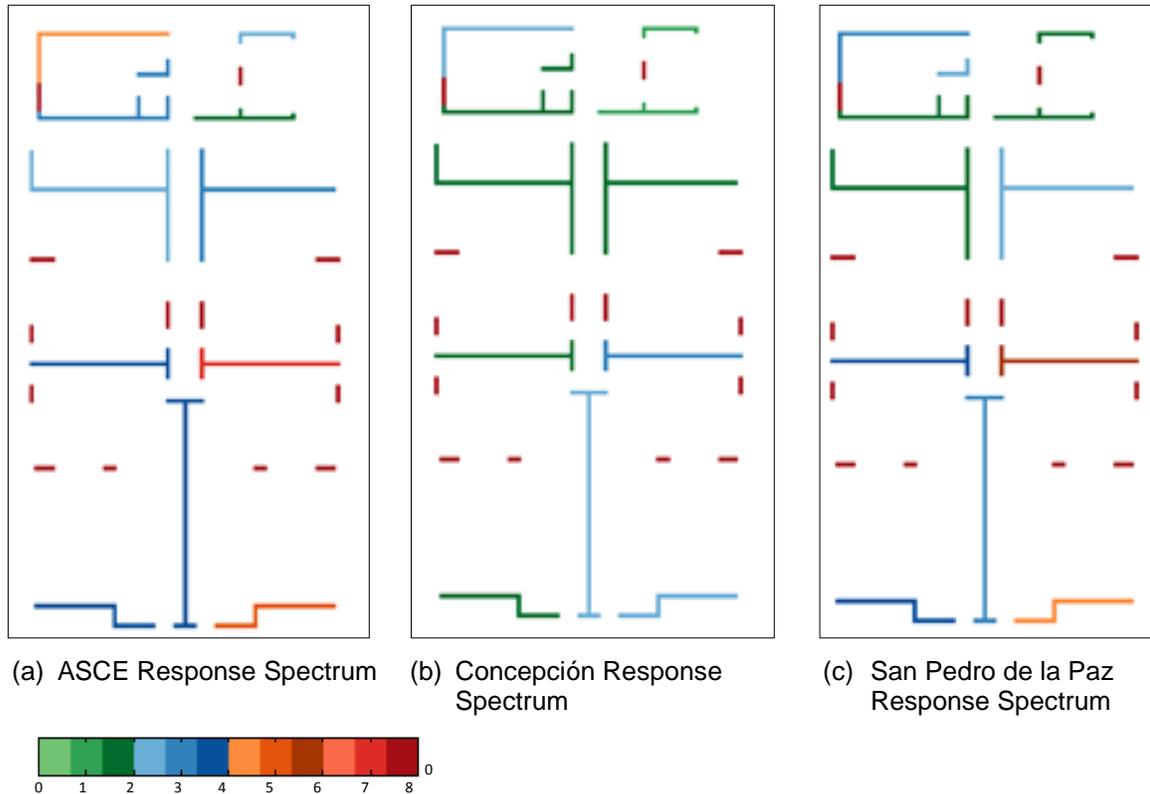
Maximum calculated DCR_u values for the walls in the first story of Plaza del Rio Building A are shown in Figure 4-23. In ASCE/SEI 41-06, DCR_u values in excess of 2.0 indicate that a linear analysis is not sufficient for evaluation, and a nonlinear analysis (Tier 3) should be performed. DCR_u values varied significantly at each wall, and were different for each spectrum used in the analysis. For the ASCE design spectrum, almost all DCR_u values exceeded 2.0, indicating that nonlinear analysis should be performed on this building at this hazard level. For the Concepción response spectrum, DCR_u values were approximately equal to 2.0.

Figure 4-23 Maximum DCR_u values in first story walls of Plaza del Rio Building A (colors indicate values of DCR_u , ranging from 0 to 8).

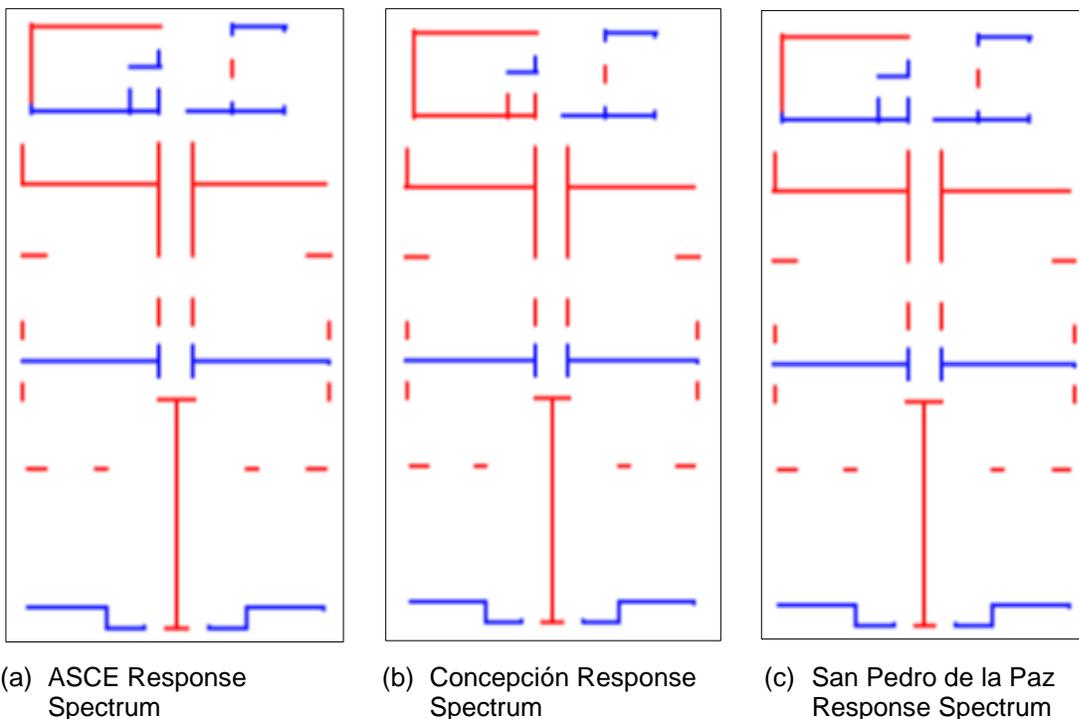
Figure 4-24 shows the controlling mechanism for each wall in the first story of Plaza del Rio Building A, determined based on calculated values of DCR_u . For longitudinal walls, the calculated mechanism was shear; for transverse walls, the calculated mechanism was flexure; and for short wall piers, the calculated mechanism was shear. As expected, the controlling mechanism for each wall was essentially independent of the spectrum used in the analysis.

In general, calculated mechanisms were found to be consistent with observed mechanisms. For the primary longitudinal walls, shear was predicted to be the controlling mechanism, and significant, well-distributed diagonal cracking was observed following the earthquake. For the primary transverse walls, flexure was predicted to be the controlling mechanism, and most walls exhibited concrete crushing, particularly at the wall boundaries, or along an approximately horizontal plane of damage. Significant and well-distributed diagonal shear cracking was

observed in the interior pair of transverse T-shaped walls; however this damage was also accompanied by concrete crushing at the wall boundaries, which is indicative of both shear response and flexural response mechanisms.

Figure 4-24 Controlling mechanisms in first story walls of Plaza del Rio Building A (blue indicates flexure mechanism; red indicates shear mechanism).

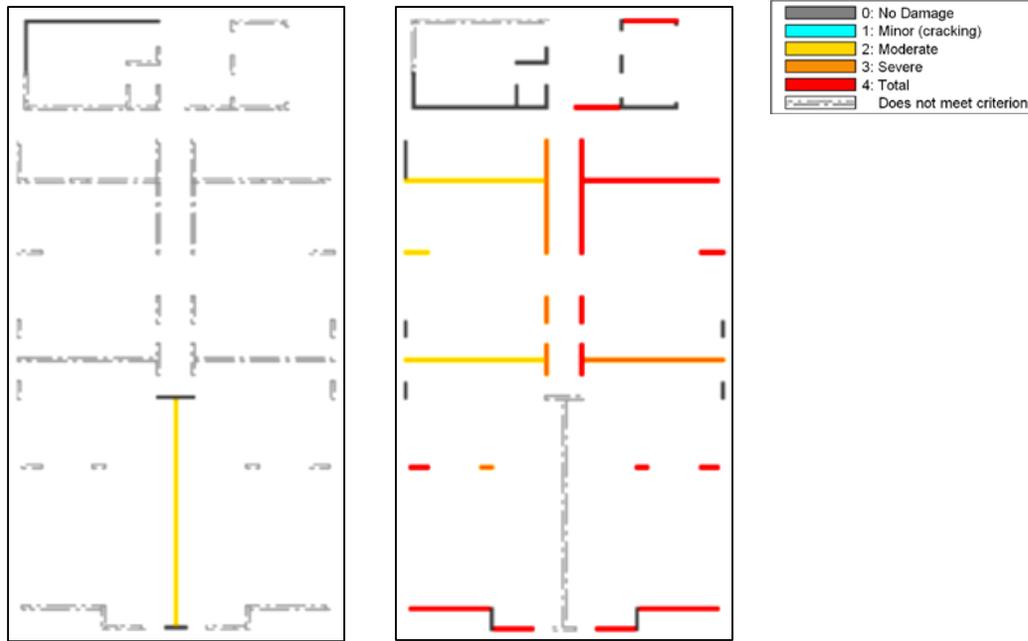
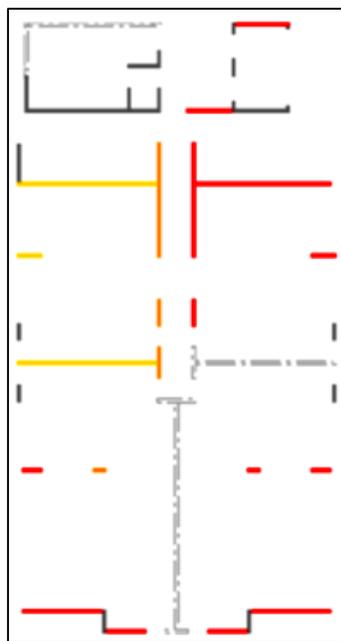
Based on the results shown in panel (b) of Figure 4-25, almost all of the primary longitudinal and transverse walls in Plaza del Rio Building A would be expected to meet the Collapse Prevention performance level for the Concepción ground motion. A significant exception is the longitudinal I-shaped wall at the south end of the building, which is inadequate for all performance objectives.

Figure 4-25 Tier 2 evaluation results for first story walls in Plaza del Rio Building A subjected to the Concepción ground motion record (dashed gray walls in each panel do not meet the performance criterion for that panel, colored walls meet the performance criterion for that panel, and colors indicate the severity of the observed earthquake damage).

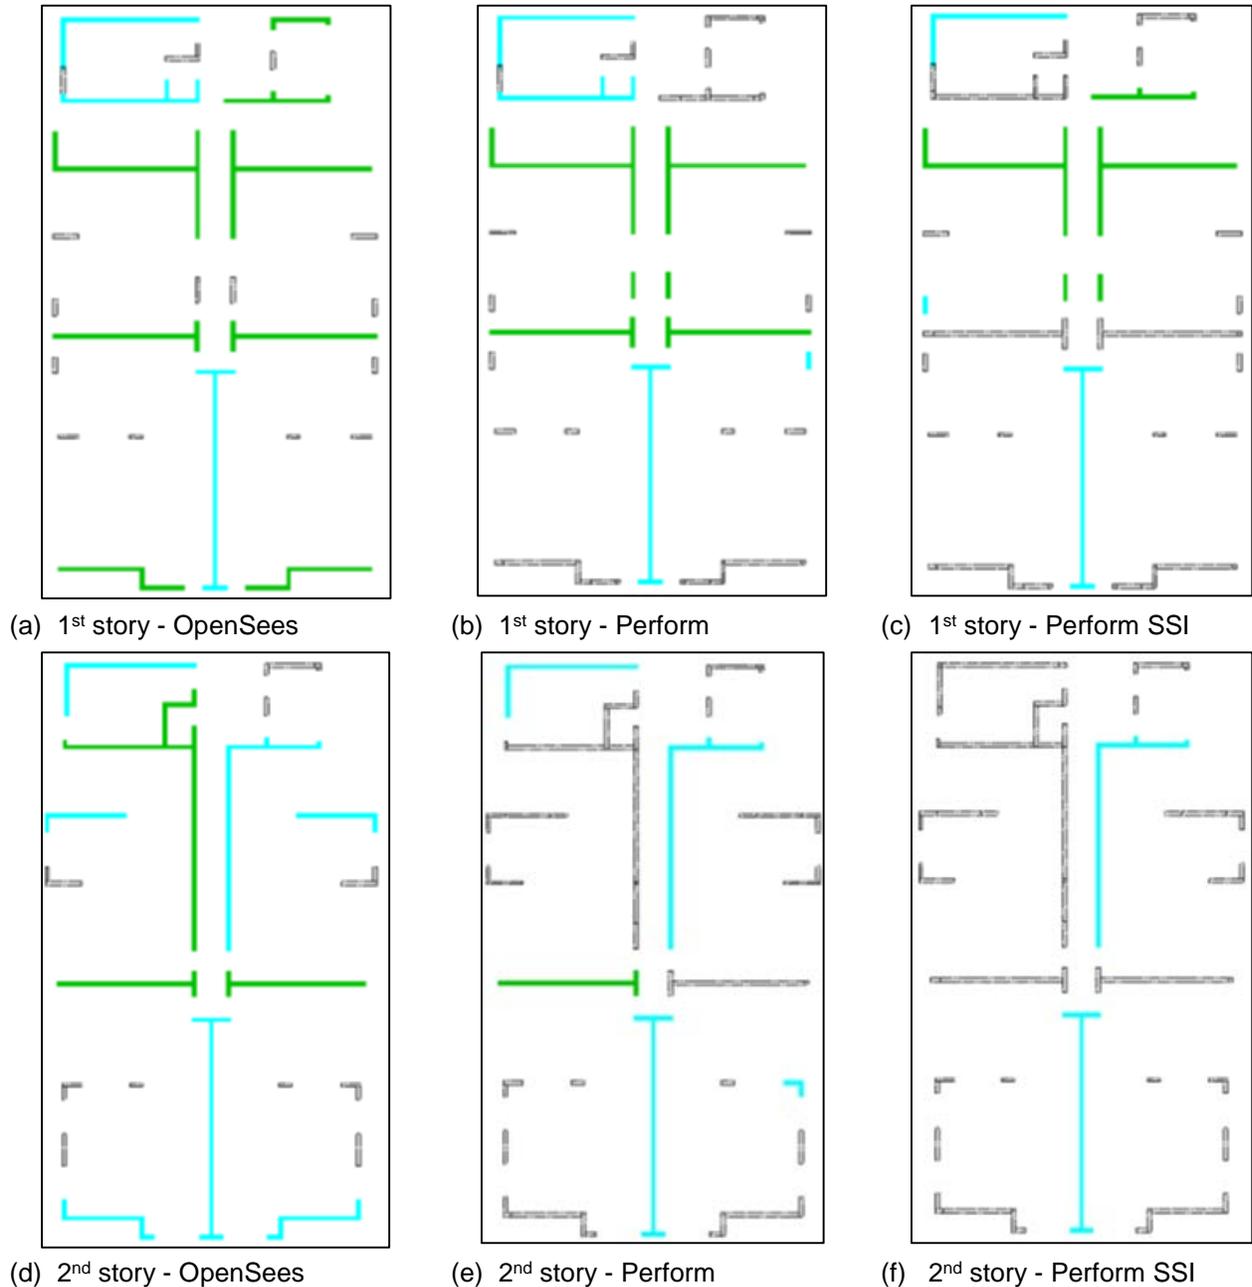
Figure 4-27 Shear failures in first and second story walls of Plaza del Rio Building A, as predicted using OpenSees, Perform Basic, and Perform SSI models. Colored wall lines indicate shear failures with $V_u > 1.1V_n$. Fill color indicates the severity of observed earthquake damage (green corresponds with severe or total damage; blue corresponds with none, minor, or moderate damage). Dashed gray walls indicate walls that are not predicted to fail in shear.

Based on the results shown in Figure 4-27, shear failure predictions were somewhat consistent with observed damage. In the longitudinal direction, shear failures were predicted, and diagonal cracking consistent with a shear response mechanism were observed in these walls. In the I-shaped wall at the south end of the building, however, the observed level of damage was less severe than would have been expected given a calculated shear failure.

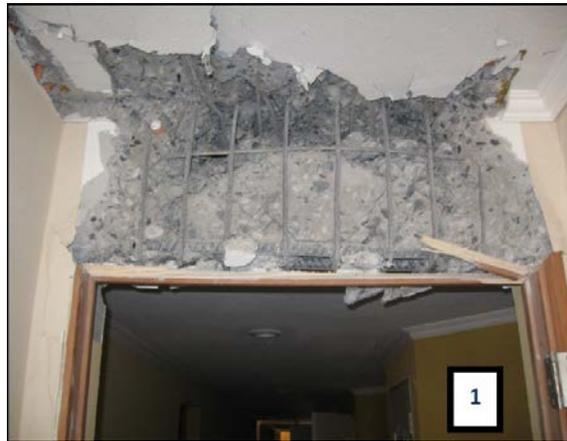
Figure 4-31 Damage to coupling beam in the Centro Mayor building, Concepción (DICTUC, 2010b).

Damage and reinforcement visible in Figure 4-31 indicate that the coupling beam was not designed to provide ductile, flexure-controlled behavior. Similar coupling-induced damage was also observed in floor slabs of other buildings (Birely, 2012).

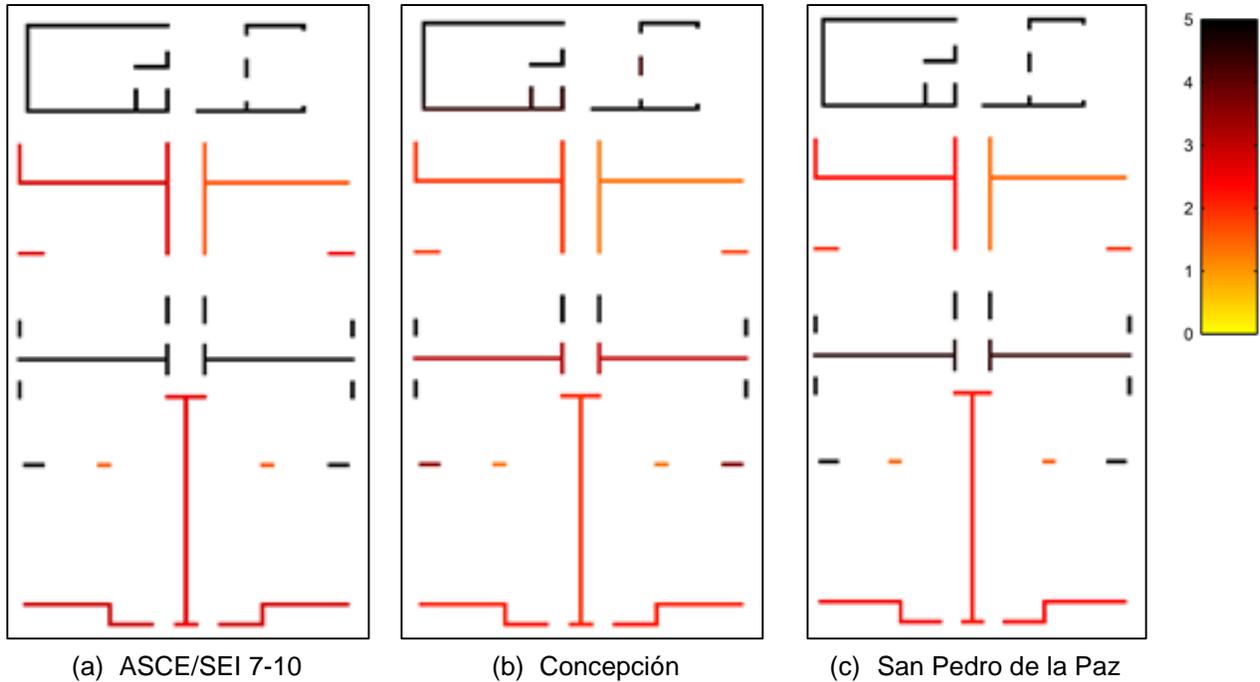
Figure 4-32 shows the ratio of maximum axial compression (gravity plus seismic) to gravity load in the first-story walls of Plaza del Rio Building A. Figure 4-33 shows maximum axial compression (gravity plus seismic) as a percentage of axial strength,

$A_g f'_c$. These figures indicate that elastic coupling response increased axial loads by a factor of 1.5 to 5.0, resulting in axial stress ratios as large as $0.5A_g f'_c$ in the walls of Plaza del Rio Building A.

Figure 4-32 Ratio of maximum axial compression (gravity plus seismic) to gravity load in the walls of Plaza del Rio Building A, calculated using elastic analysis.

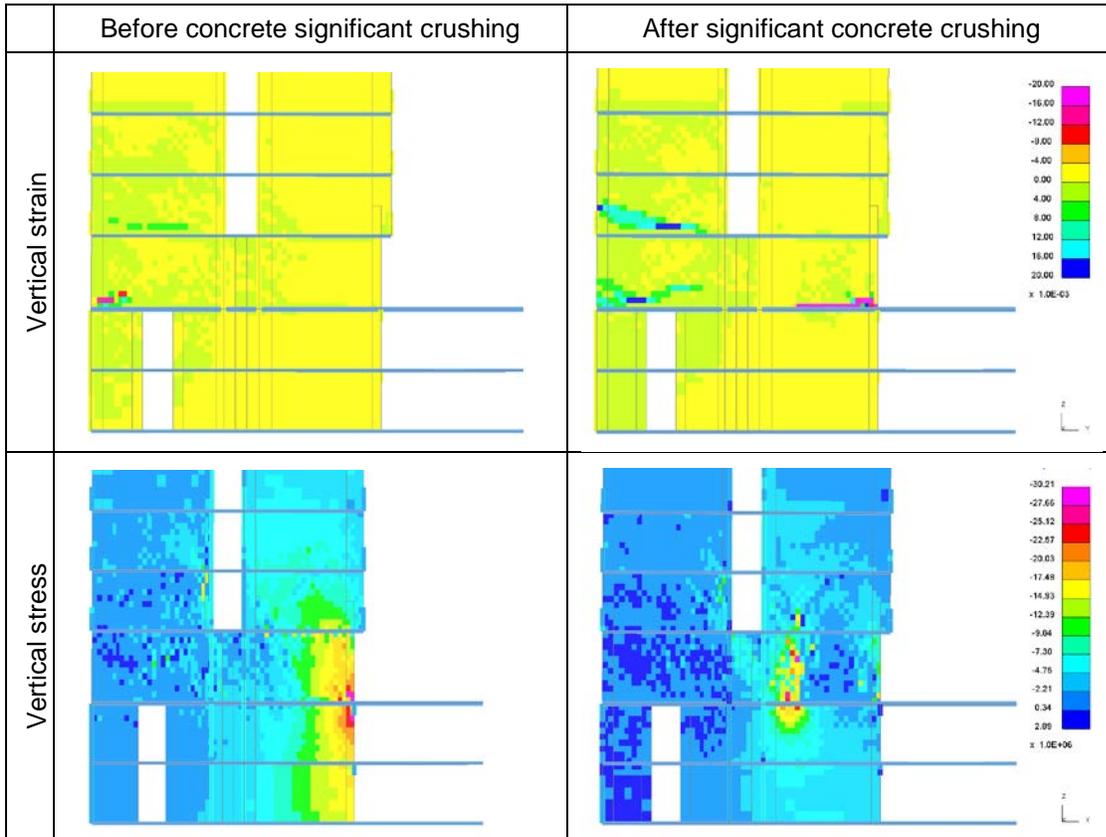
Figure 5-17 illustrates vertical strain and stress distributions in the wall on Grid 13 before and after concrete crushing during the response cycle approximately 11 seconds into the motion record for the triaxial simulation. Tensile stresses and strains are positive. In this cycle, a horizontal band of (essentially unconfined) concrete is predicted to crush (i.e., compression resistance becomes zero at strain greater than 0.005) on the east side of the wall at Grid 13 at ground level. The stress distribution after crushing shows that the highest compression stress has moved from the extreme edge of the wall to a point 3.7 m (12 feet) inwards of this; the entire zone outwards of this has fully unloaded. Figure 5-18 illustrates shear stress distribution in the wall on Grid 13 before and after concrete crushing.

Figure 5-17 Vertical strain and stress distributions in the wall on Grid 13 before and after concrete crushing.
