NIST GCR 14-917-25

Recommendations for Seismic Design of Reinforced Concrete Wall Buildings Based on Studies of the 2010 Maule, Chile Earthquake

NEHRP Consultants Joint Venture
*A partnership of the Applied Technology Council and the
Consortium of Universities for Research in Earthquake Engineering*

March 2014

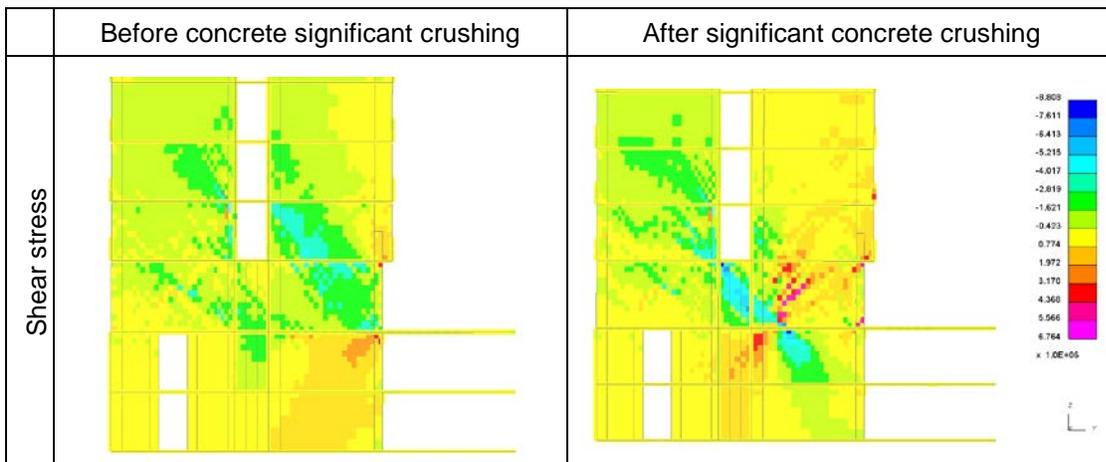
The shear stress distribution in Figure 5-18 just prior to crushing shows that, above the first story, more shear is taken in the east wall than the west wall. This is consistent with the fact that this wall carries a higher vertical stress at this time (about 0.9 ksi, 6 MPa) than the west wall (approximately zero). The peak shear stress in the east wall of less than 0.6 ksi (4 MPa) implies a principal compressive stress of 1.2 ksi (8 MPa) and principal tensile stress of 0.3 ksi (2 MPa), which is close to the tensile strength of the concrete. With the stiff basement assumption, there is clear evidence that the shear is transferring to the grade level slab for reaction into the soil.

Figure 5-18 Shear stress distribution in the wall on Grid 13 before and after concrete crushing.

After the ground level concrete band on the east side of the wall on Grid 13 has crushed, the highest shear stress occurs in the region of solid wall in the first story below a series of stacked openings where the two upper walls connect, which is a

configuration investigated in Chapter 4 of this report. High shear stresses in the opposite direction are seen in the upper part of the first story east wall to enable the vertical gravity compression in the wall above to transition towards the center of the wall to circumvent the failed zone at grade level. As more of the concrete in the wall on Grid 13 crushes at grade level in successive loading cycles, more of the gravity load on this wall transfers to the longitudinal corridor walls. Eventually, the vertical load path at the base of the first story is reduced to the wall around the corridor.

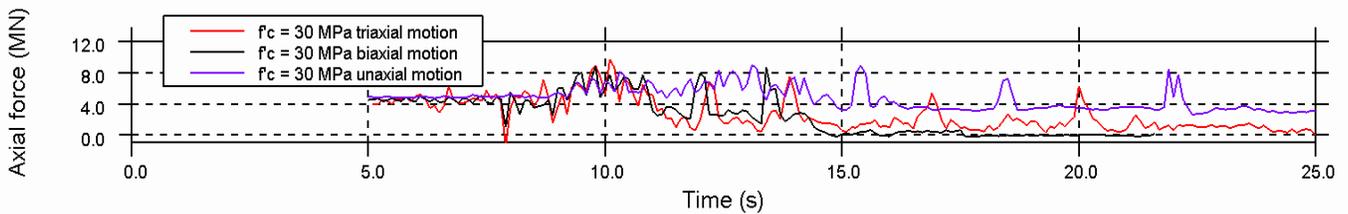
Figure 5-19 shows the total axial force in the wall on Grid 13 under uniaxial, biaxial (no vertical component), and tri-axial simulation cases. Except in the uniaxial excitation case, a major reduction in load in this wall occurs between 11 and 15 seconds into the shaking due to the crushing effect described above, occurring first at the east, and then at the west end of the wall in the first story (with the vertical load transferring to the longitudinal corridor walls). The observation of compression damage over only a short height of the wall is predictable for the strain softening failure associated with largely unconfined concrete and low reinforcement ratio. It is also consistent with the observed damage on many of the buildings that remained standing after the event.

Figure 5-19 Total axial force in the wall on Grid 13 under uniaxial, biaxial (no vertical component), and tri-axial simulation cases.

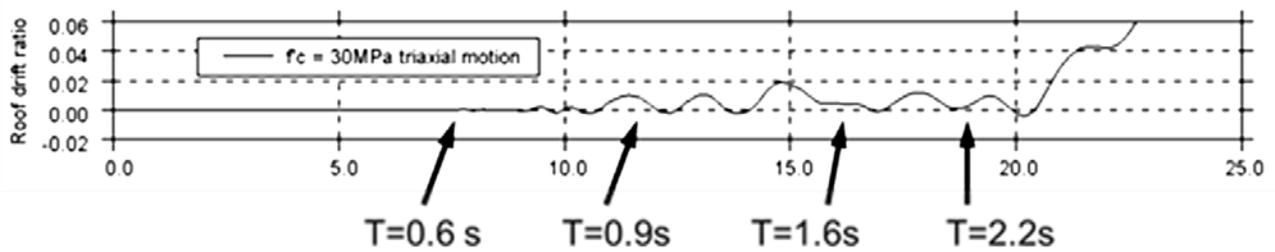
Figure 5-20 shows the response history of the transverse roof deflection ratio, indicating that the period increases from about 0.6 seconds to 2.2 seconds just prior to collapse. The elongation of the period beyond 1.3 seconds makes the building susceptible to the sharp peak in the horizontal pseudo-acceleration spectra in the 1.5 to 2 second period range. This makes the building substantially more vulnerable to damage, and ultimately leads to the rocking-induced collapse of the structure.

Figure 5-20 Roof deflection relative to ground and corresponding roof drift ratio showing period elongation prior to collapse.

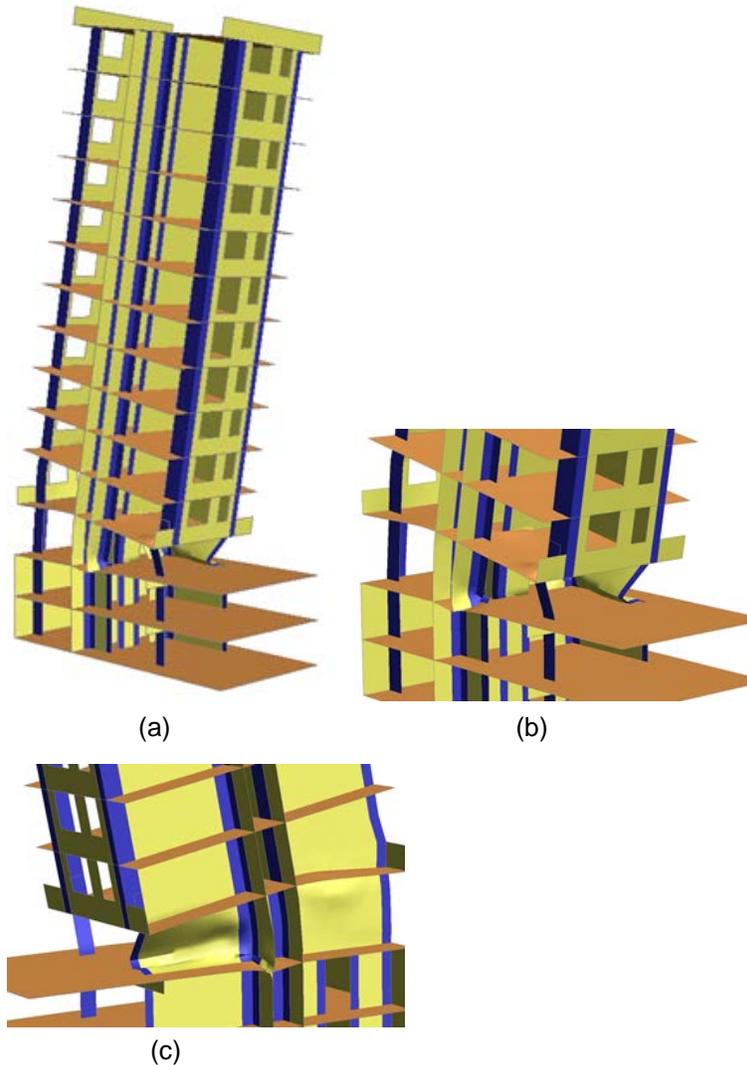
Eventually, as vertical load-carrying capacity is lost at both ends of the wall at Grid 13, the building topples under gravity. Figure 5-24 shows a close-up of the damage

pattern in the lower stories of the wall as collapse approaches, with a concentration of vertical compression strain occurring at the first floor level.

Figure 5-24 Predicted damage: (a) overall view; (b) close-up of damage pattern; and (c) alternate view of damage pattern.

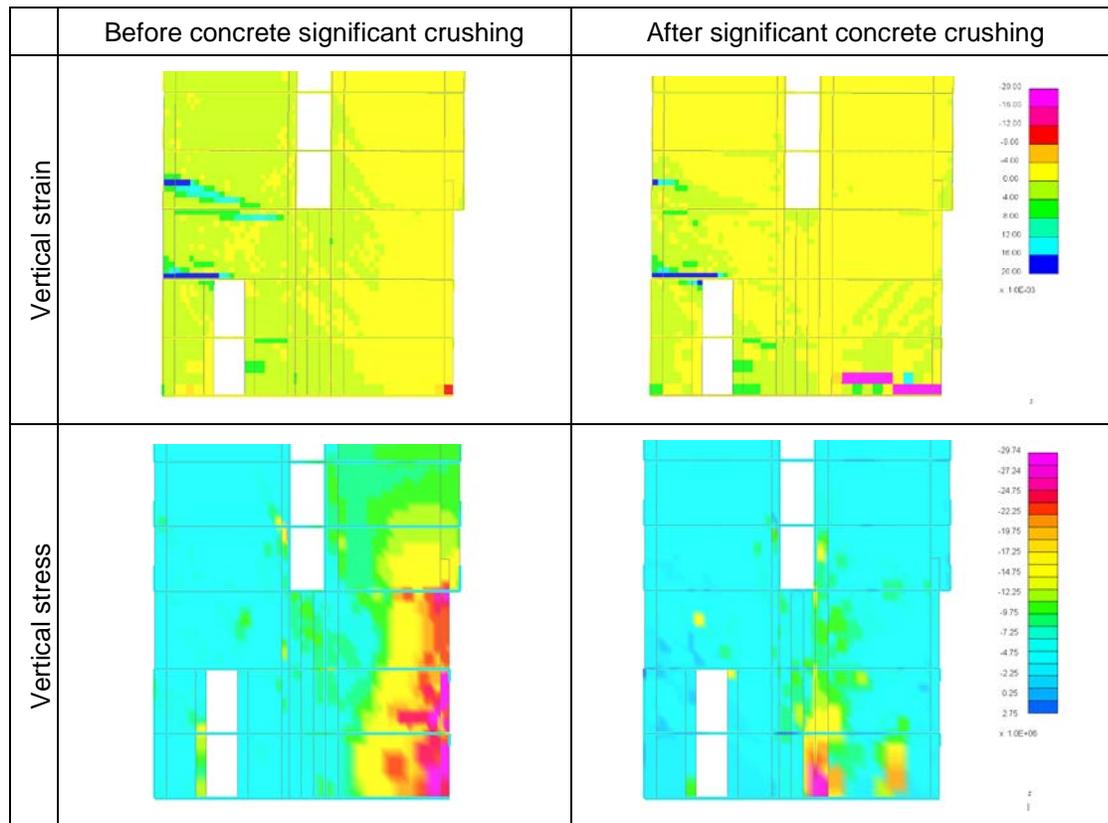
The analysis was repeated with expected properties. As shown in Figure 5-25, significant concrete crushing occurred in the walls at the bottom basement level, but the slice model did not collapse.

Figure 5-25 Vertical strain and stress distributions in the wall on Grid 13 before and after concrete crushing.

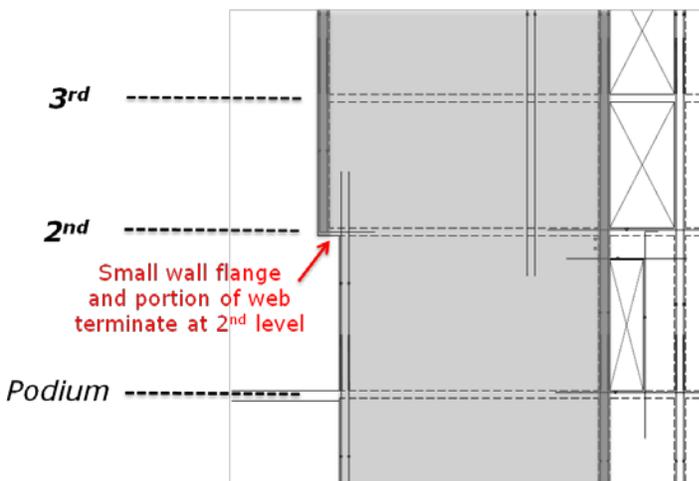
Many of the transverse walls on the northern half of the building have setbacks in the first story. This configuration has been referred to as “flag-shaped,” and was a characteristic of many buildings in Chile. Also, the returns (i.e., flanges) in the upper stories are discontinued in the first story, resulting in localized vertical discontinuities in the walls. An elevation of a typical “flag-shaped” wall configuration, along with discontinuous flanges, is shown in Figure A-3.

Figure A-3 Alto Rio (Building No. 1) – typical wall setback and discontinuous flanges in the first story.

The building collapsed as a result of the earthquake. The podium level was the critical level, and damage to the flag-shaped walls with discontinuous flanges in the first story was identified as the likely cause of collapse.

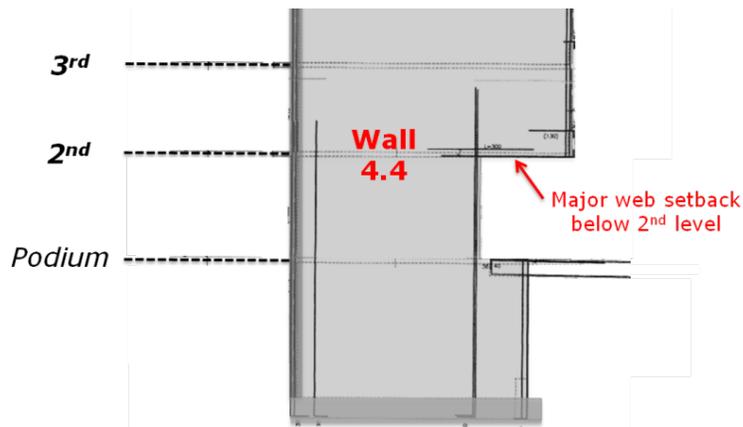
Many of the transverse walls have setbacks in the first story, characteristic of a flag-shaped configuration. The floor plan shown in Figure A-8 identifies the walls investigated as part of this study. Figure A-9 illustrates a typical wall setback and reduction in the length of the web in the first story of the building.

Figure A-9 Toledo (Building No. 4) – typical setback and reduced web in the first story walls.

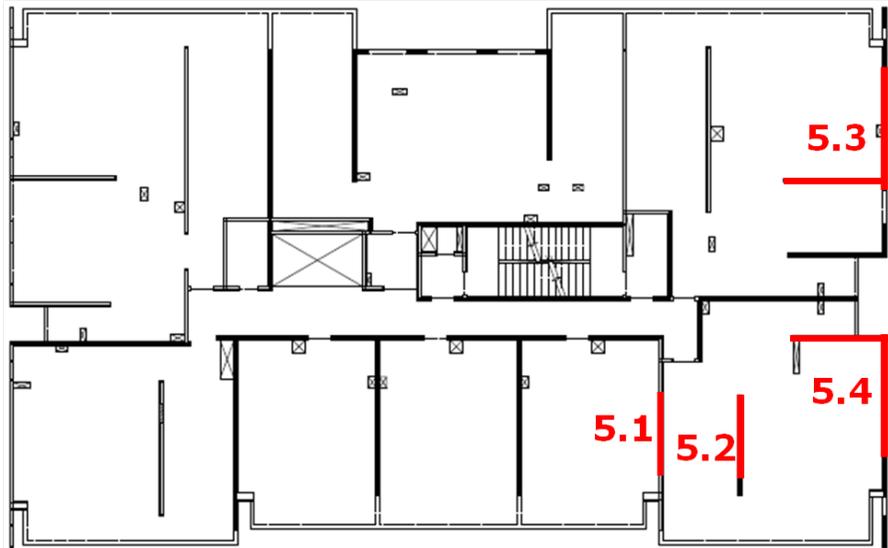
Significant damage to walls was observed in the first subterranean level of parking. Many of the walls in the parking levels have significant setbacks and reduced web sections relative to the residential levels above. The floor plan in Figure A-10 identifies the walls that were damaged and investigated as part of this study.

Figure A-10 Undisclosed Building A (Building No. 5) – typical floor plan with case study walls highlighted.

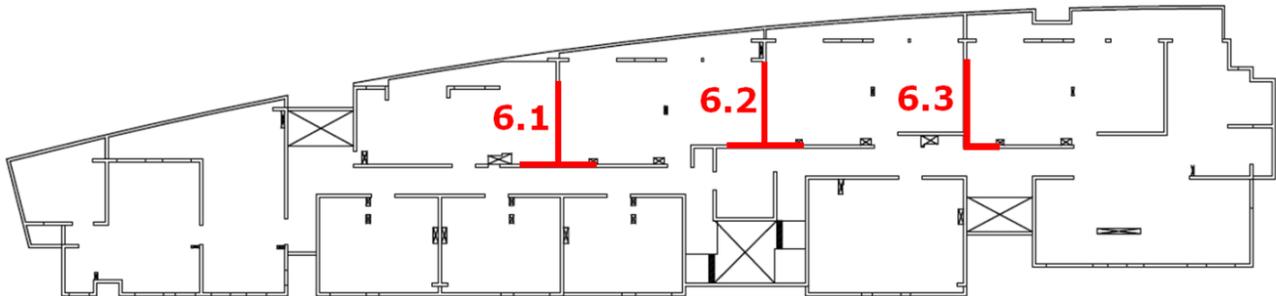
Undisclosed Building B (Building No. 6) is a 20-story structure with 4 levels of underground parking designed in 2006. The gravity and seismic force-resisting systems consist of reinforced concrete bearing walls. Damage was observed in the transverse walls of the first subterranean level of parking. Damage included concrete crushing and spalling of concrete cover, bar buckling and fracture, and apparent out-of-plane wall buckling.

Figure A-12 Undisclosed Building B (Building No. 6) – typical floor plan with case study walls highlighted.

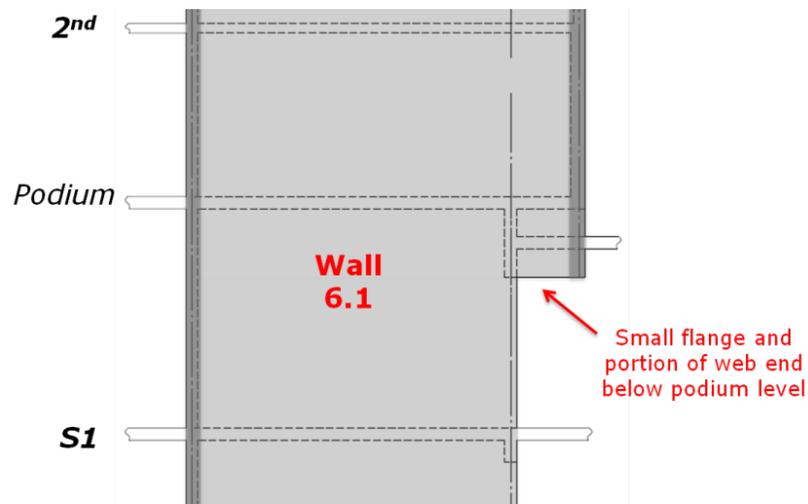
Figure A-14 Undisclosed Building B (Building No. 6) – typical setback and reduced web in the first subterranean level.

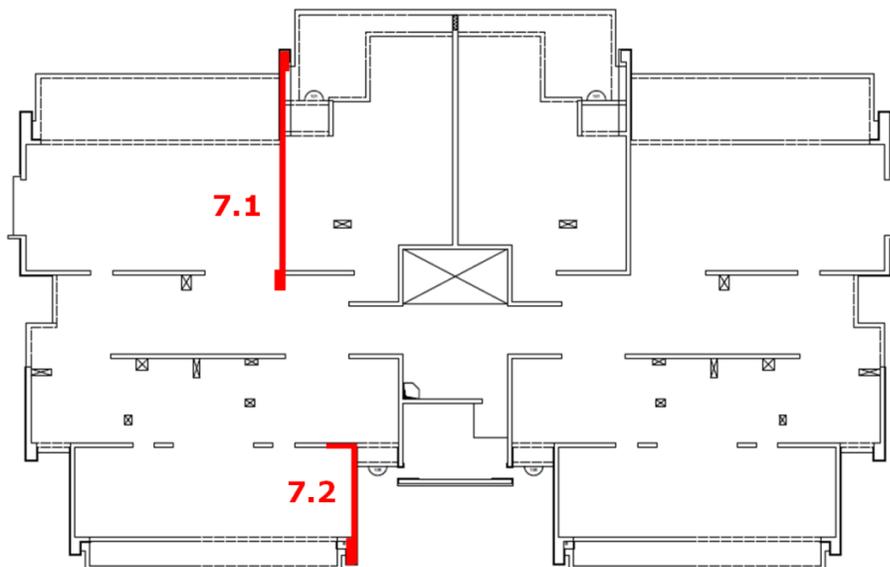
Figure A-15 Mongolio (Building No. 7) – typical floor plan with case study walls highlighted.

The floor plan in Figure A-15 identifies the walls that were investigated as part of this study. Wall 7.1 has some vertical discontinuity in the flange at one end, but at the critical level, it has a barbell-shaped cross-section. Wall 7.2 is a flanged wall with a barbell-shaped stem. The barbell sections at each end have hoops around the longitudinal reinforcing bars, providing a more stable critical section than in other buildings investigated. Figure A-16 shows an elevation of Wall 7.1 along with the details of the barbell sections at each end.

Although wall damage was documented in several walls, little to no damage was noted in the boundaries of these walls. Table A-7 summarizes the geometric properties of the critical wall sections considered in the Mongolio building (Building No. 7).

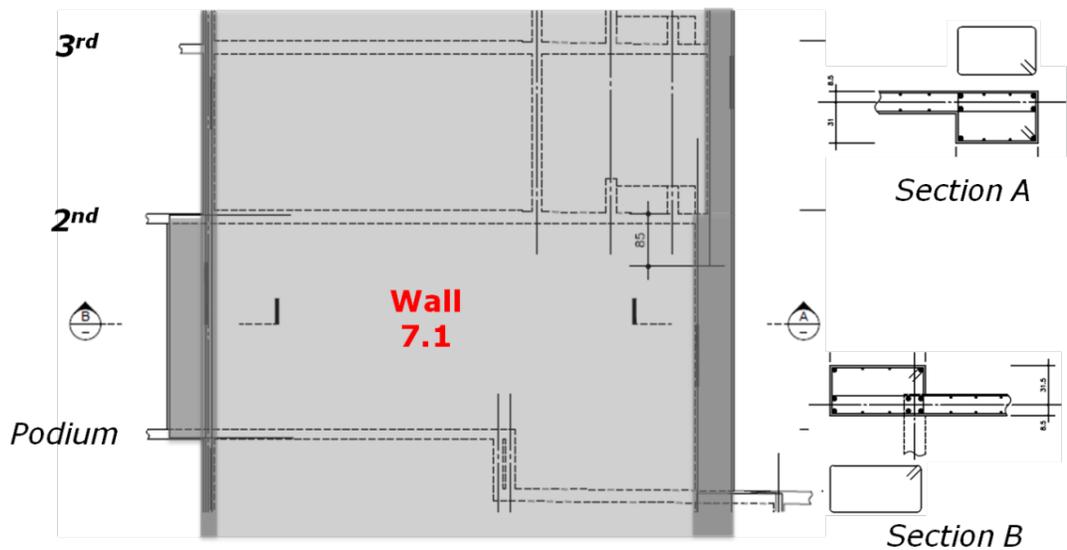
Figure A-16 Mongolio (Building No. 7) – elevation of Wall 7.1 and details of barbell sections at each end.

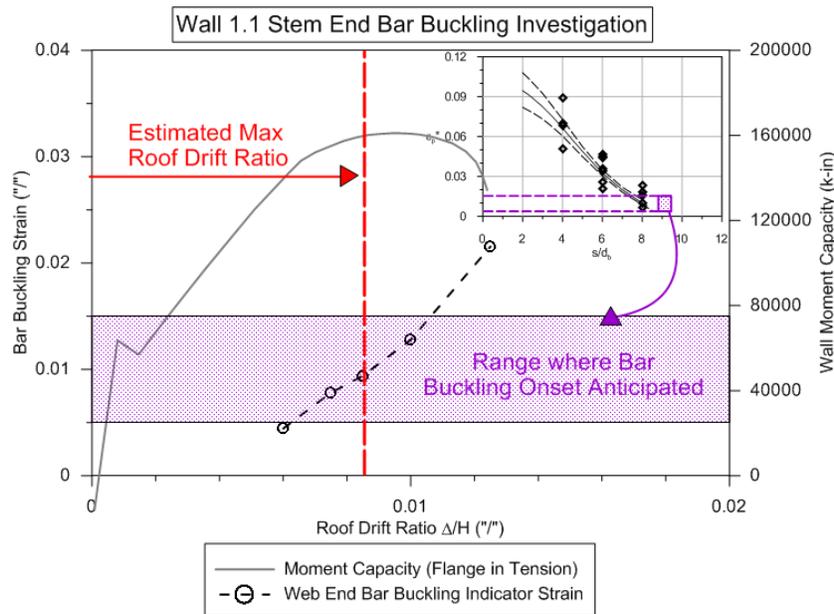
Figure A-31 Moment capacity and buckling strain indicator relations versus roof drift ratio for Wall 1.1.

At the estimated drift demand calculated for Alto Rio (Building No. 1), all walls are approaching their peak moment capacity, and each wall experiences strain levels that are in the range where onset of buckling might be expected. If drift levels exceeded calculated demands, both concrete crushing and bar buckling would be expected to occur.

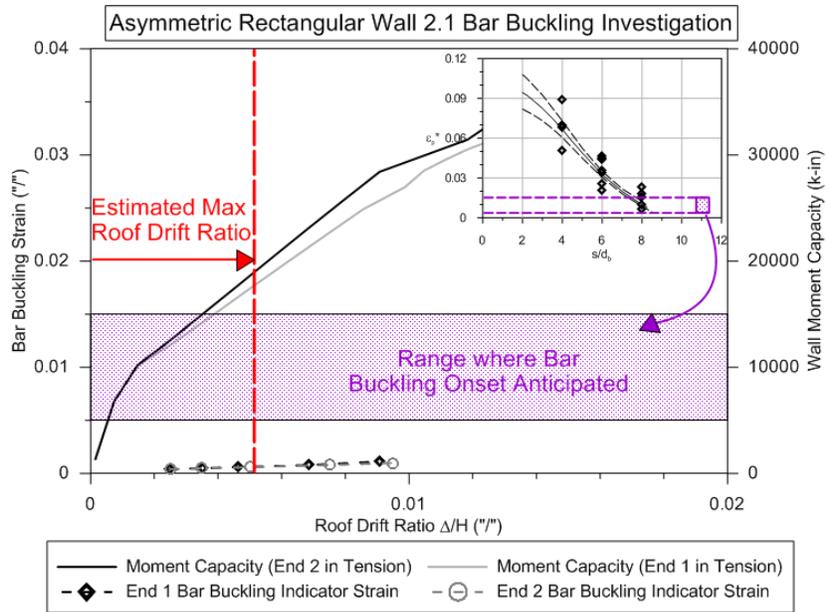
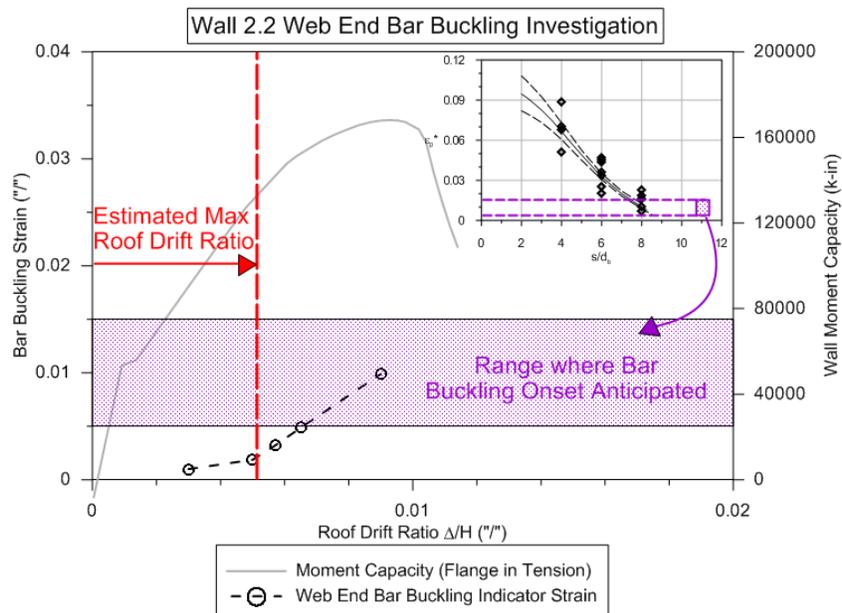
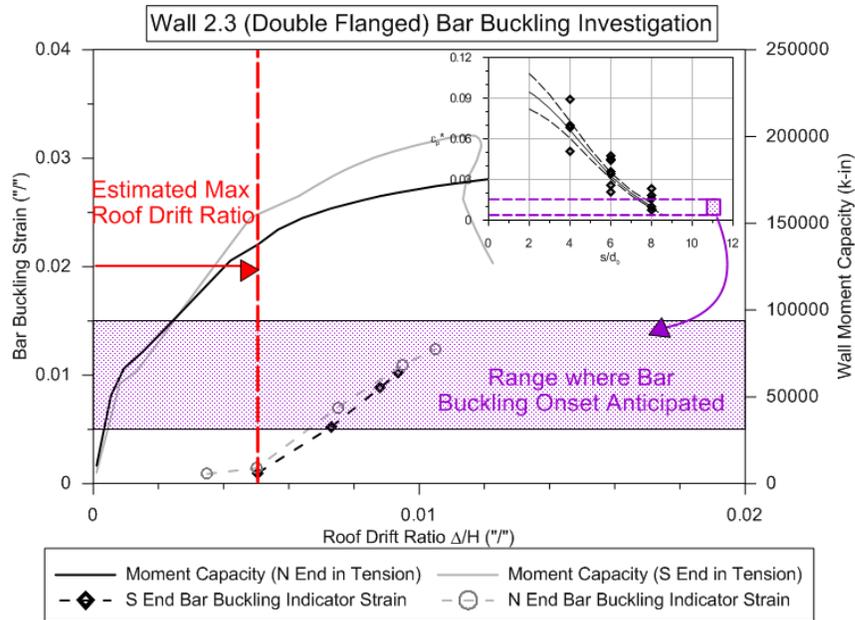
Plaza del Rio Building B (Building No. 2) did not suffer the severe damage experienced by the adjacent Plaza del Rio Building A. As shown in Table A-19, despite having large spacing to longitudinal bar diameter ratios (e.g., above 11 for all walls considered), bar buckling indicator strains did not reach the levels where onset of bar buckling would be expected.

Buckling strain indicators and moment capacity curves associated with Walls 2.1 to 2.3 are shown in Figures A-37 through A-39.

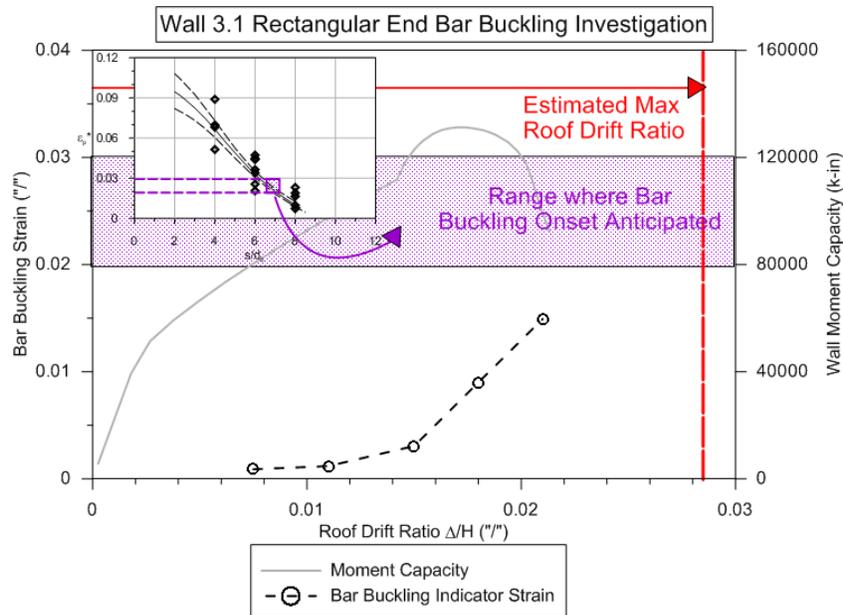
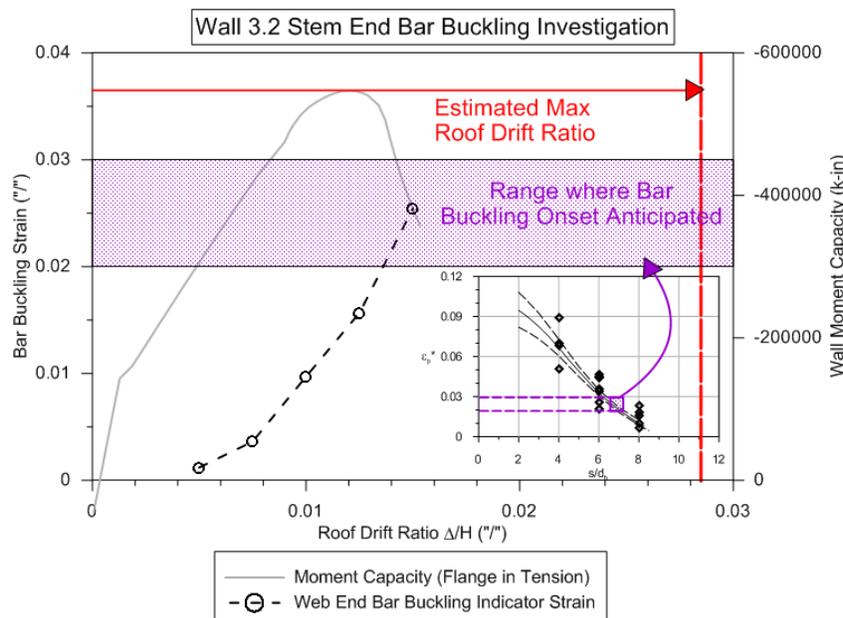
Drawings called for horizontal web reinforcement to wrap around longitudinal boundary reinforcement and terminate at the far side of the wall with 135-degree hooks. With a relatively small vertical spacing, and correspondingly smaller s/d_b ratios, the walls evaluated in Concepto Urbano (Building No. 3) would not be expected to exhibit bar buckling until after the concrete crushed (as long as the

horizontal reinforcement remained engaged with the confined core of the wall boundary). Buckling strain indicators and moment capacity curves associated with Walls 3.1 and 3.2 are shown in Figures A-40 and A-41.

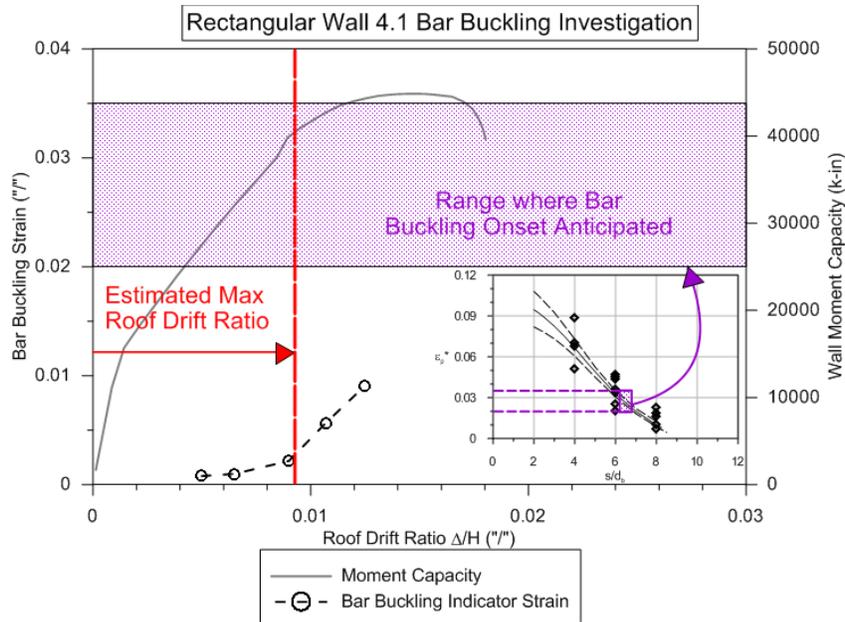
Buckling strain indicators and moment capacity curves associated with Walls 4.1 to 4.6 are shown in Figures A-42 through A-47. The building was severely damaged in the earthquake. In Walls 4.1, 4.3, and 4.4, calculated strains do not suggest that bar buckling would be initiated, but in the absence of hoops or ties at the wall boundaries, it is likely that effective s/d_b ratios were larger than reported.

Figure A-42 Moment capacity and buckling strain indicator relations versus roof drift ratio for Wall 4.1.

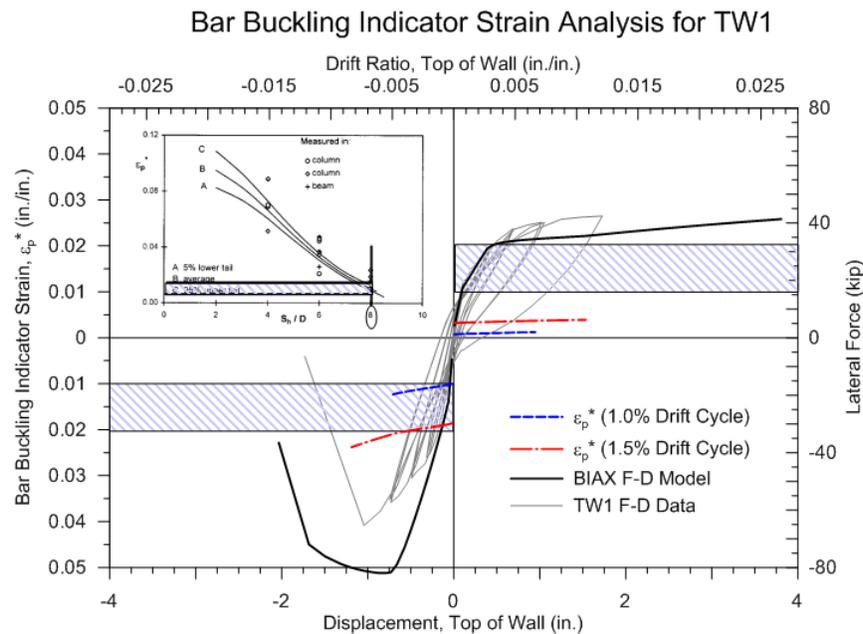
Figure A-57 Bar buckling analysis of wall specimen TW1 (Thomsen and Wallace (1995, 2004).

TW1 experienced sudden loss of lateral strength during the first (negative) cycle to 1.5% drift, which loaded the web boundary (opposite the flange) in compression. At approximately -1.0% drift, based on video data, minor concrete spalling occurred, corner bars appeared to grow unstable, and then a brittle, explosive failure occurred where all eight vertical boundary bars and several pairs of web vertical bars buckled, thrusting off the concrete cover. The calculated ϵ_p^* at a drift level of -1.0%, after considering the web longitudinal bars had already experienced tensile strains associated with the +1.5% drift cycle, was about 0.023. Longitudinal bar strain history plots (Thomsen and Wallace, 1995) revealed that maximum tensile strain for boundary vertical bars was about 0.025, and the extreme fiber concrete compression strain at the wall web boundary opposite the flange at the 1.5% drift level was about 0.005, producing an ϵ_p^* value of 0.03 from the test, suggesting that the calculated ϵ_p^* of 0.023 from moment-curvature analysis was fairly conservative (i.e., predicted

onset of buckling for lower strains than measured). One possible reason for this discrepancy is the role of concrete cover, which might provide some lateral support and delay the onset of bar buckling. Another possible reason for the discrepancy is that the onset of bar buckling occurred prior to observed strength loss.

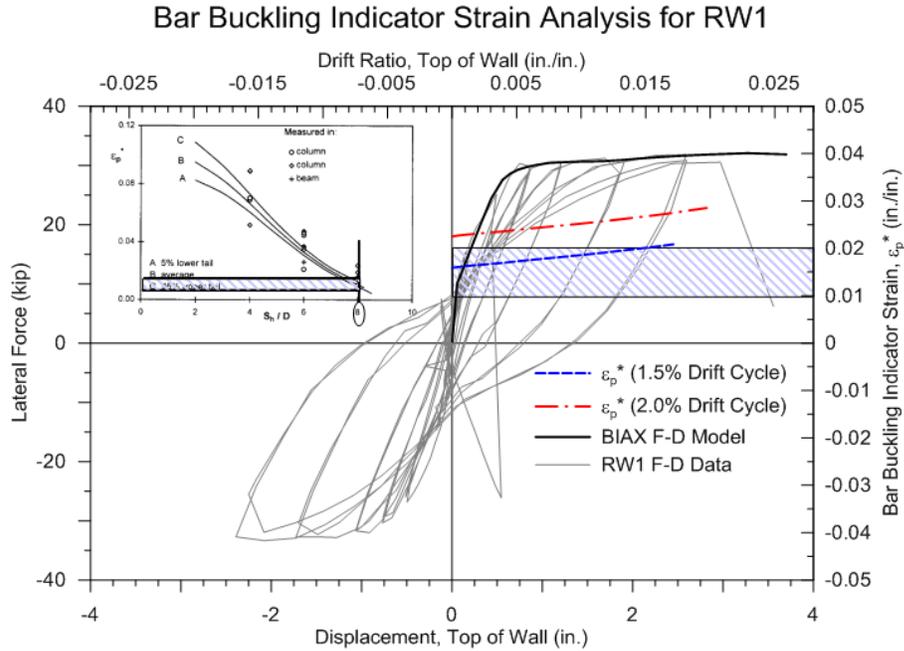
Figure A-58 Bar buckling analysis of wall specimen RW1 (Thomsen and Wallace (1995, 2004).

For example, the plot shows that for the 1% drift cycle longitudinal bar strains entered the lower bound range of when onset of buckling might be expected. By the time the experiment reached the 1.5% drift cycle, bar strains were beyond the upper bound of when buckling would initiate. Analyses also indicated that when the flange was in compression, bar strain history never exceeded 0.5%. This was much lower than the anticipated level where buckling might initiate, and no damage associated with bar buckling was observed at the flanged end of the wall.

The results for RW1 indicate that the onset of bar buckling would be possible at a drift ratio as low as 1.0%, would be quite likely at a drift ratio of 1.5%, and would be expected at a drift ratio of 2.0%. These results are consistent with test observations, where initial (onset) of buckling was noted between 1.0% and 1.5% drift, visible and significant buckling of boundary edge bars was observed for 1.5% and 2.0% drift cycles, and significant strength loss was noted for the first cycle to 2.5% drift.

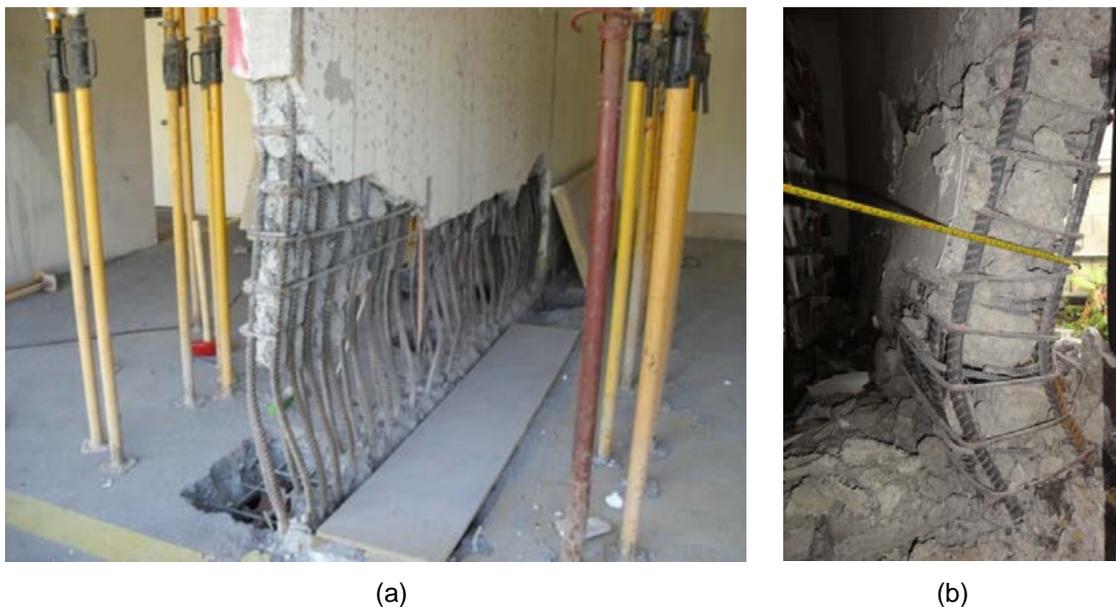
This appendix presents the derivation of wall instability relationships provided in Equations 3-1 to 3-3 of Chapter 3. Design practices prior to the 1990s favored rectangular walls with enlarged boundary elements, contributing to stability of the flexural compression zone. More recently, however, prevailing practices in many countries have favored rectangular sections without enlarged boundaries. More slender flexural compression zones can be susceptible to inelastic lateral buckling, as reported in EERI (2010) and EERI (2011), and shown in Figure B-1.

Figure B-1 Examples of wall lateral buckling: (a) 2010 Maule earthquake (DICTUC, 2010d); and (b) 2011 Christchurch earthquake (photo courtesy of Ken Elwood).

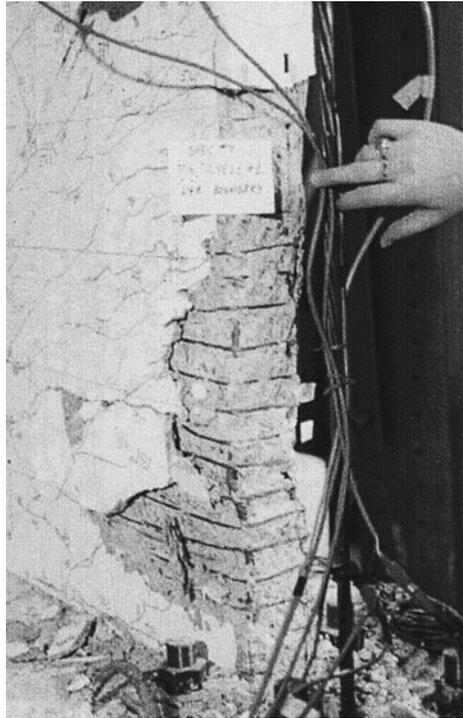
Specimen TW2 had an aspect ratio $h_u/b \approx 24/4 = 6$. From Equation B-9, this specimen should be stable to peak tensile strains on the order of $\varepsilon_{sm} = 0.21$. As expected, specimen TW2 remained stable through large lateral deformations, but it buckled laterally during cycles in which lateral drifts reached 2.5% of the wall height,

with peak tensile strain of approximately 0.05 (Thomsen and Wallace, 1995). The buckled section is shown in Figure B-5.

Figure B-5 Out-of-plane buckling observed in T-shaped wall specimen TW2 (Thomsen and Wallace, 1995).

Notably, at this stage of testing, the cover concrete has completely spalled from the confined core, leaving a more slender boundary element ($h_u/b \approx 24/2.75 \approx 9.6$). If Equation B-9 is applied to the core only, buckling would be expected for peak tensile strains of about $\epsilon_{sm} = 0.08$, which is on the order of the measured strain of 0.05. Thus, buckling of specimen TW2 can be understood by applying the buckling model to the wall boundary using the thickness of the confined core.

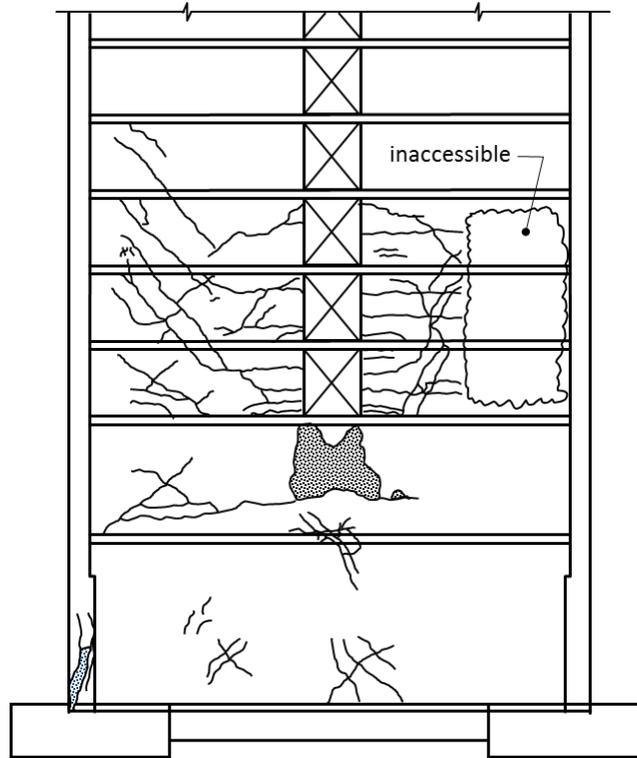
Figures C-1 through C-5 show examples of characteristic damage to solid panels above or below a stack of openings. Figure C-1 is a crack map from a building in Northern California following the 1989 Loma Prieta earthquake. Figures C-2 through C-5 show damage map and photographs of buildings damaged in the 2010 Maule earthquake.

Figure C-1 Damage map from a building in Northern California damaged in the 1989 Loma Prieta earthquake (image courtesy of Jack Moehle).

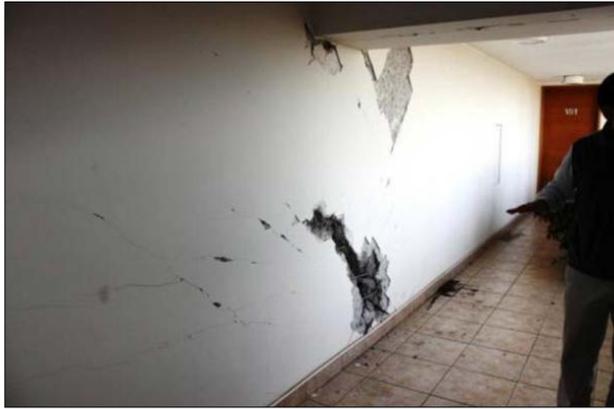
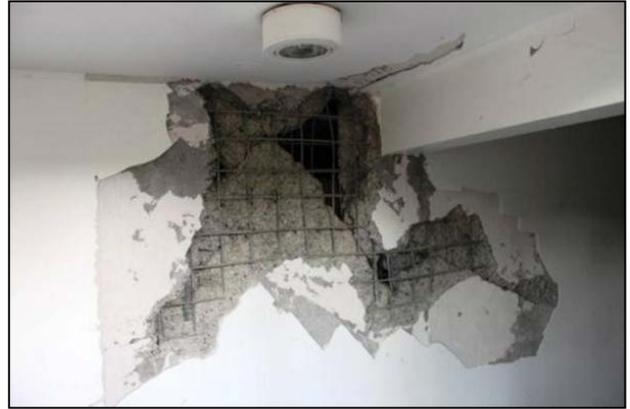
Figure C-3 Damage observed in solid panels at the top and bottom of a stack of openings in the Torre Mayor building in Chillán, Chile following the 2010 Maule earthquake (photo courtesy of EERI Chile earthquake reconnaissance team).

1. The Alto Rio building was described in Section C.2.
2. Torre Mayor is a 17-story structure located in the city of Chillán. The building did not collapse during the 2010 Maule earthquake, but suffered damage along a discontinuity region below a stack of door openings (Figure C-3).
3. Centro Mayor is a 16-story structure located in the city of Concepción. The building did not collapse during the 2010 Maule earthquake, but suffered extensive damage in the first four stories, including damage to a wall below a stack of opening (Figure C-4).
4. Marina del Sol is a 20-story structure located in the city of Viña del Mar. The building did not collapse during the 2010 Maule earthquake, but suffered damage to a first floor wall below a stack of openings (Figure C-5).

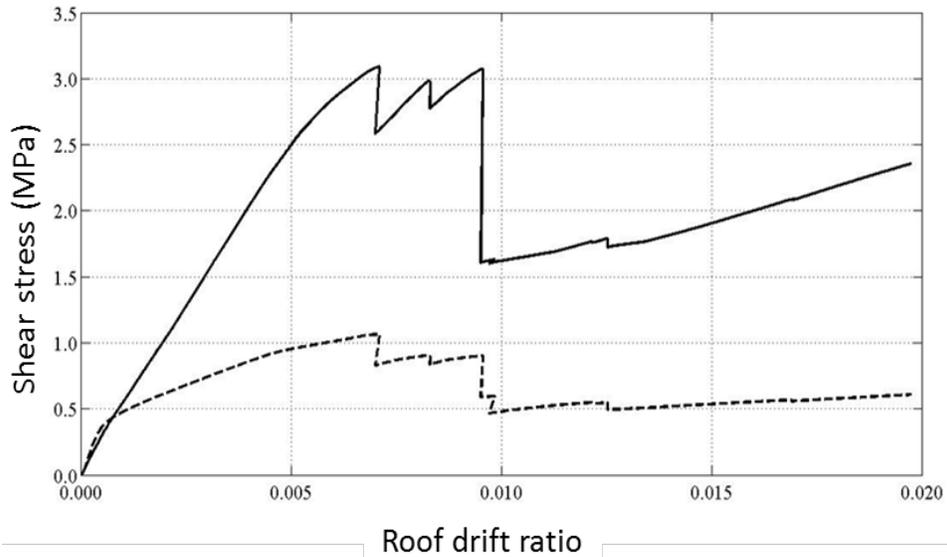
Figure C-7 shows the calculated average shear stress to roof drift ratio relationship for the discontinuity region below the stack of openings (solid line) and the entire wall cross-section (dashed line), for the model in which the discontinuity region is modeled as linear-elastic. The average stress in the discontinuity region is approximately three times the average stress acting across the entire wall section. This result is consistent with the results reported by Naeim et al. (1990).

Figure C-7 Relationship of shear stress to roof drift ratio of discontinuity region (solid line) and of average for entire wall (dashed line), using a linear model for the discontinuity region. Stress for the discontinuity region is the average value over the height of the story below the stack of openings.

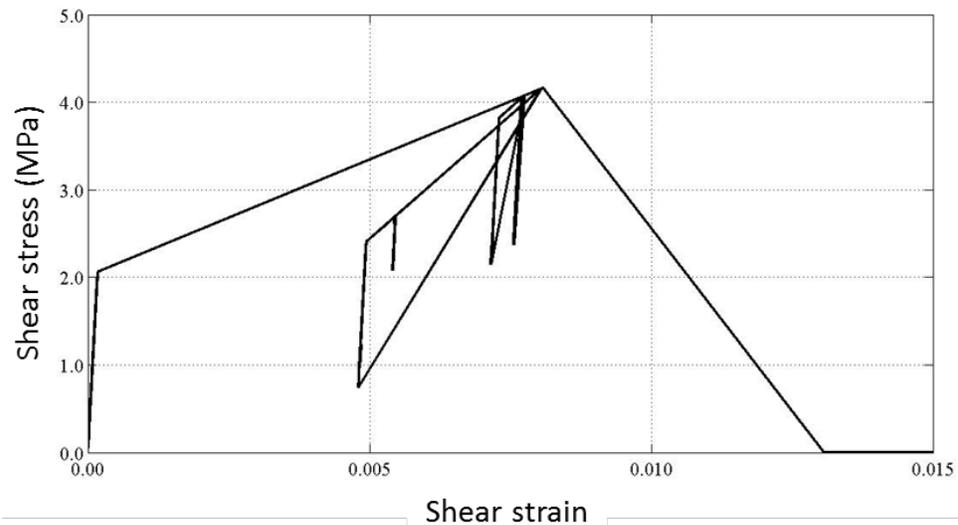
Figure C-8 shows the calculated relationship between shear stress and shear strain in the discontinuity region for the model in which the discontinuity region is modeled using an inelastic shear material. Inelastic response of the region is apparent.

Figure C-8 Shear stress–strain relationship of the discontinuity region, using an inelastic shear material.

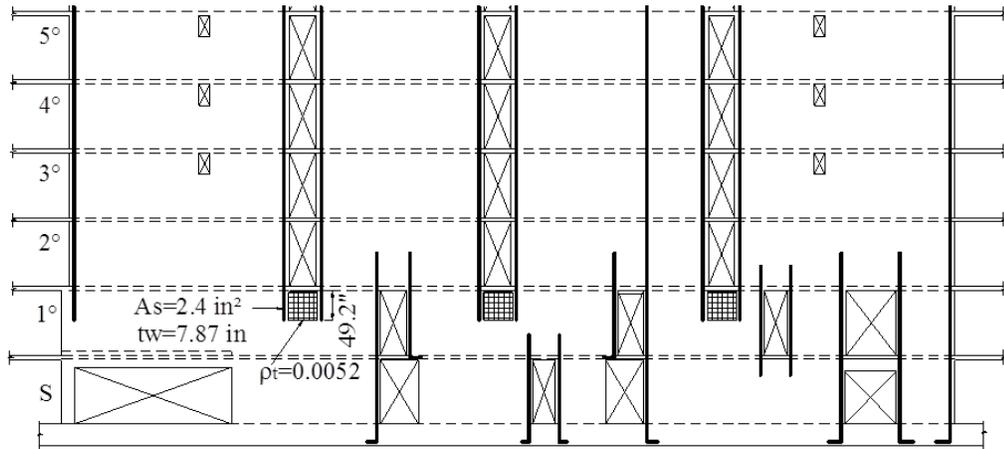
In the Torre Mayor building, boundary bars were discontinued 49.2 inches below stacks of openings (Figure C-13). Calculated shear stresses are above the cracking strength, and 77% of calculated nominal strength.

Figure C-13 Torre Mayor building reinforcement details around panel zone of interest.

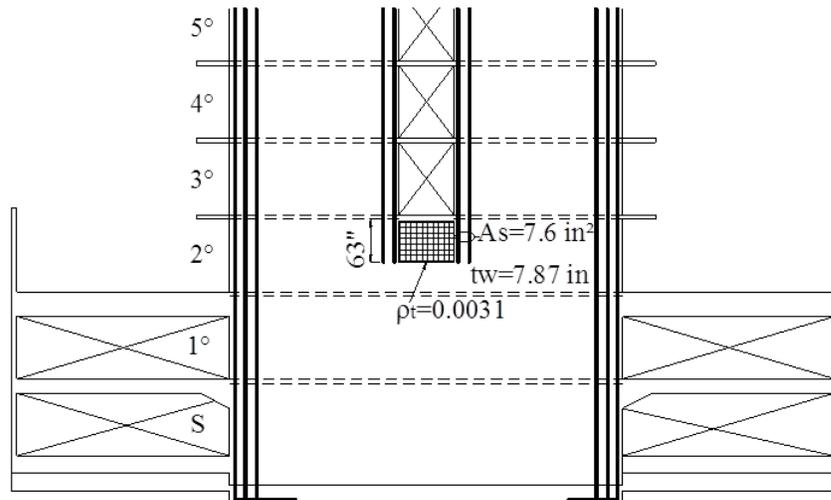
In the Centro Mayor building, boundary bars are discontinued 63 inches below stacks of openings (Figure C-14). Calculated shear stresses are well above the cracking and nominal strengths.

Figure C-14 Centro Mayor building reinforcement details around panel zone of interest.

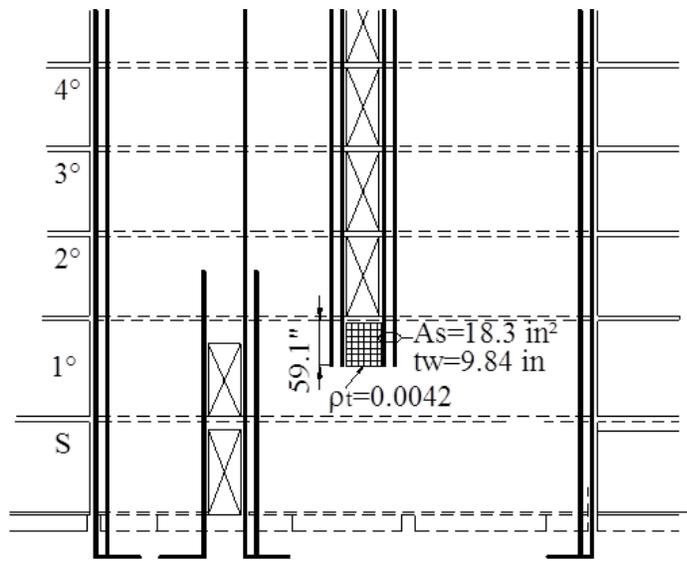
In the Marina del Sol building, boundary bars are discontinued 59.1 inches below stacks of openings (Figure C-15). Calculated shear stresses are well above the cracking and nominal strengths.

Figure C-15 Marina del Sol building reinforcement details around panel zone of interest.

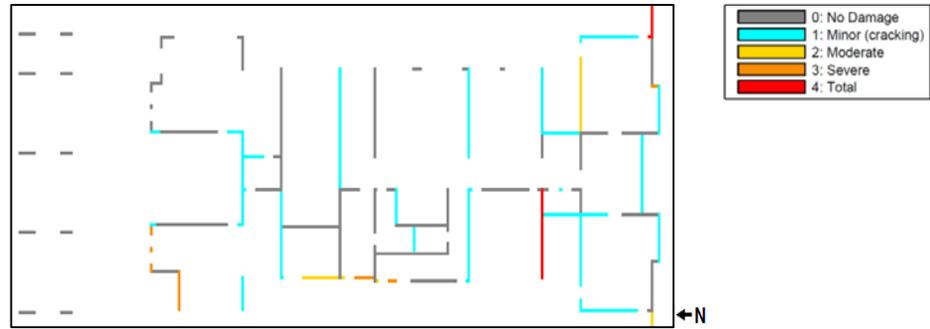
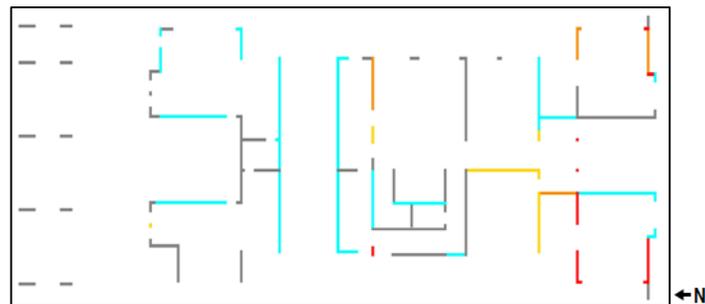
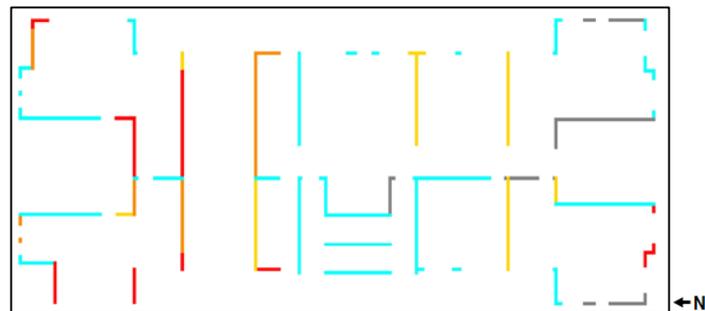
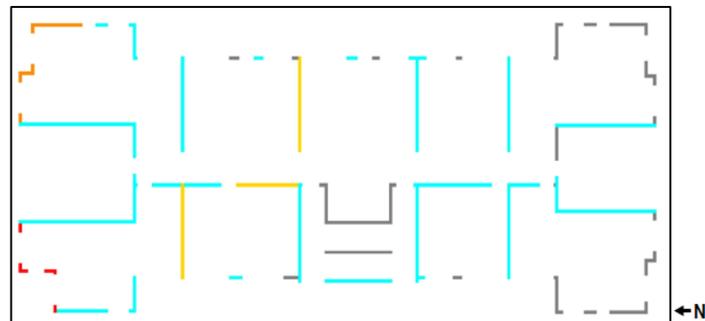
Damage to the structure included: (1) severe concrete damage in walls in the east-west direction in the second and third stories and basement; (2) concrete damage extending diagonally through multiple piers separated by openings; (3) concrete and reinforcing steel damage in wall piers; (4) diagonally oriented damage to horizontal wall segments/coupling beams; (5) extensive concrete damage in T-, L-, and D-shape walls; and (6) slab damage. Figure D-5 shows the layout of the walls on the basement floors and first two above grade floors, with the damage level indicated by the colors specified in Table D-1.

Figure D-5 Layout of walls for the lower four floors of Centro Mayor building (beams and slabs are not shown). Color indicates the level of damage according to Table D-1.

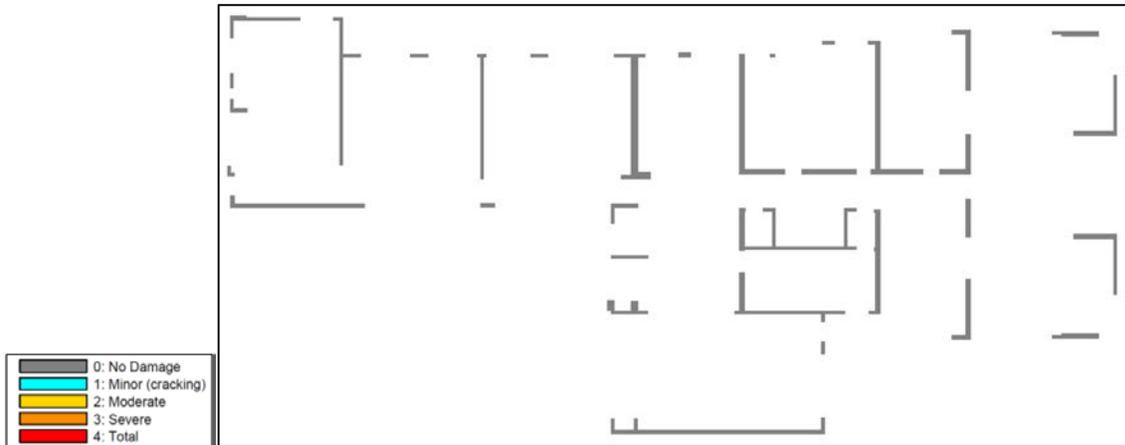
No damage was reported following the earthquake. Figure D-8 shows the layout of the walls on the first two floors, with all walls indicating no damage by the colors specified in Table D-1.

Figure D-8 Layout of walls for a typical floor of Concepto Urbano building (beams and slabs are not shown). The gray color indicates no observed damage.

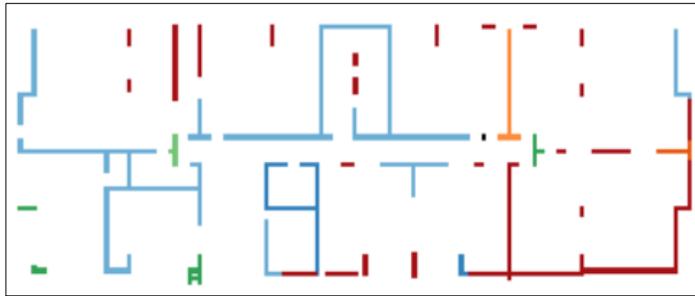
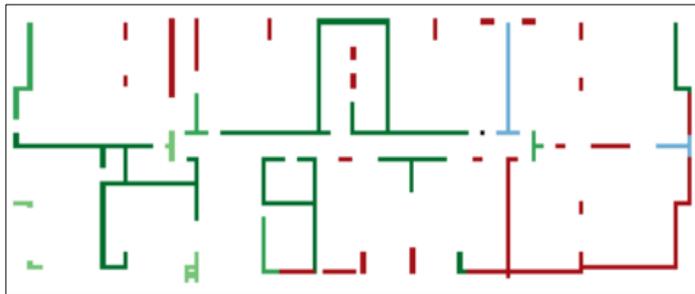
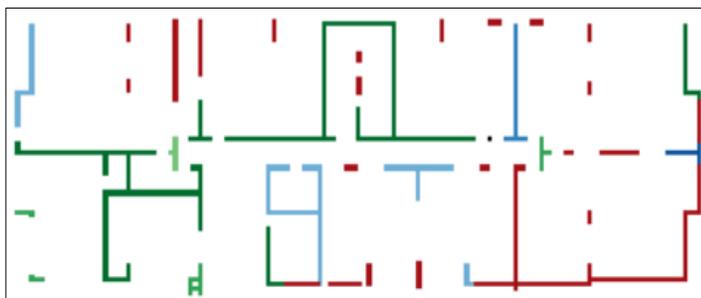
Figure D-9 Maximum DCR_u values for first story walls at Plaza del Rio Building B. Values range from 0 (light green) to 8 (dark red).
