NIST GCR 14-917-25

Recommendations for Seismic Design of Reinforced Concrete Wall Buildings Based on Studies of the 2010 Maule, Chile Earthquake

NEHRP Consultants Joint Venture
*A partnership of the Applied Technology Council and the
Consortium of Universities for Research in Earthquake Engineering*

March 2014

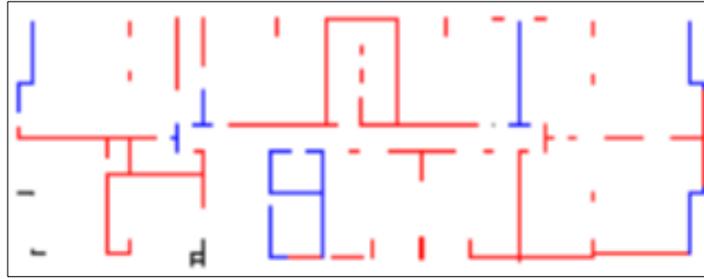
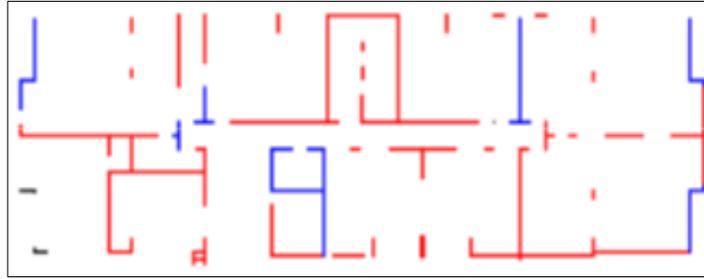
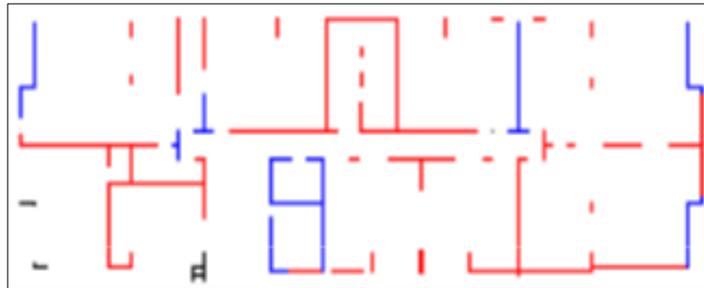
Figure D-10 Controlling response determined by largest DCR_u value for first story walls at Plaza del Rio Building B. Blue indicates flexure mechanism; red indicates shear mechanism; black indicates axial mechanism.

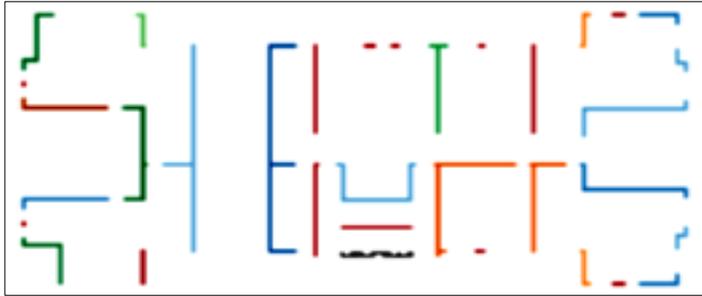
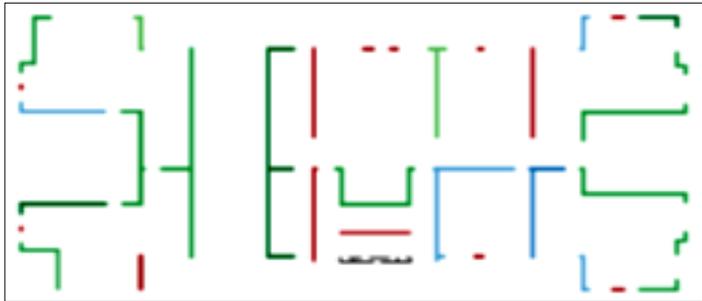
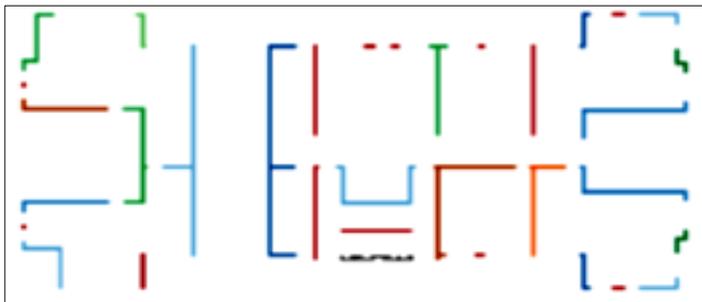
Figure D-11 Maximum DCR_u values for first story walls at Centro Mayor building. Values range from 0 (light green) to 8 (dark red).

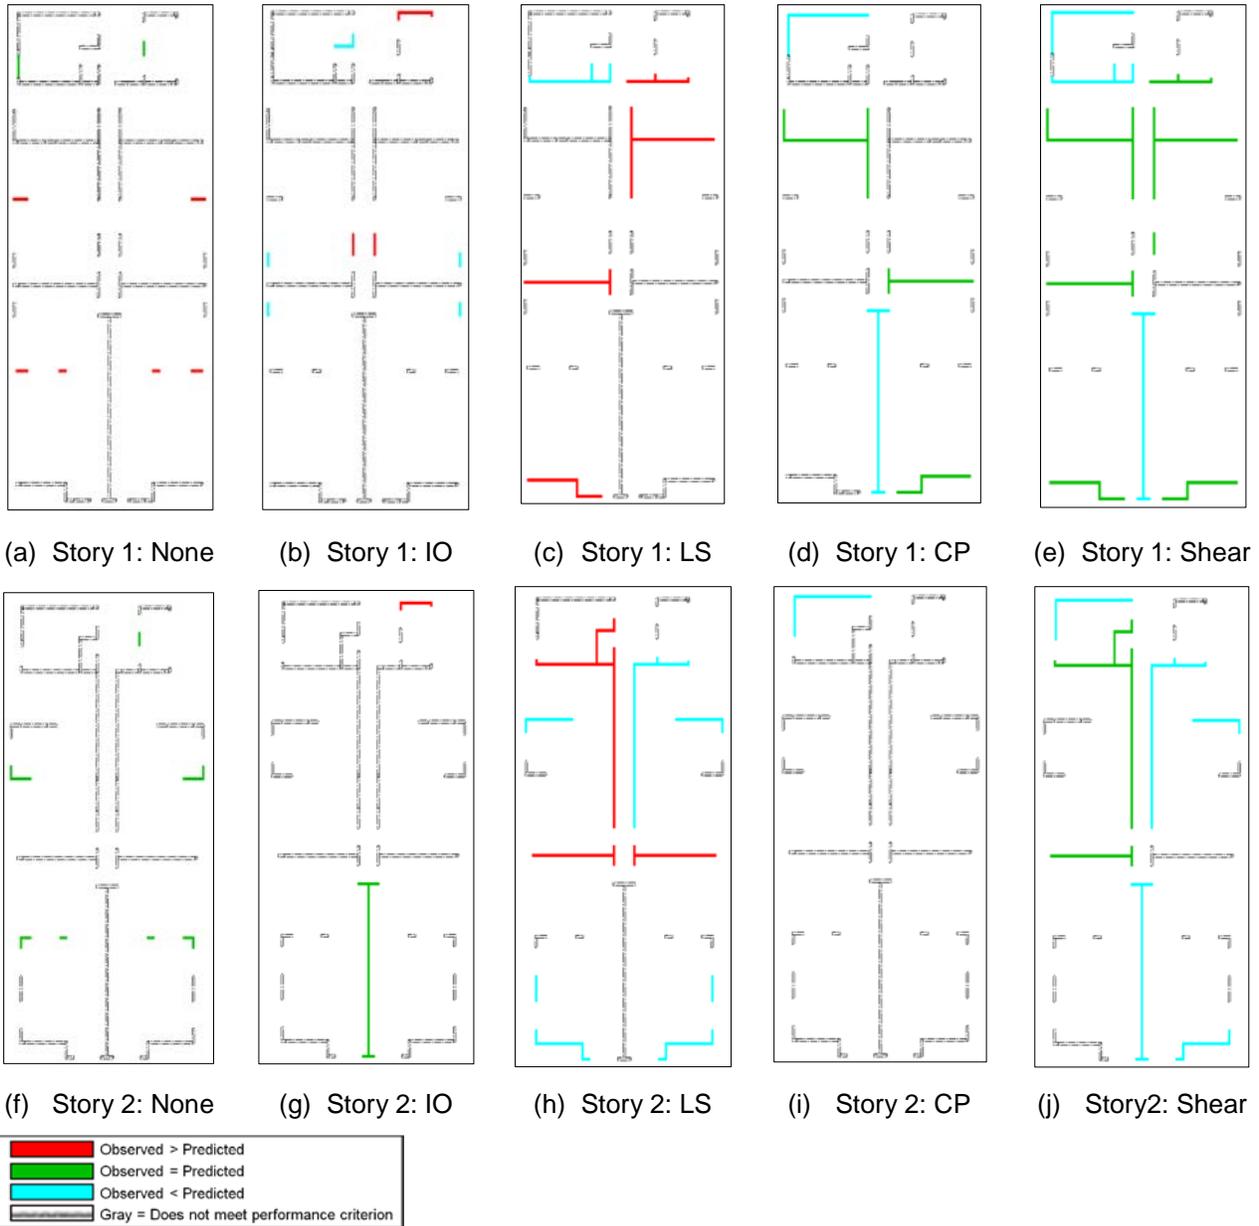
- Most walls could be expected to exhibit shear failure;
- Most primary lateral load-carrying walls were predicted to have damage exceeding the LS or CP performance levels per ASCE/SEI 41-06 deformation capacities;
- All primary lateral load-carrying walls were predicted to have damage exceeding DS 4 (Damage State 4, which requires replacement of the wall) per fragility functions developed in Birely (2012);
- Most primary lateral load carrying walls were predicted to have strains in excess of those causing concrete spalling but not concrete crushing per ASCE/SEI 41-06 usable strain limits; and
- Predicted damage was not highly correlated with observed damage for demands determined by the San Pedro de la Paz ground motion record.

Figure D-25 Response of first and second story walls in Plaza del Rio Building A to unscaled San Pedro de la Paz ground motion. Colored walls indicate walls that exceed ASCE/SEI 41-06 acceptance criteria for each performance level. Colors indicate whether observed damage is less than, approximately equal to, or greater than predicted damage. Walls colored in the “shear” plan view are considered to have failed in shear with $V_u > 1.1 V_n$. Dashed gray walls indicate walls that do not meet the performance criterion for that panel.

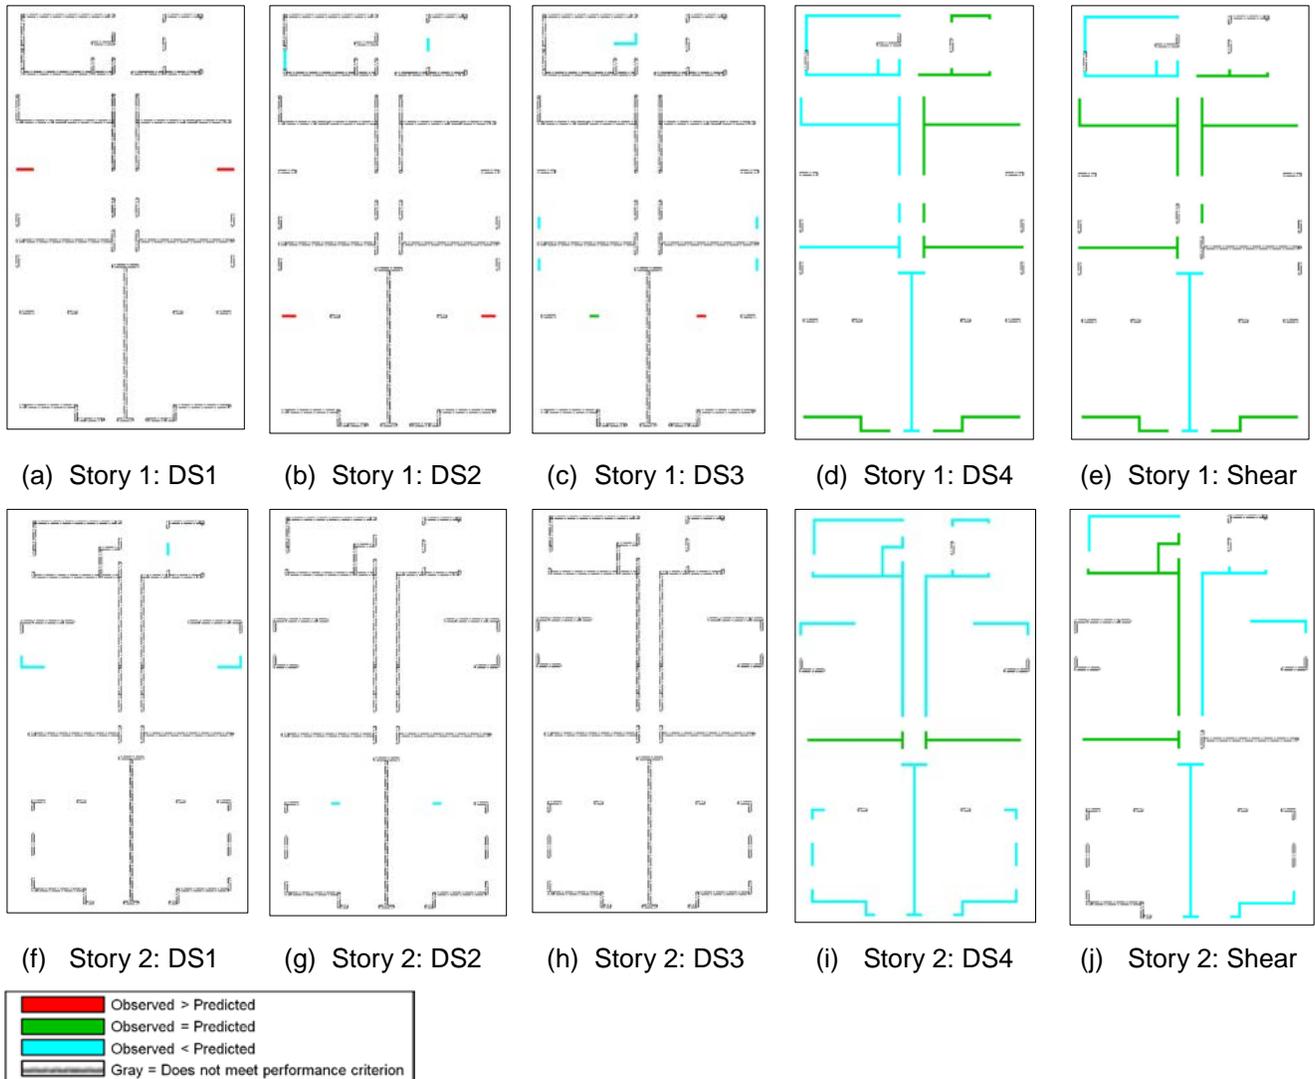
Figure D-26

Response of first and second story walls in Plaza del Rio Building A to unscaled San Pedro de la Paz ground motion. Colored walls indicate walls that exceed median drift at onset of damage states by Birely (2012). Colors indicate whether observed damage is less than, approximately equal to, or greater than predicted damage. Walls colored in the “shear” plan view are considered to have failed in shear with $V_u > 1.1 V_n$. Dashed gray walls indicate walls that do not exceed the median drift for that damage state.

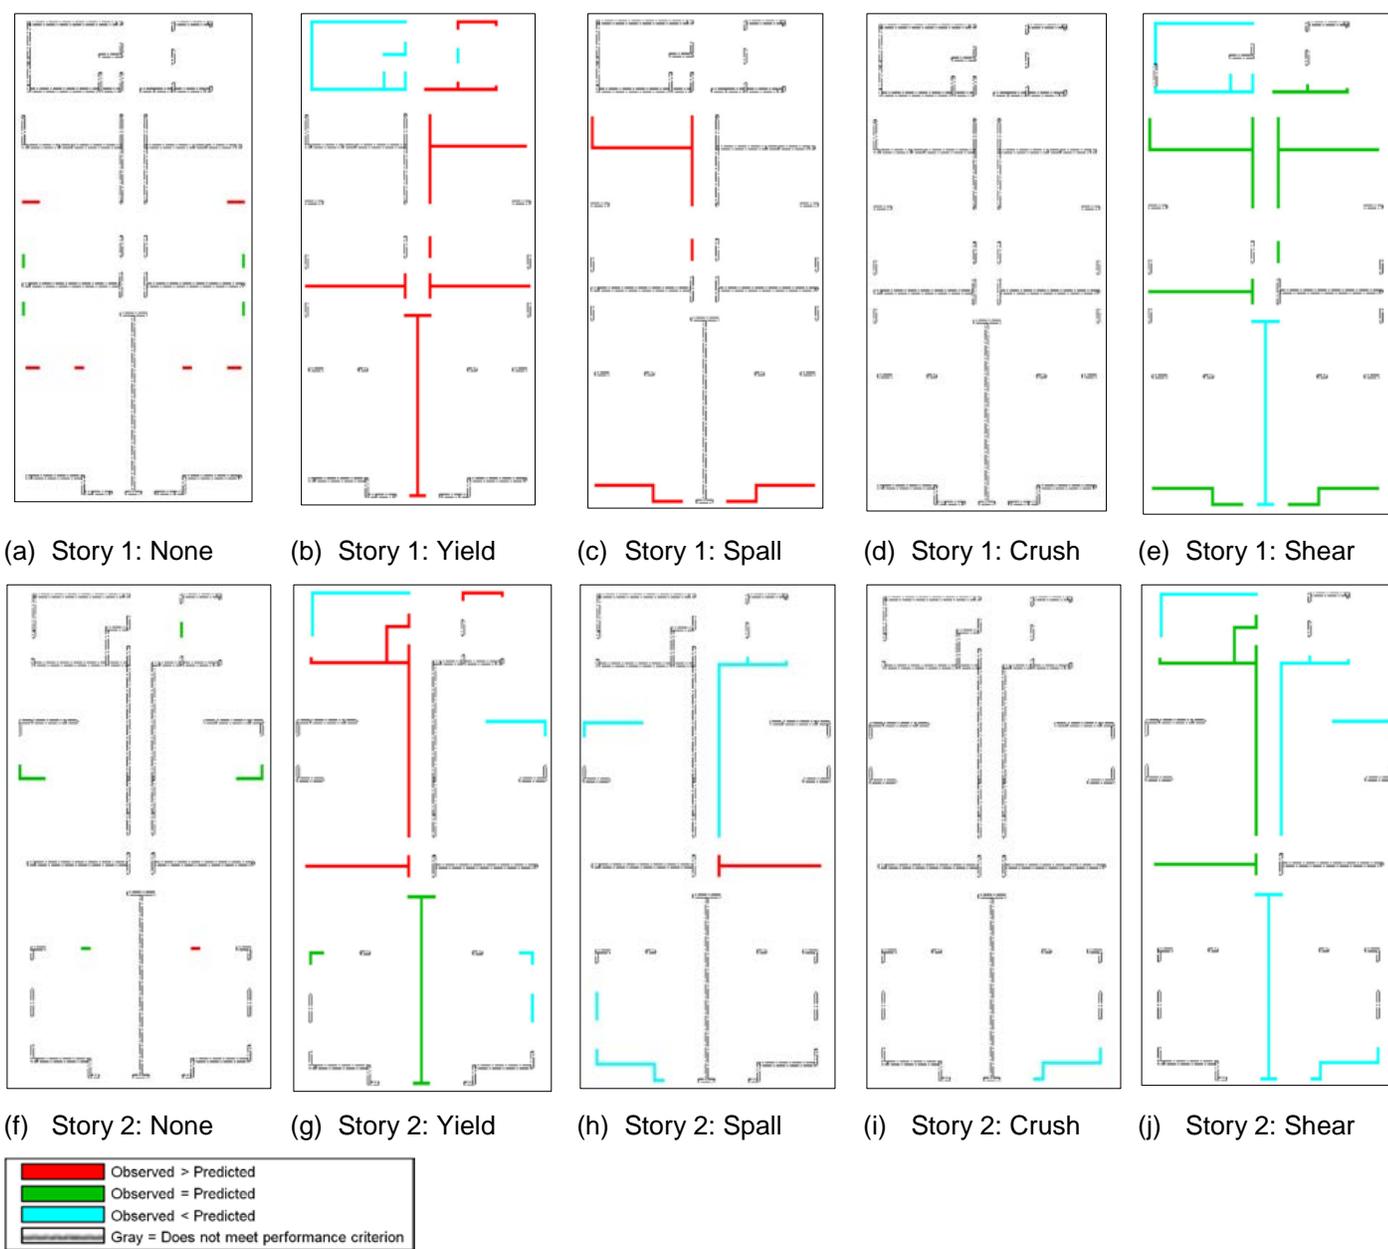
Figure D-27 Response of first and second story walls in Plaza del Rio Building A to unscaled San Pedro de la Paz ground motion. Colored walls indicate walls exceed strain at onset of steel yielding and concrete spalling and crushing. Colors indicate whether observed damage is less than, approximately equal to, or greater than predicted damage. Walls colored in the “shear” plan view are considered to have failed in shear with $V_u > 1.1 V_n$. Dashed gray walls indicate walls that are not predicted to fail in shear.

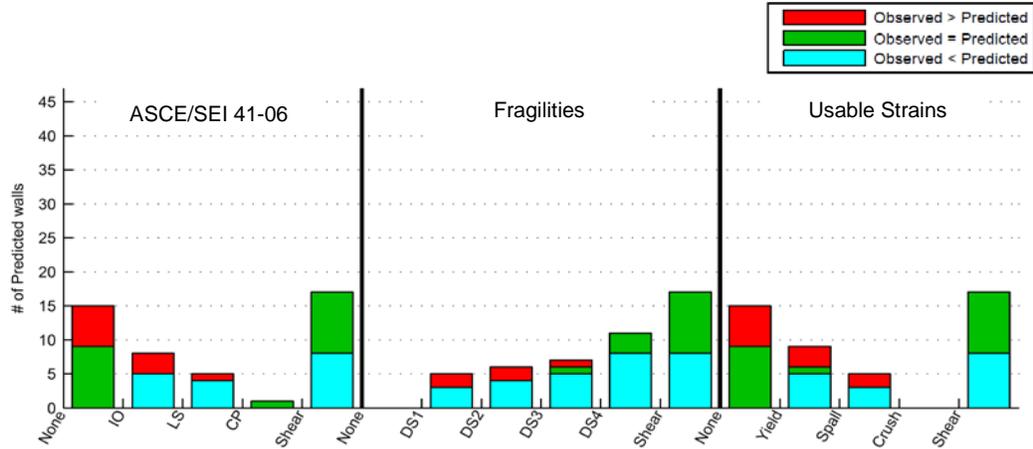
The data in Figures D-25 through D-27 were compiled into the bar chart shown in Figure D-28, which shows the number of walls in the first and second story of the building exceeding each of the considered performance states. Bars in Figure D-28 are colored to show the number of walls with observed damage that was less than, equal to, or greater than predicted. The range of colors in each bar indicate that there is little correlation between observed and predicted damage, however, the small

proportion of the bars in the figure that are colored red indicate that the criteria are producing a generally conservative assessment (for this case study building).

Figure D-28 Number of walls in Plaza del Rio Building A exceeding acceptance criteria for each performance measure.

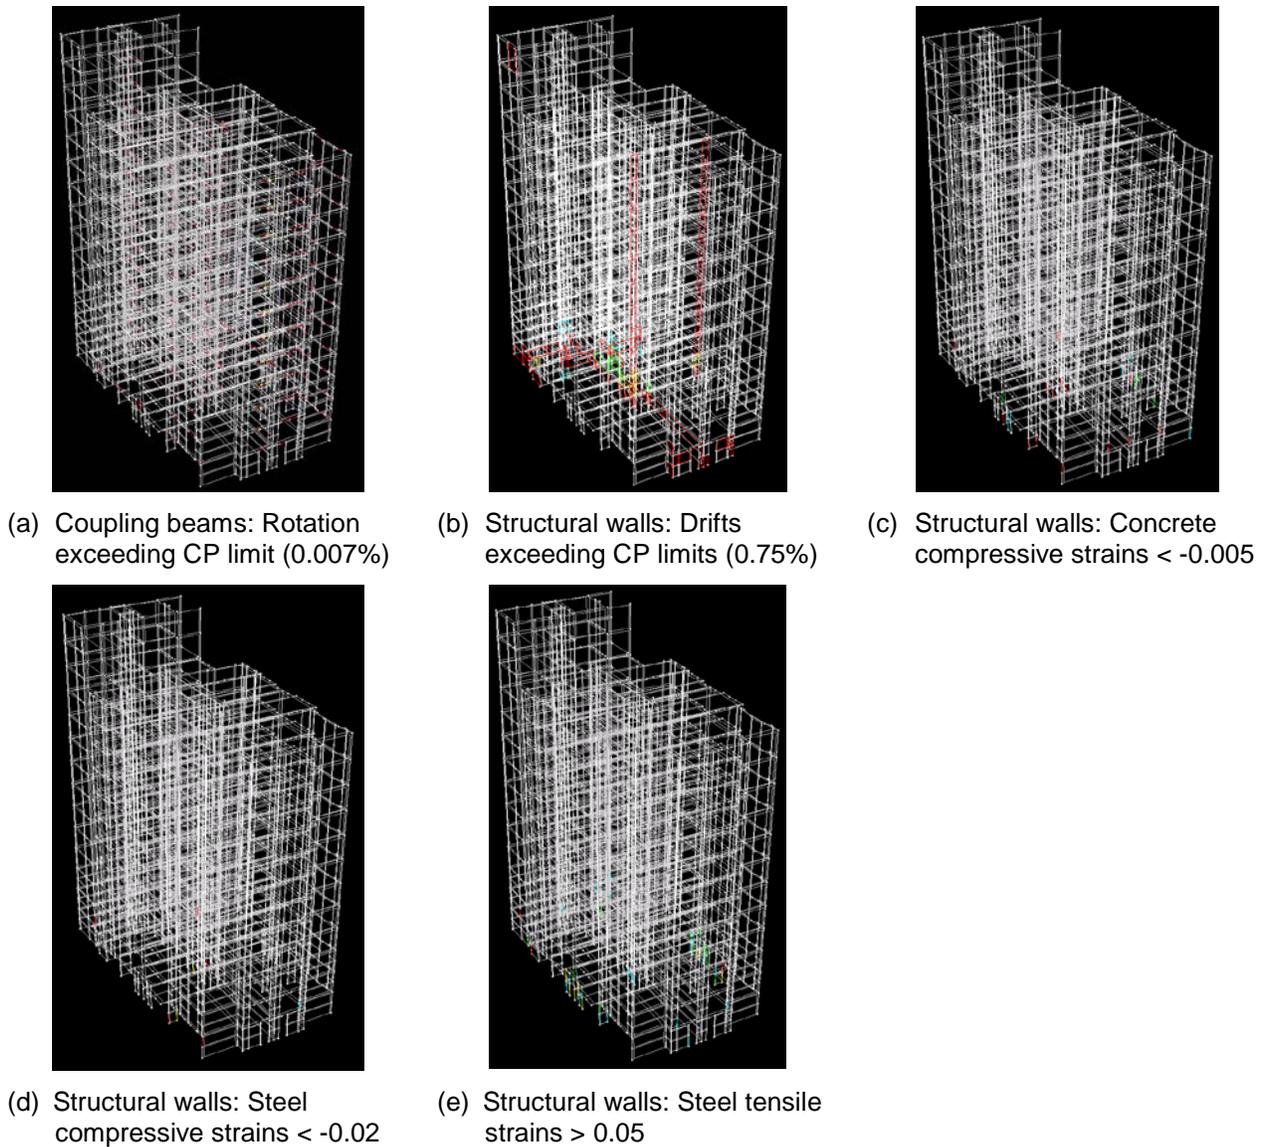
Figures D-29 and D-30 show walls and coupling beams that experienced deformation demands in excess of the ASCE/SEI 41-06 Collapse Prevention limit states and usable material strains. These figures show that for many coupling beams, rotation demands exceeded the ASCE/SEI 41-06 limit for Collapse Prevention and, thus, many coupling beams could be considered to have failed.

Figure D-29 Perform Basic model results showing damage exceeding Collapse Prevention limits in shear walls (shear and flexure models) and coupling beams for the Concepción record.

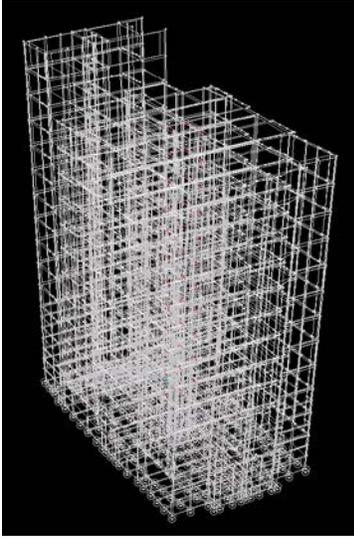
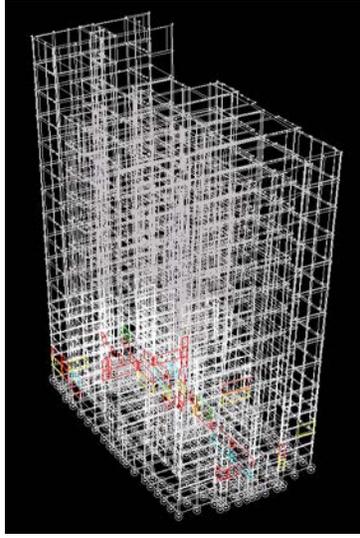
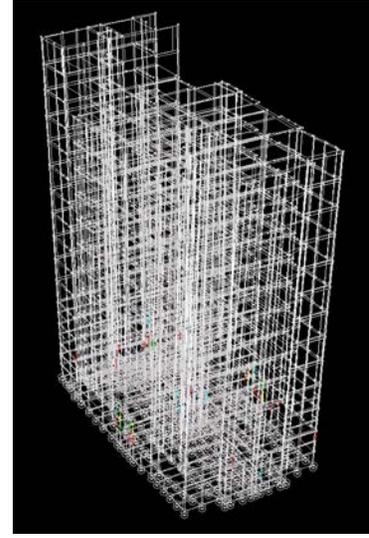
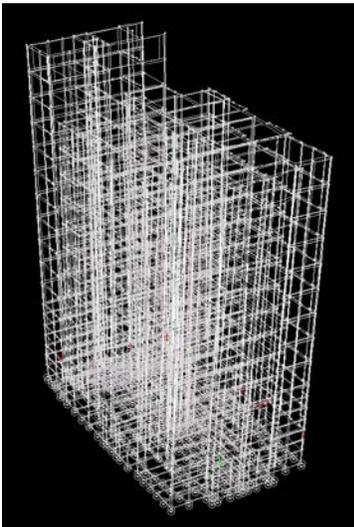
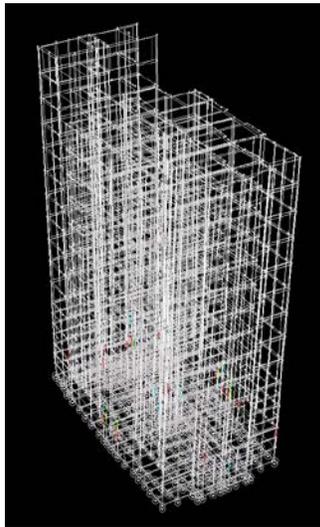
Comparison of results from the Perform Basic and Perform SSI models indicates that foundation flexibility significantly affected simulation of structural response and assessment of performance.

Figure D-30 Perform SSI model results showing damage exceeding Collapse Prevention limits in shear walls (shear and flexure models) and coupling beams for the Concepción record.

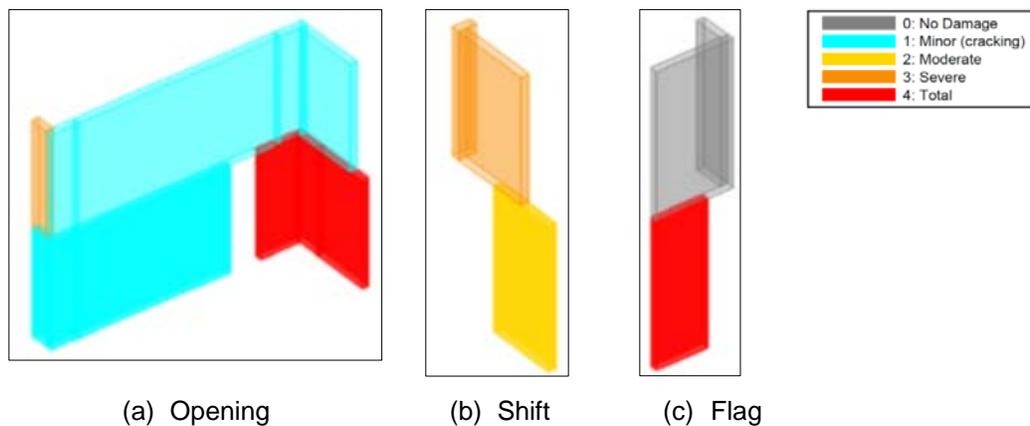
The colors shown in Figure D-31 indicate the level of damage observed in walls that exhibited the identified local discontinuity.

Figure D-31 Typical local wall discontinuities observed in case study buildings.

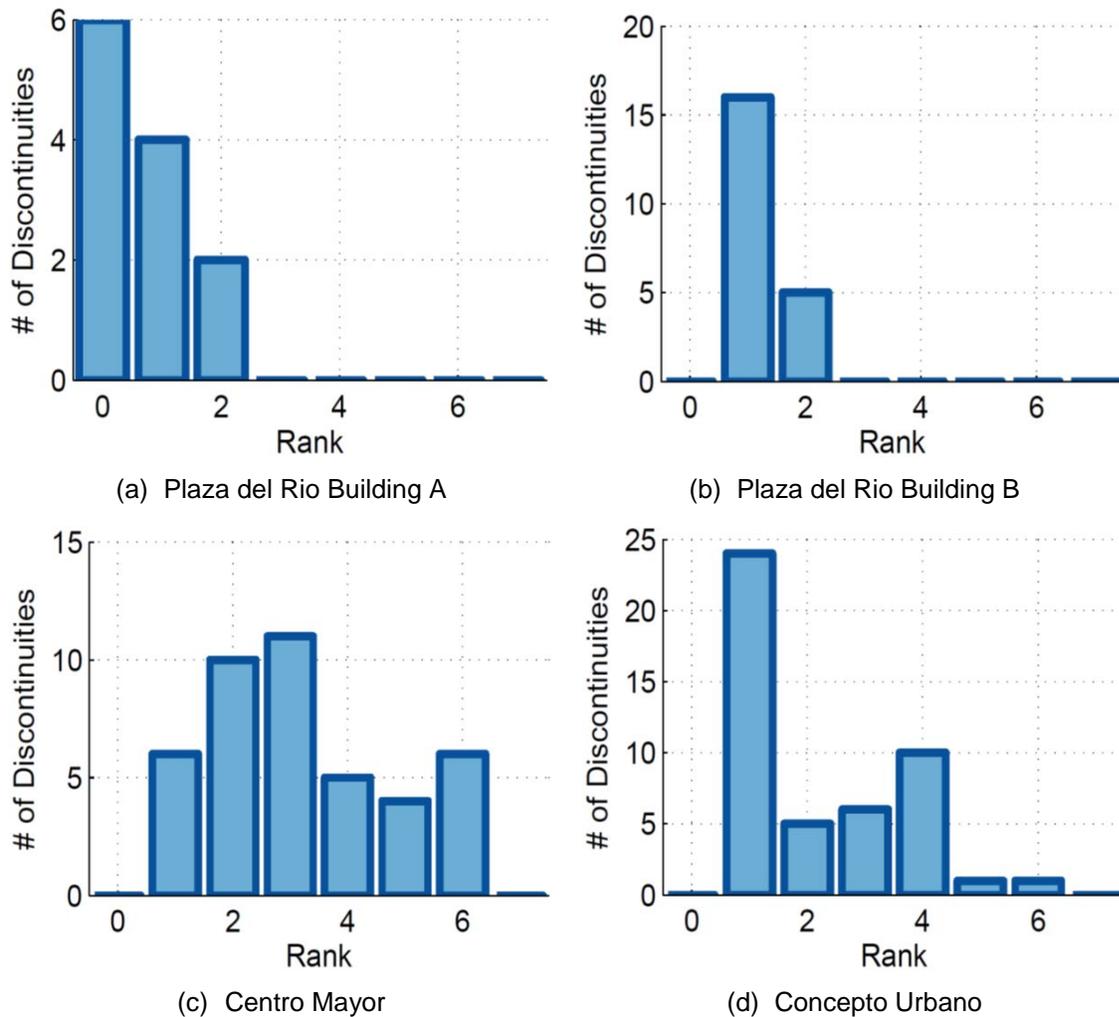
Quality rankings ranged from 0 for a high quality data point, to 6 for a low quality data point. Figure D-32 shows the number of local discontinuities at each quality ranking in each of the four case study buildings. Correlation between local discontinuity measures and observed damage was investigated using “high-quality” data points with quality rankings of 0 or 1.

Figure D-32 The number of local discontinuities at each quality ranking in each of the four case study buildings.

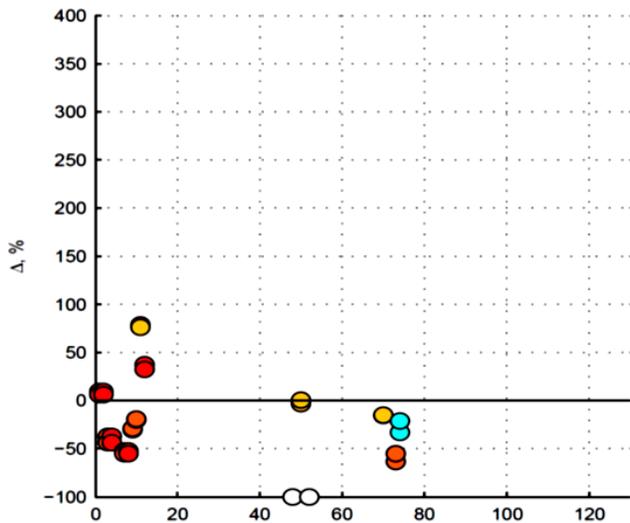
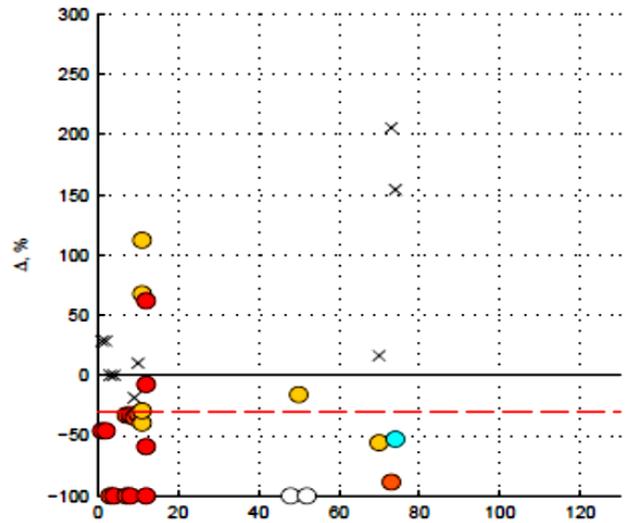
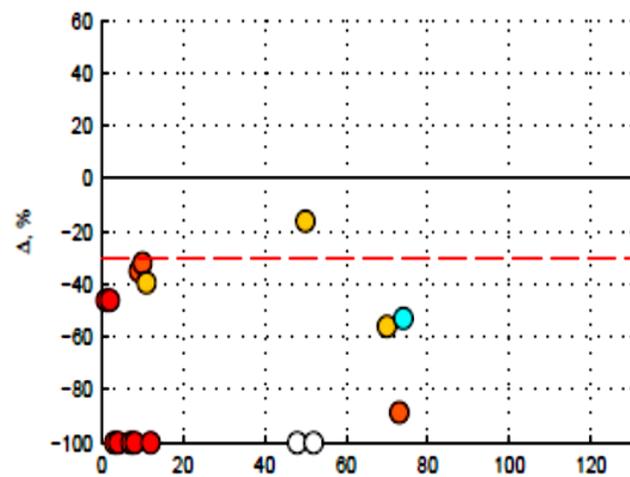
Approximately 120 discontinuities were identified in the case study buildings and each was assigned an ID number. Figure D-33 shows plots of the magnitude of the discontinuity (% change) versus discontinuity ID number for each of the local discontinuity measures considered. Values shown are for discontinuity ID numbers with a quality ranking of 0 or 1 in severely damaged case study buildings (Centro Mayor and Plaza del Rio Building A). The color of each data point indicates the level of earthquake damage observed in the building in the vicinity of the discontinuity.

Correlation between the discontinuity measure and observed damage can be seen in the way that data points in the figure change to red (i.e., damage becomes more severe) as the magnitude of the discontinuity (% change) increases. Based on the information shown in Figure D-33, it was concluded that damage was correlated with a change that exceeded 30% in the centerline length or centroid location of a wall (identified by the dashed lines in the figure). Correlation was strongest when the controlling directional properties (i.e., maximum values between two directions) were considered (Figure D-33c). A modification to the ASCE/SEI 31-03 Tier 1 Evaluation in the form of a new checklist statement was developed to capture this result.

Figure D-33 Magnitude of discontinuity measure for each discontinuity ID (color indicates the level of earthquake damage observed in the building in the vicinity of the discontinuity).

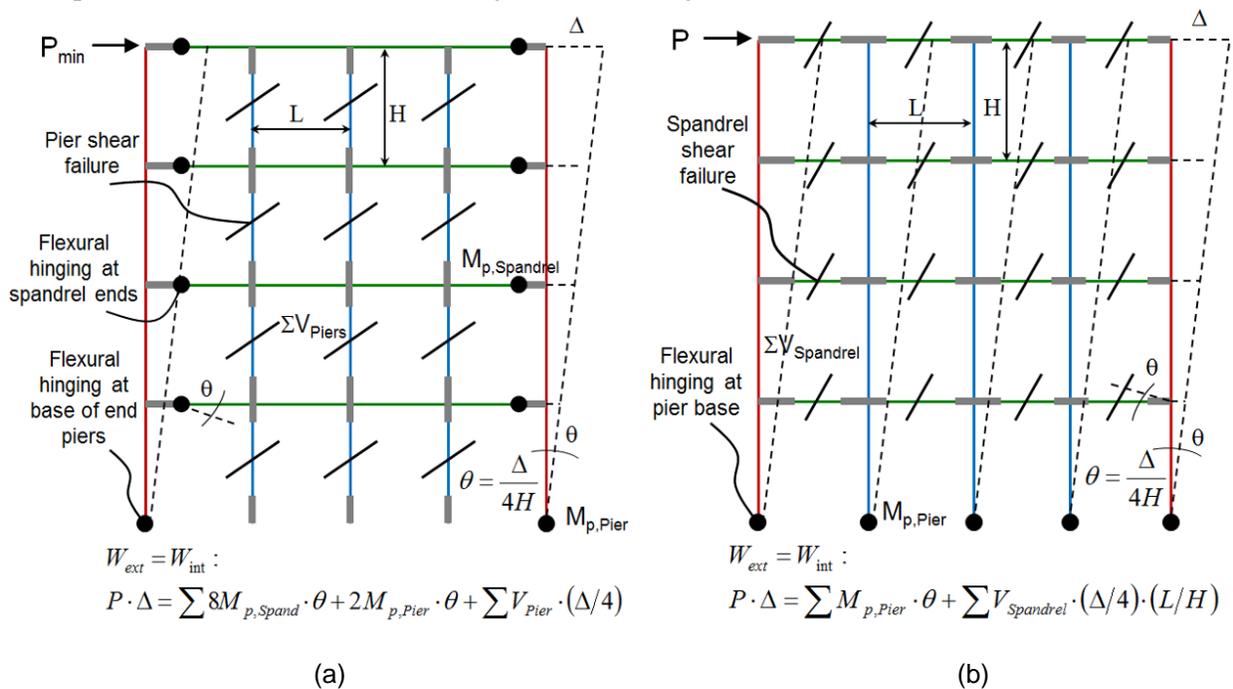
A system mechanism comprising shear damage to interior piers and flexural yielding at the end of the spandrels and exterior piers was found to have the lowest mechanism load and, thus, controls response. This mechanism is also consistent with the expected behavior and observed damage in the building.

Figure E-2 Sample plastic mechanisms studied: (a) mechanism validated by calculation and post-earthquake observations; and (b) mechanism considered and shown by calculation not to govern.

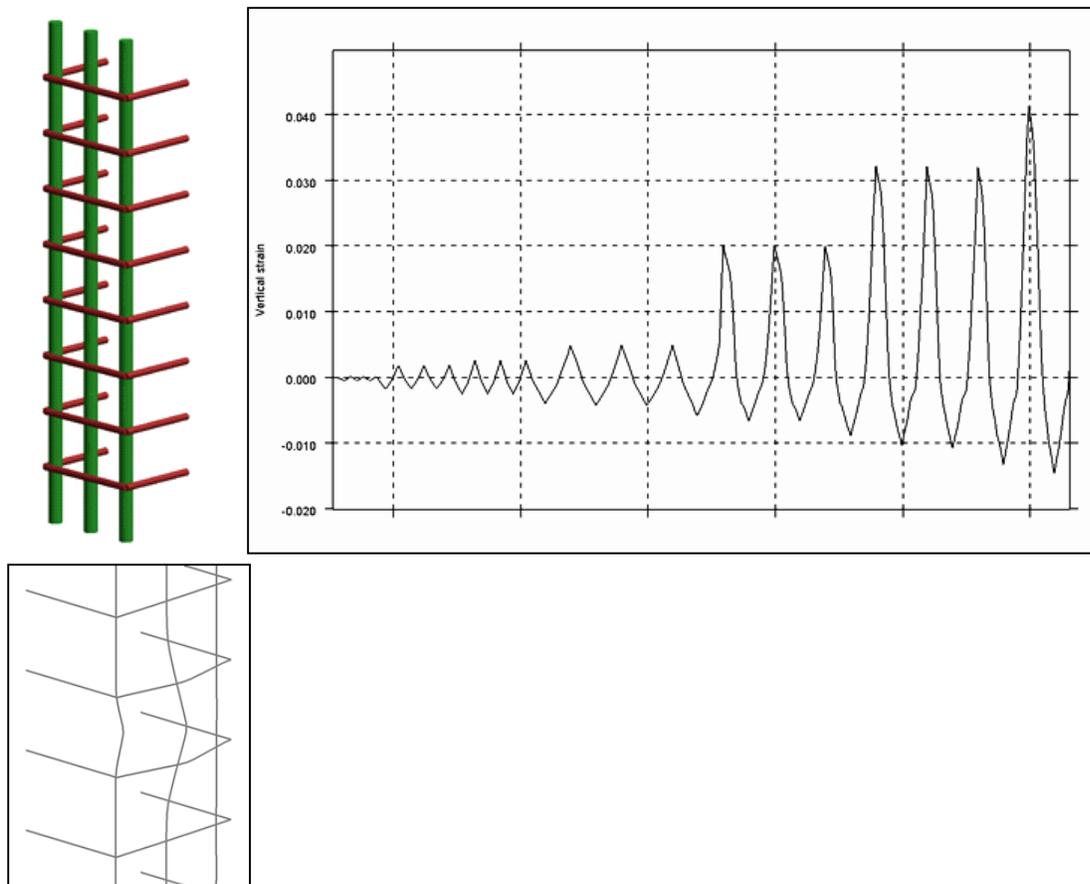
A detailed study was performed to examine bar buckling at the confined boundary region of the PW4 shear wall specimen by modeling the reinforcing bar with a refined mesh of fiber beam elements as in the simulation of the Rodriguez et al. tests. In this case, because the middle bar on the end face of the wall is not restrained by a hook, the entire rebar cage of the end of the wall was modeled with fiber beam elements, as shown in Figure F-11a. This model was subjected to the average vertical strain history predicted at this boundary in the initial LS-DYNA simulation of PW4 specimen (Figure F-11b). The reinforcement cage was restrained such that bars could not deflect into the core of the wall, but could deflect outwards as would be the case if the cover concrete had spalled. Figure F-11c shows the shape of the rebar cage after buckling. The middle (untied) bar buckles first, followed by the corner bars.

Figure F-11 Simulation of reinforcement cage buckling at PW4 wall specimen.

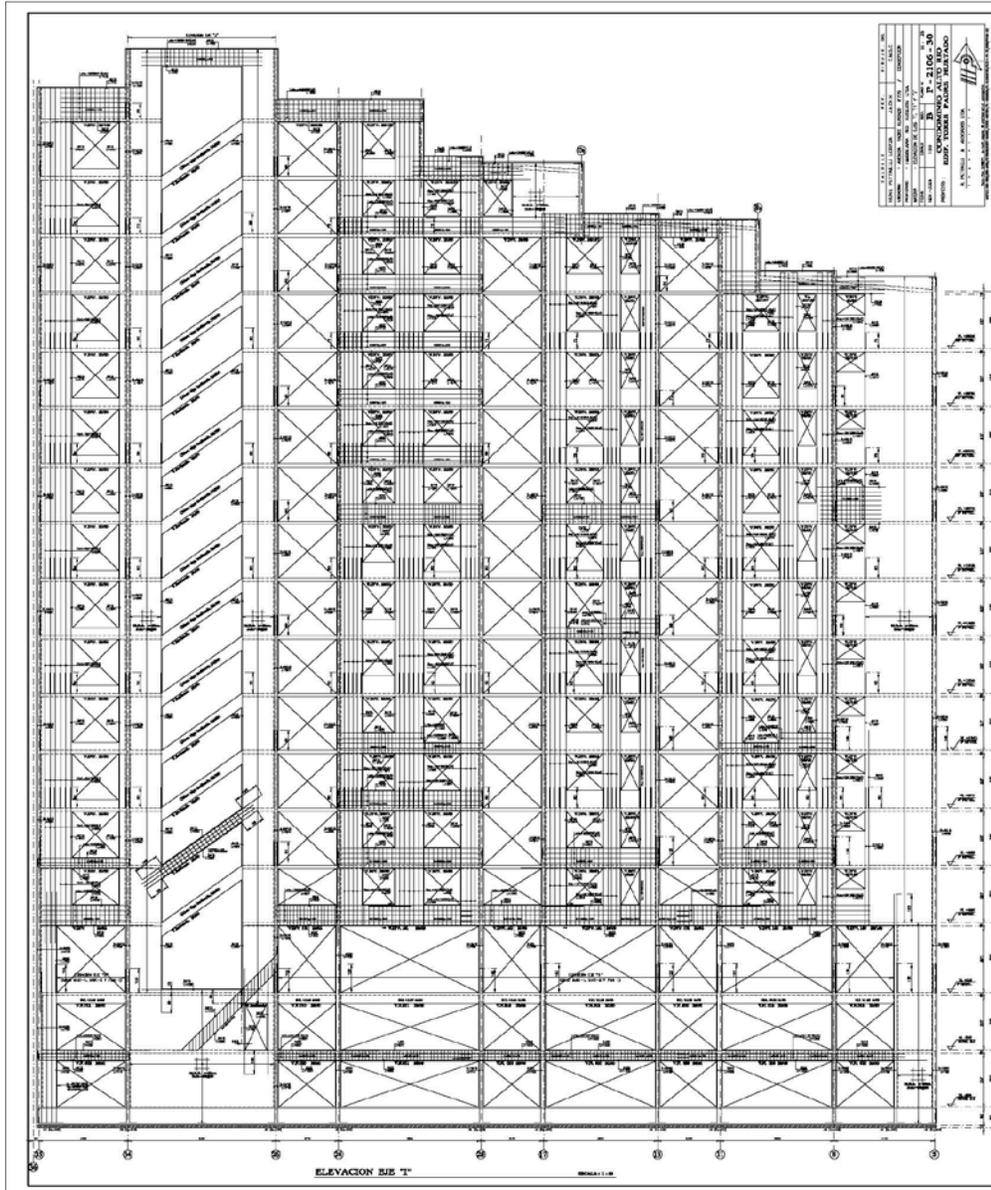
The Alto Rio building was 15 stories above grade with two basement levels below grade, supported by a mat foundation on alluvial soil. A longitudinal elevation of the building is provided in Figure F-13. The LS-DYNA analysis model comprised a representative three-dimensional slice of the building.

Figure F-13 Alto Rio Building longitudinal section (courtesy of Patricio Bonelli).

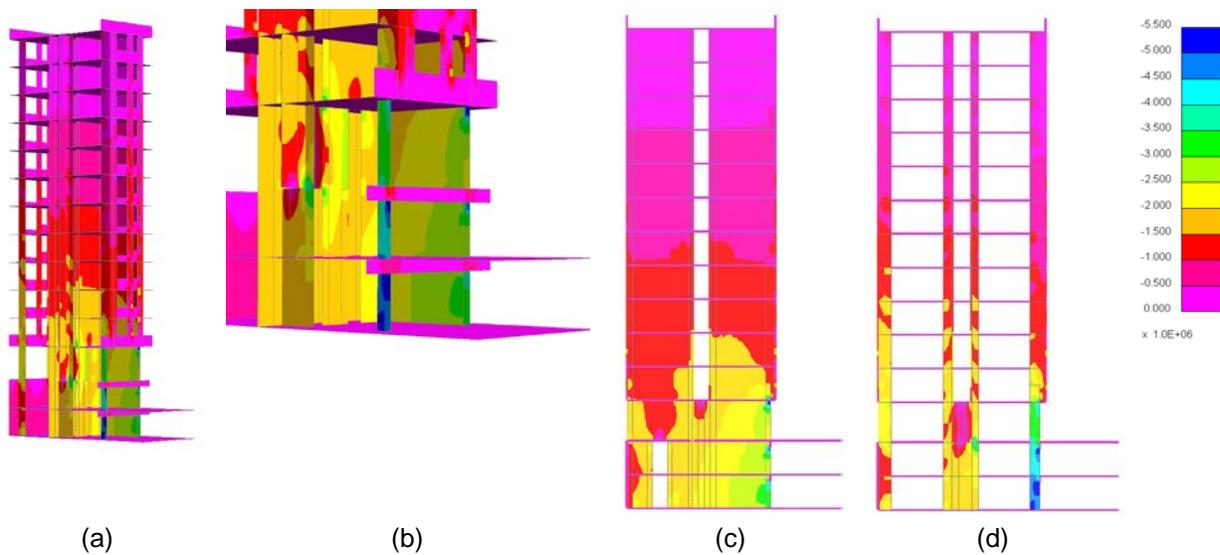
Figure F-16 illustrates the vertical stresses in the walls of the modeled portion of the building due to gravity. At grade level the average stress is 260 psi (1.8 MPa), or 0.04A_gf'_c, and the maximum stress is about 725 psi (5 MPa), or 0.12A_gf'_c.

Figure F-16 Gravity stresses (MPa) in LS-DYNA model (1 MPa = 145 psi): (a) perspective view; (b) close-up of basement, first, and second floors; (c) elevation at Grid 13; and (d) elevation at Grid 17.
