# **Brief Review of Building Damage by The 2011 Tohoku Japan Earthquake and Following Activities for Disaster Mitigation**

Masanori Iiba<sup>1</sup>, Isao Nishiyama<sup>2</sup>, Hiroshi Fukuyama<sup>3</sup>, Izuru Okawa<sup>1</sup> and Yasuo Okuda<sup>4</sup>

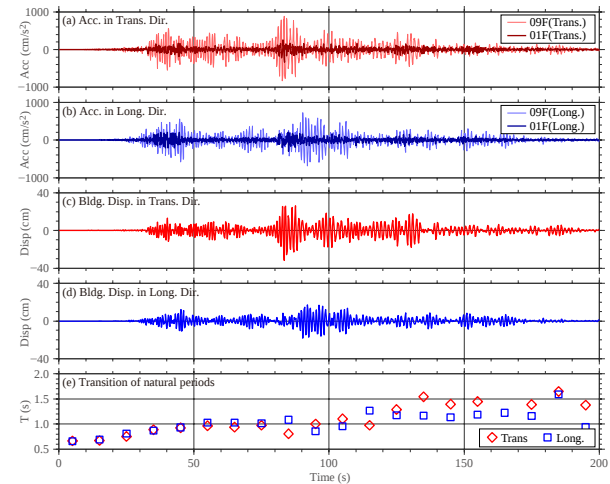
At least 4 buildings suffered severe earthquake motions with some damage. One example of the damaged buildings is a 9 storied steel reinforced concrete building in Sendai city. This building has a long history of recording of strong motions. Among them, strong motion records on the ninth floor that were obtained during the 1978 Miyagi-Ken-Oki earthquake are well known to have exceeded a maximum acceleration of more than  $1000\text{cm/s}^2$ . By that earthquake, multi-story shear walls suffered shear crack and later repaired to behave in a ductile manner. In the meantime, during the Tohoku Japan earthquake, the repaired multi-story shear walls suffered flexural failure. Figure 1 shows the records of the strong motions and the fundamental natural periods of the building ( $T$ ) calculated every 10 seconds (Kashima and Kitagawa [5]). The  $T$  increased from 0.6 seconds to 1.5 seconds during the earthquake. The change of  $T$  clearly shows and is consistent with the building damage.

Fig. 1 Recorded strong motion and the calculated fundamental natural period

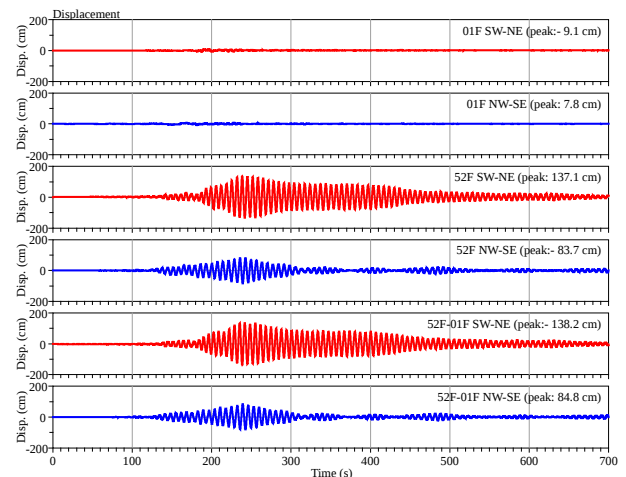
During the Tohoku Japan earthquake, long-duration and long-period earthquake ground motions were observed in Tokyo, Osaka and other large cities. One example is the 52+3 storied steel office building on the coast of Osaka Bay that is 770 km away from the hypocenter. Figure 2 shows the records of the absolute and relative displacement waveforms. The absolute displacements in the SW-NE and in the NW-SE directions on the 1<sup>st</sup> floor was less than 10 cm, but the 52<sup>nd</sup> floor in the building suffered a large motion with a zero-to-peak amplitude of more than 130 cm, which is thought to be due to a

resonance phenomenon. This indicates the importance of the prediction of long-duration and long-period ground motions by mega-earthquakes possibly to occur in Nankai trough.

Fig. 2 Recorded strong motion of 52+3 storied steel office building located at 770km from the epicenter
